FIELD SERVICE ACTION		
To: For the attention of: Please copy to:	All North American Dealers The Service Manager The Dealer Principal The Parts Manager Aston Martin Technician(s)	Reference: FSA: 0144 Issued: June
Model:	DB9 and V8 Vantage	2006
Vin Range:	DB9 00001 to 05265, V8 Vantage see list	
Subject:	Body System Diagnostic Socket Cover	Page: 1 of 3

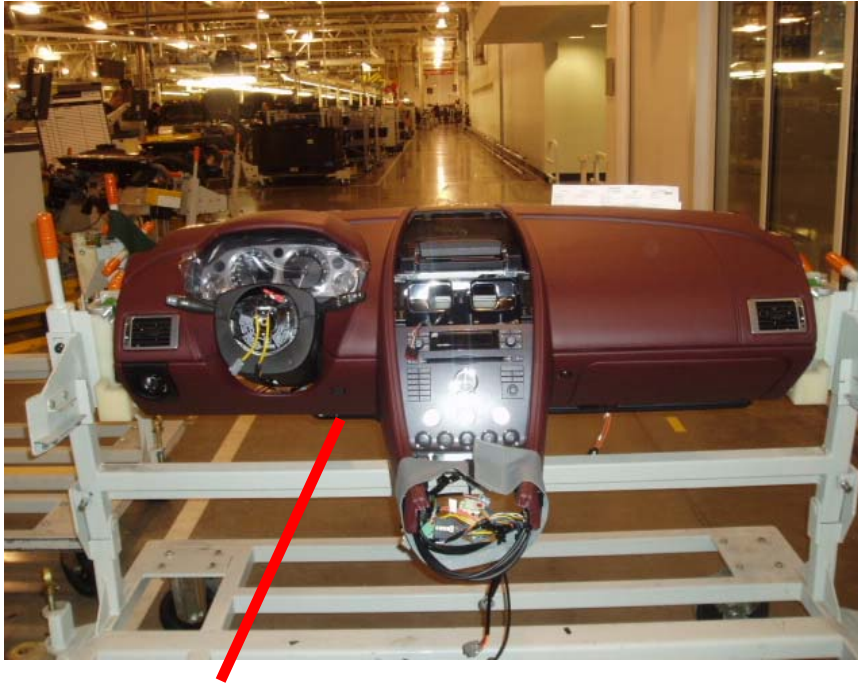
Figure 1

- Locate the Body system diagnostic connector as indicated in figure 1 (the body system diagnostic connector is the connector positioned closest to the centre console)

Diagnostic connector located in this area
