FIELD SERVICE ACTION		
To: For the attention of: Please copy to:	All Dealers/Importers The Service Manager The Dealer Principal The Parts Manager Aston Martin Technician(s)	Reference: FSA: 129
Model:	DB9	Issued: September 2005
VIN Range:	(--)0001 to (--)3811	
Subject:	Front Anti Roll Bar Bracket Fixings	Page: 1 of 3

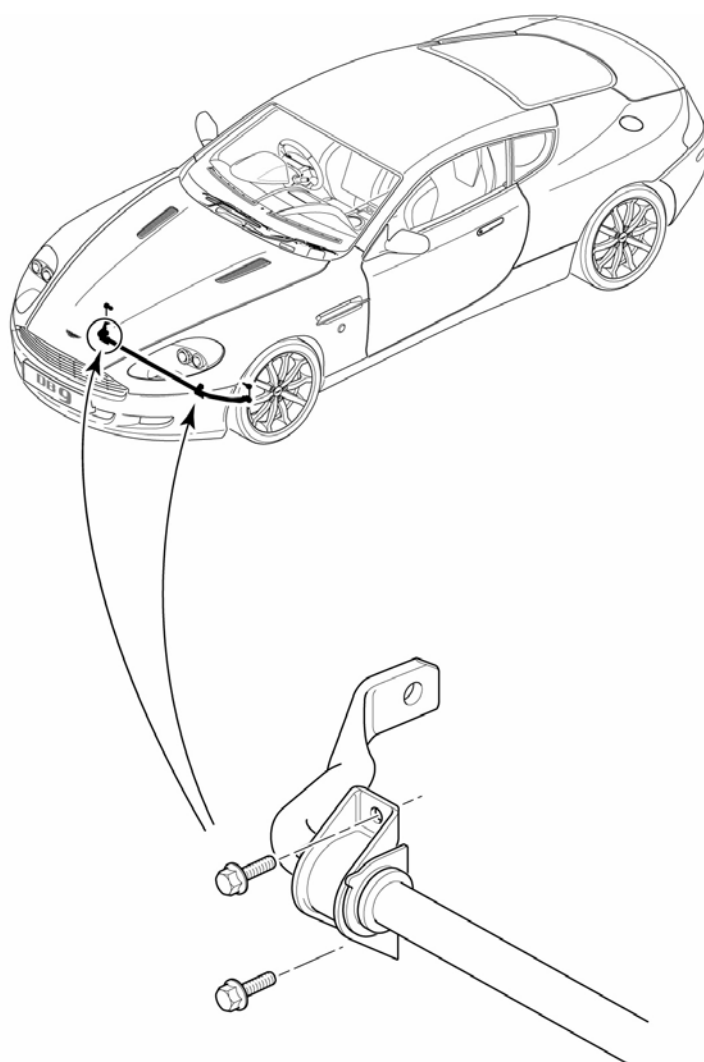
FRONT ANTI-ROLL BAR BRACKET FIXINGS (X4)

As a result of continuing Quality and Engineering investigations, a potential torque relaxation issue has been identified on the DB9 Front Anti Roll Bar Bracket fixings. To address this issue, please carry out the following workshop procedure.

- Ensure that the DB9 workshop vehicle protection kit is fitted
- Position the vehicle on a two-post wheel free ramp and raise the vehicle
- Remove the front undertray for access
- Locate the four Front Anti Roll Bar Bracket Fixings (M8 x 20 Flange Head Bolts, Part Number 700123) See the illustration overleaf
- Check and torque the fixings to 24Nm
- Refit the front undertray
