DB9

OBD II Diagnostic Manual
Preliminary Issue

ASTON MARTIN LAGONDA LIMITED

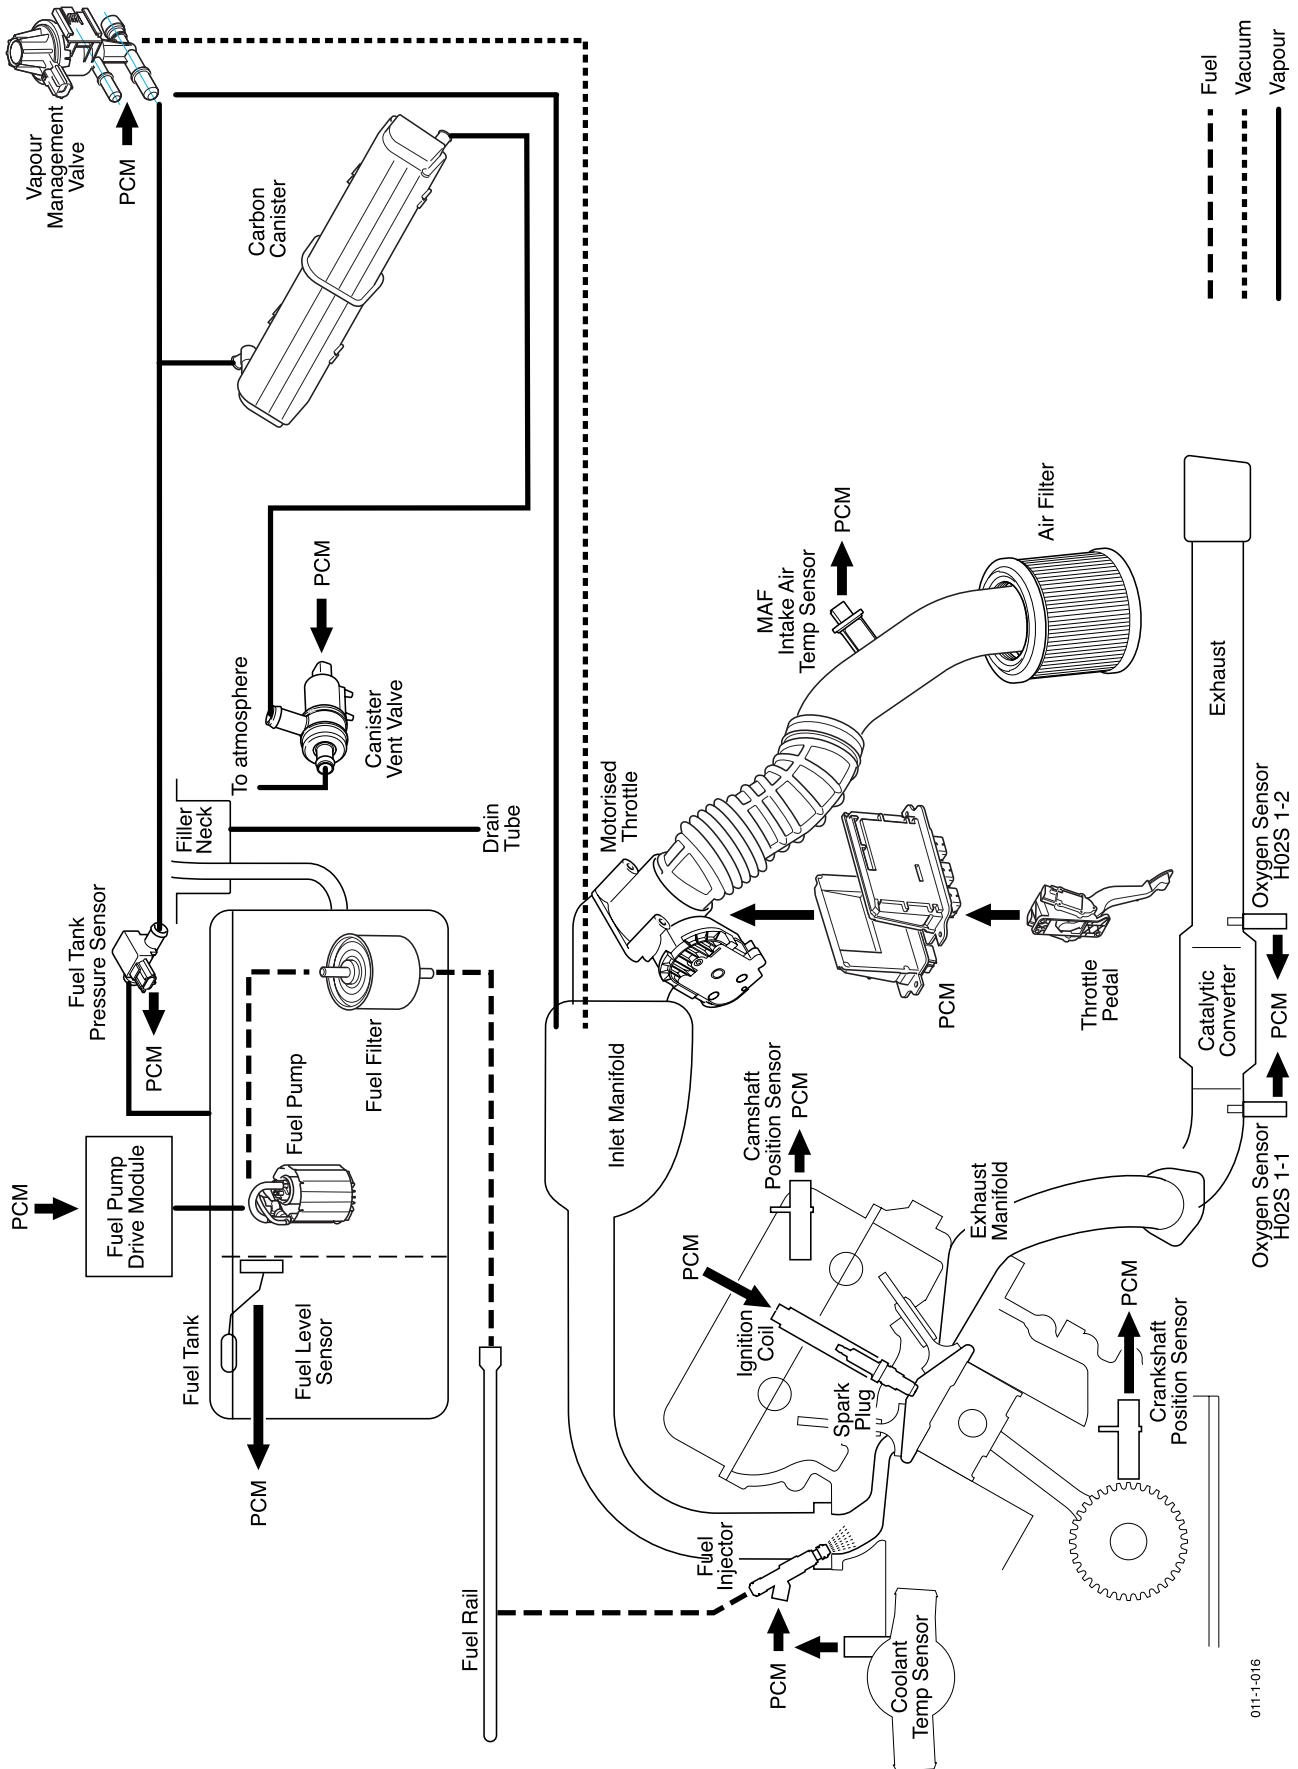
011-1-016

Engine Management - Schematic Diagram

The engine management system is controlled by the Powertrain Control Modules (PCMs), which receive signals from the sensors, compares them to the required standards and then modify the fuel and ignition settings to maintain an optimum, stoichiometric, fuel and air mixture under all conditions. Sensor information is supplied to the Control Module Inputs, and control commands are issued through the Control Module Outputs. The PCMs are located one under each front wing.

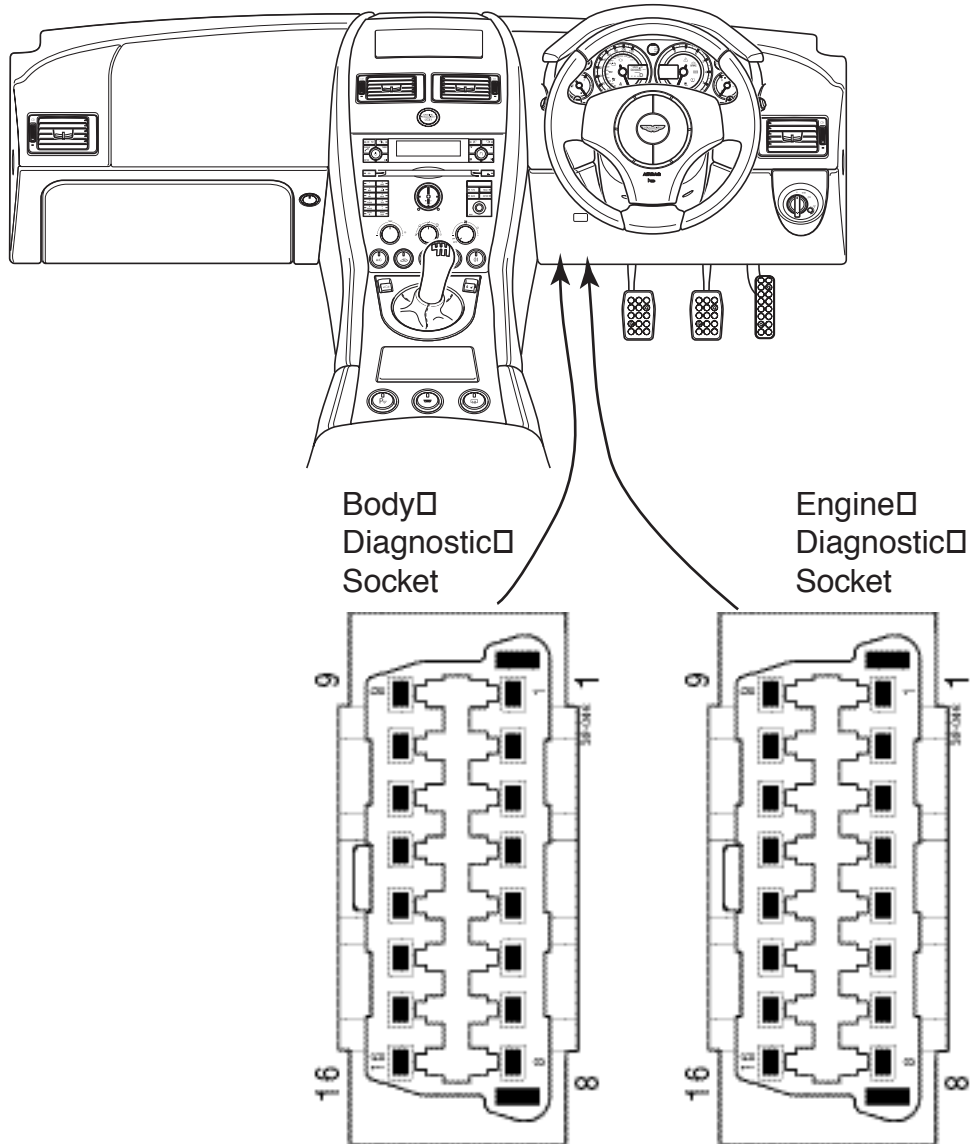
Diagnostic Sockets Location and Use

The two diagnostic sockets are located on the drivers side of the centre console. Note that the sockets change sides between left and right hand drive vehicles. The following systems are accessed from each socket:

Body Socket - Closest to the Centre Stack

- Airbag and Seat Belt Pretensioner System
- Security System
- Body Module
- Transmission Control Unit (datalogging and DTC read)

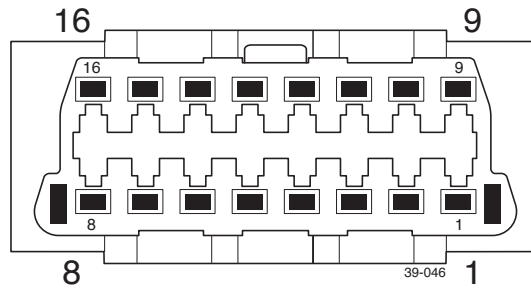
Diagnostic Sockets - Pin Location and Function

Engine Socket (Drivers Side)

Pin	Function	Used by:
1		
2		
3		
4	Power Ground	All
5	Chassis Ground	All
6	CAN Link (+) High Speed	
7		
8		
9	+12V Ignition Supply	Input Power/Signal
10		
11	No Connection	
12	No Connection	
13	FEPS	Flash reprogramming
14	CAN Link (-) High Speed	
15	No Connection	
16	12V Battery	All

The pin connections to each socket are shown on the following page:

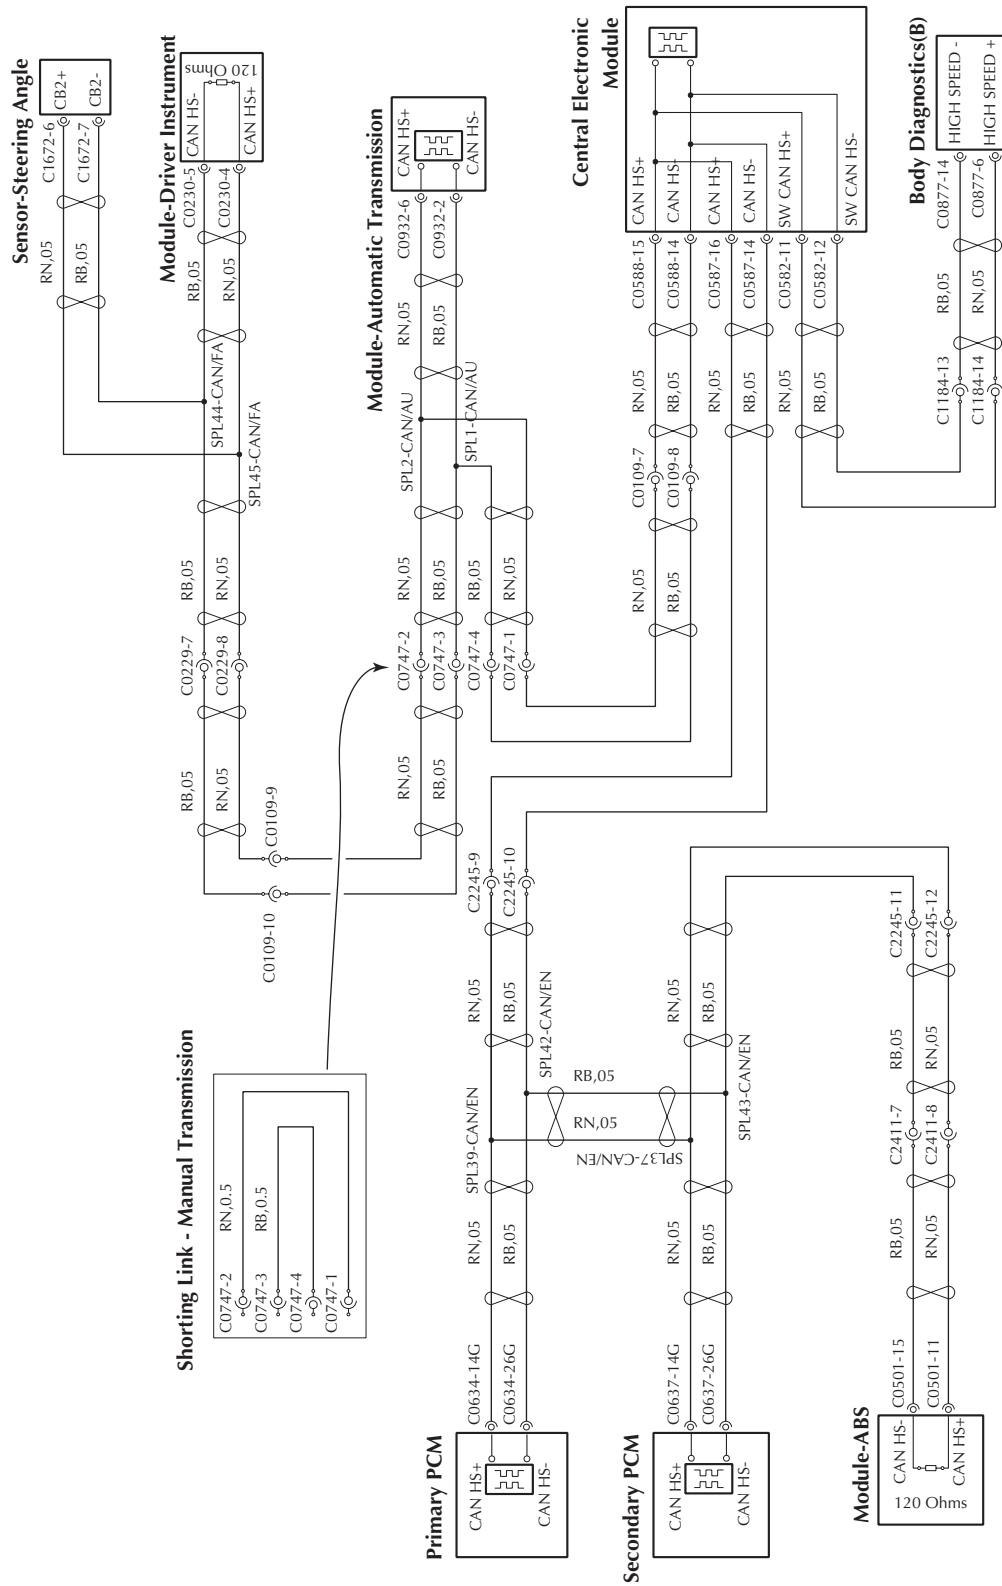
3. Check for relevant modules off-line. (Cross check against the following High Speed CAN Circuit).

DB9
CAN Bus 2
(High Speed Volcano)

9. If DE49 (Steering Angle Sensor not alive) is logged, Disconnect the steering angle sensor and check continuity of the HS CAN + line from C1672-6 to C0877-6 and the HS CAN - line from C1672-7 and C0877-14.
10. Set WDS Datalogger to monitor the Steering Angle Sensor. Turn the steering wheel and check for a corresponding change in the sensor reading. If the response does not match steering wheel movement, the sensor is faulty. Replace the steering angle sensor. Reconnect all components and retest the sensor to ensure that the problem is resolved.

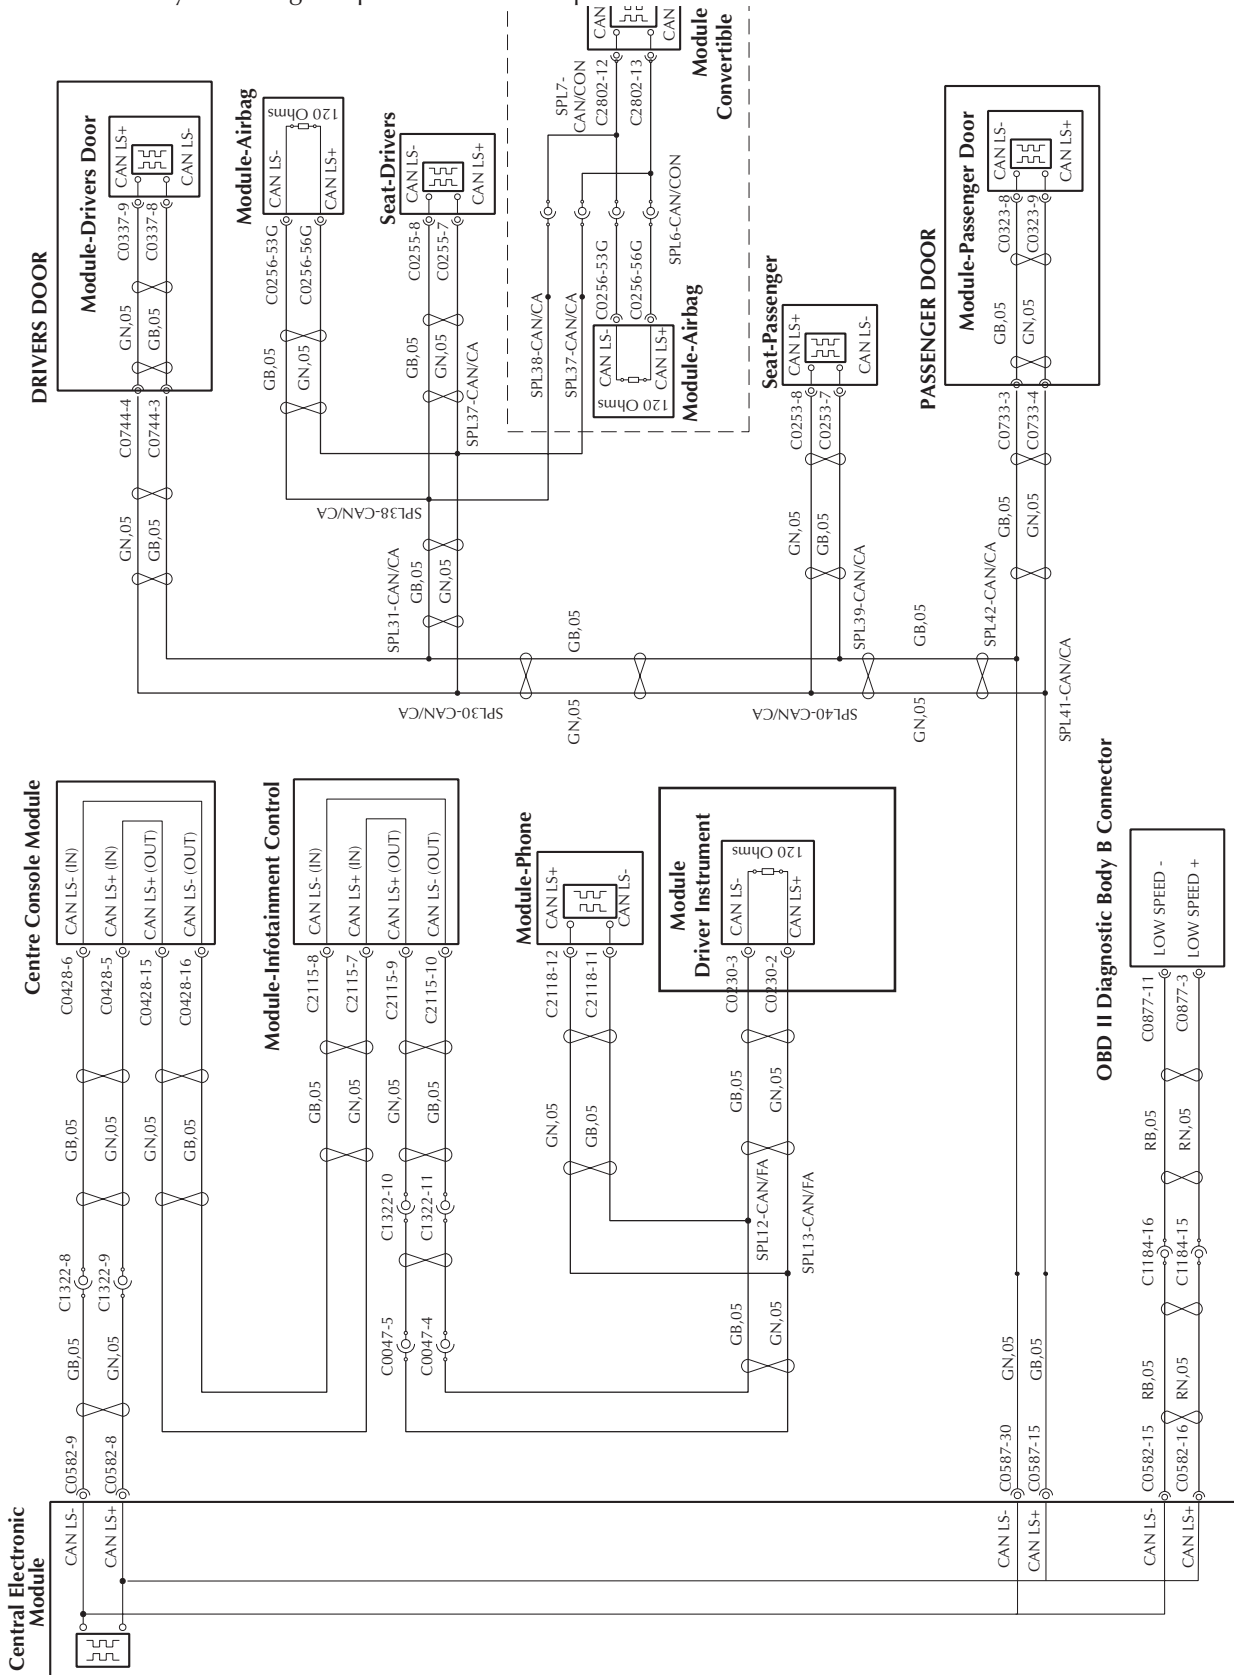
- From the logged DTCs, check for relevant modules off-line. (Cross check against the following Low Speed CAN Circuit). If any module is Off-Line, check the power and ground supplies to that module and service as necessary.

If no fault is found in the power and ground supplies, note the CEM fault code(s) and service the defective CAN link as necessary following this procedure from step 5.

5. If any of codes DE29, DE51, DE54, or DE58 is present, there is a continuity fault in the CAN Bus between the terminator resistors. Go to step 6.

If none of the above codes is logged but any of codes DE42, DE 43, DE45, DE52 or DE64 is present, the continuity check in step 6 should pass. The fault lies in a LS CAN bus spur and not in the main CAN bus between the terminator resistors. Go to step 7.

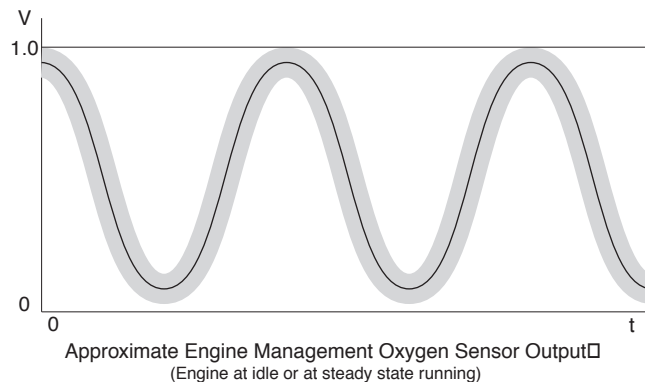
3. Start the engine and run at idle until the temperature gauge rises above minimum.
4. Start the datalogger to monitor the upstream engine management VEGO signals. Observe the signal trace and compare with the illustration below

5. Note also the fuel rail pressure for both fuel rails.
6. Raise the engine speed to a steady level of approximately 2000 rpm. Again monitor the upstream VEGO signals and Δ FPRESS readings.
7. If there are no engine management DTCs logged and if the signal patterns observed in steps 4 and 6 meet the following guidelines, then engine running is acceptable.

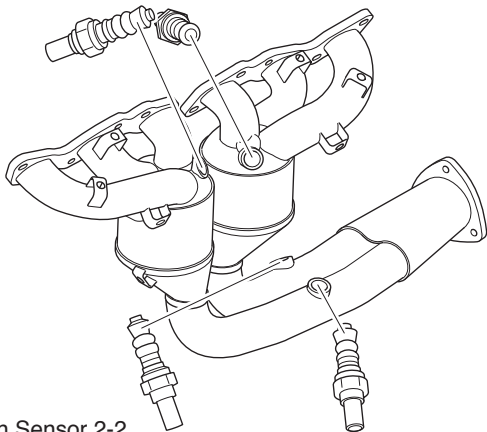
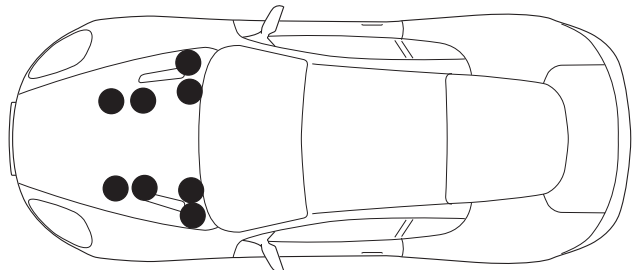
Heated Oxygen Sensor 1-1 Heated Oxygen Sensor 2-1

Heated Oxygen Sensor 2-2 Heated Oxygen Sensor 1-2

Figure 1. HO2S Location

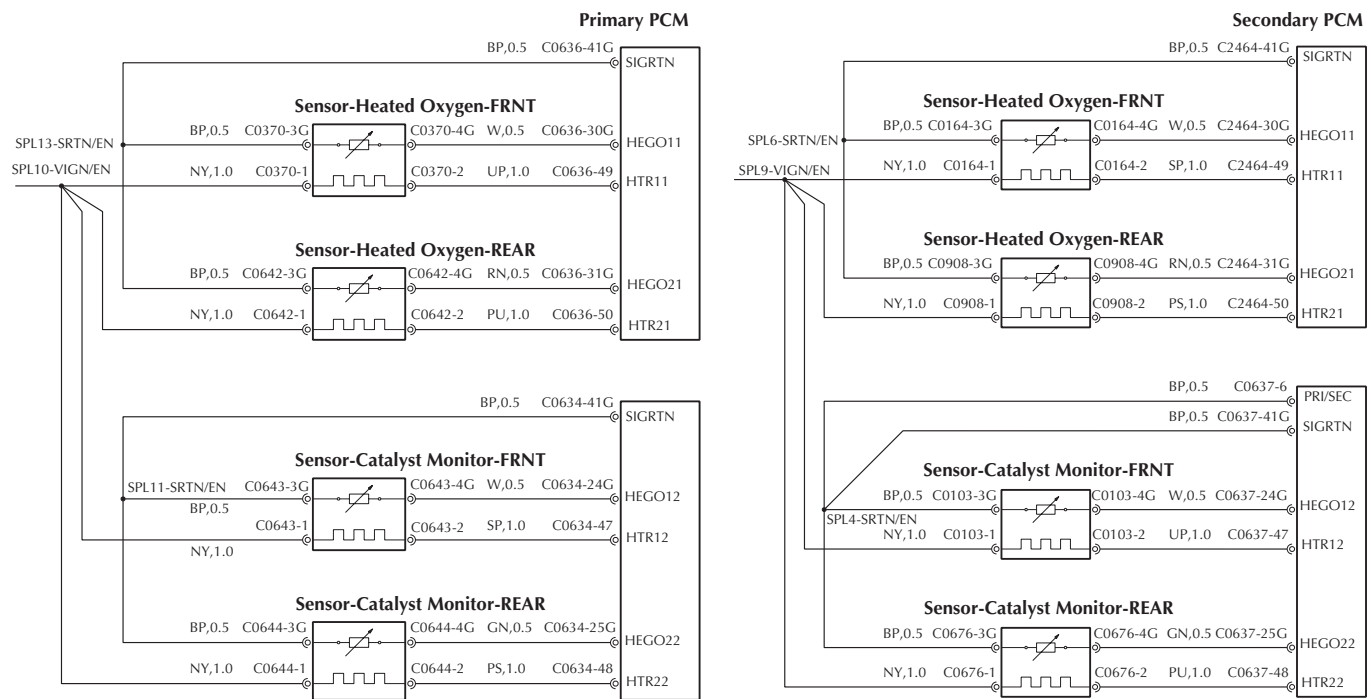
Figure 2. HO2S - PCM Interface Circuits

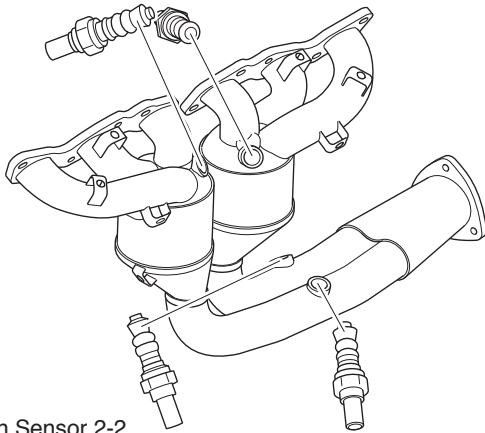
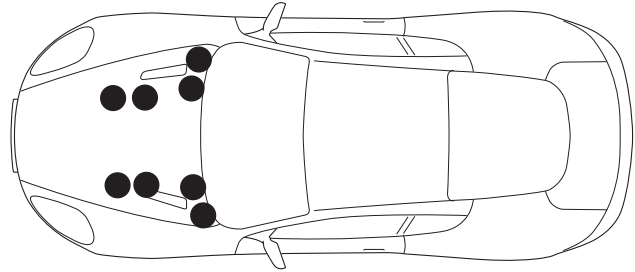
Heated Oxygen Sensor 1-1 Heated Oxygen Sensor 2-1

Heated Oxygen Sensor 2-2 Heated Oxygen Sensor 1-2

Figure 1. HO2S Location

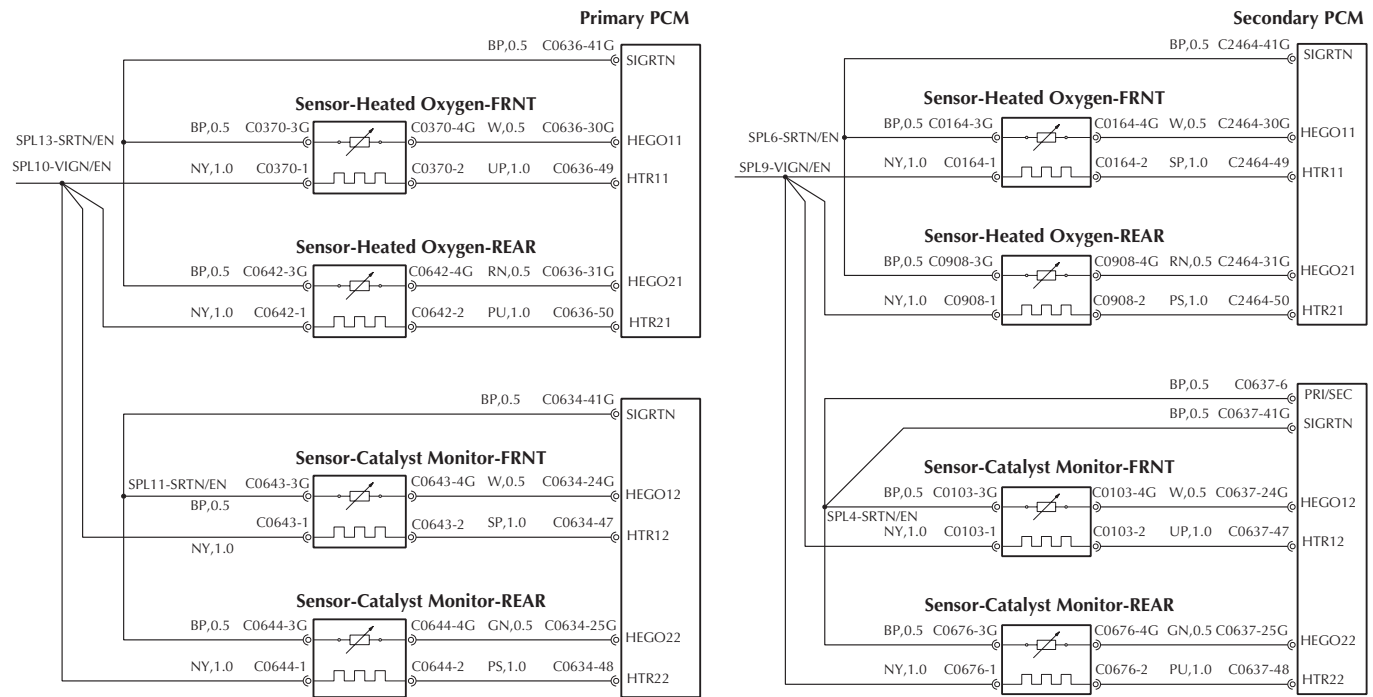
Figure 2. HO2S - PCM Interface Circuits

6. If the applied voltage measured in step 4 is above 10.5 volts, check the resistance of the HO2S heater which should be between 3 and 5Ω when cold. If the heater resistance is not within range, replace the oxygen sensor.

7. If the heater resistance is in specification, check for a short circuit to ground within the sensor. Measure from the sensor power connection to the sensor case. If the resistance is less than 10kΩ, replace the sensor.

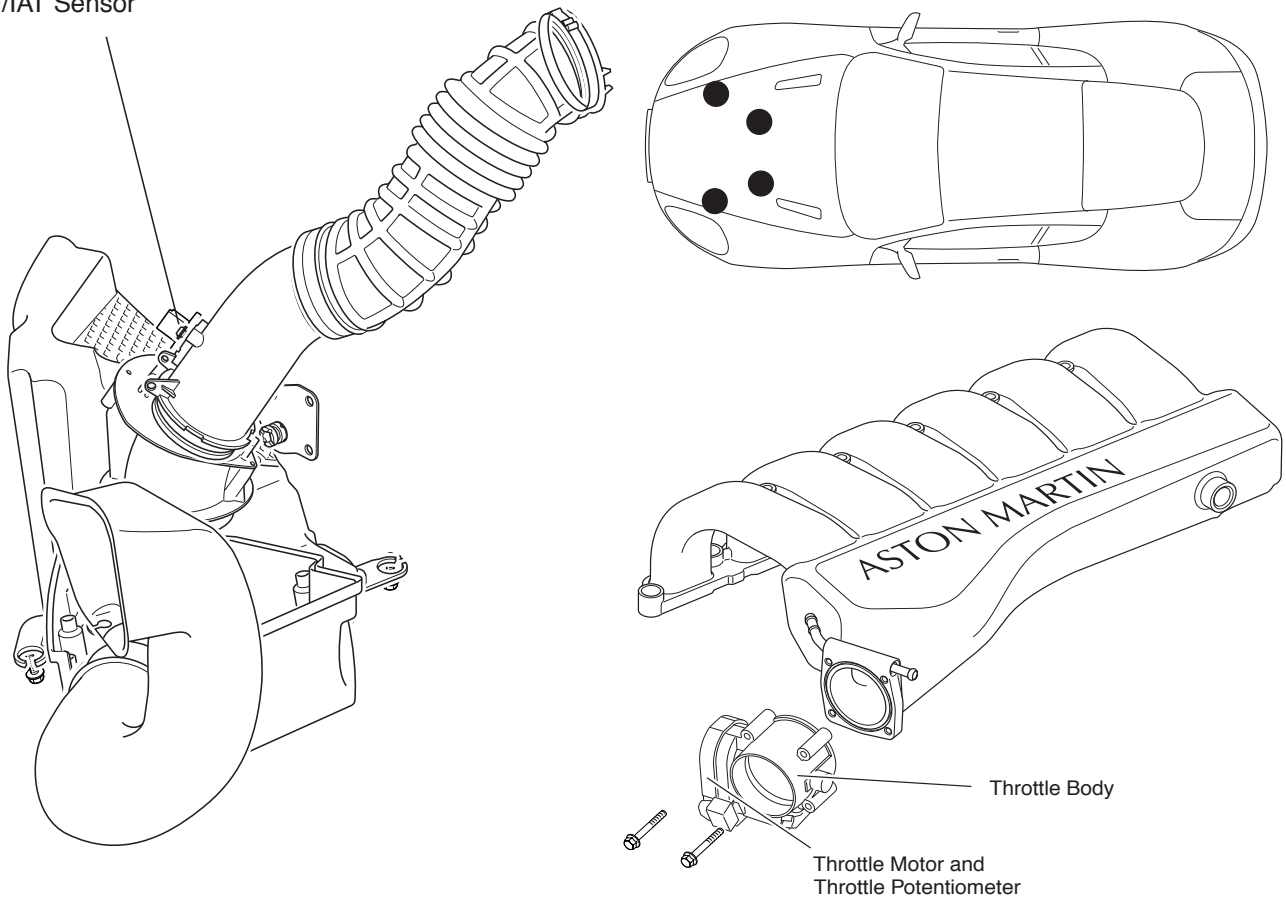
MAF/IAT Sensor

Figure 1. MAF and TP Locations

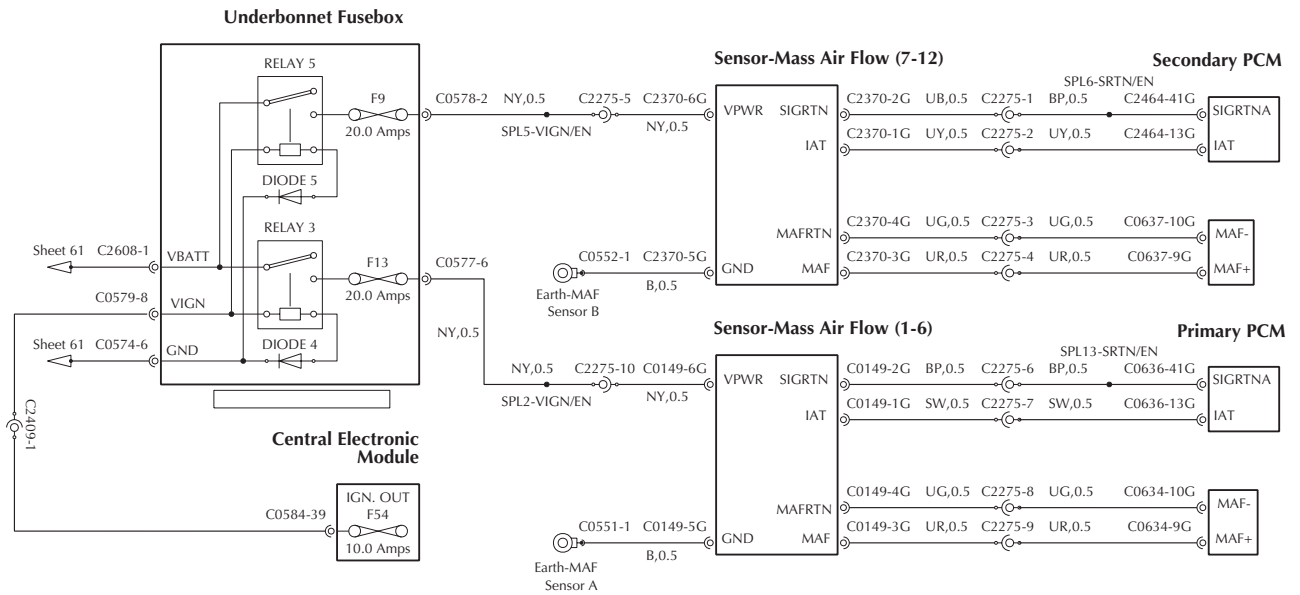
Figure 2. MAF Sensor Circuits

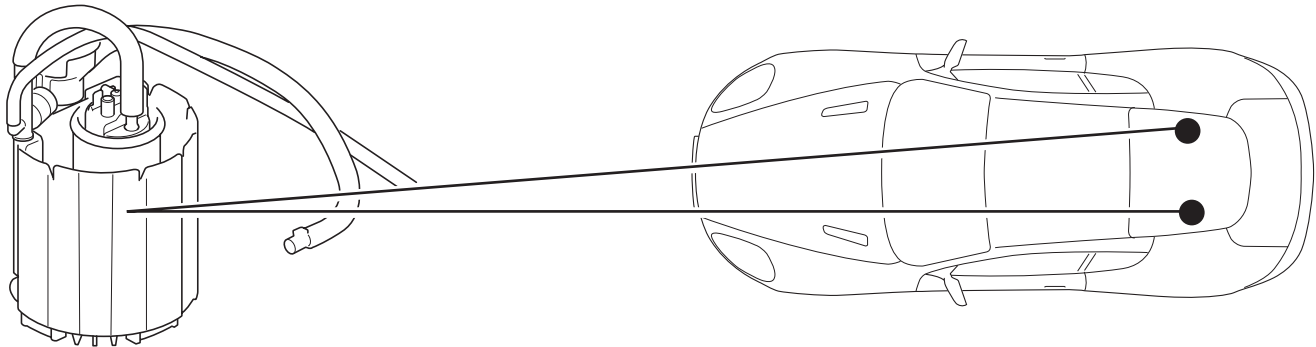
Figure 1. Fuel Pumps Location

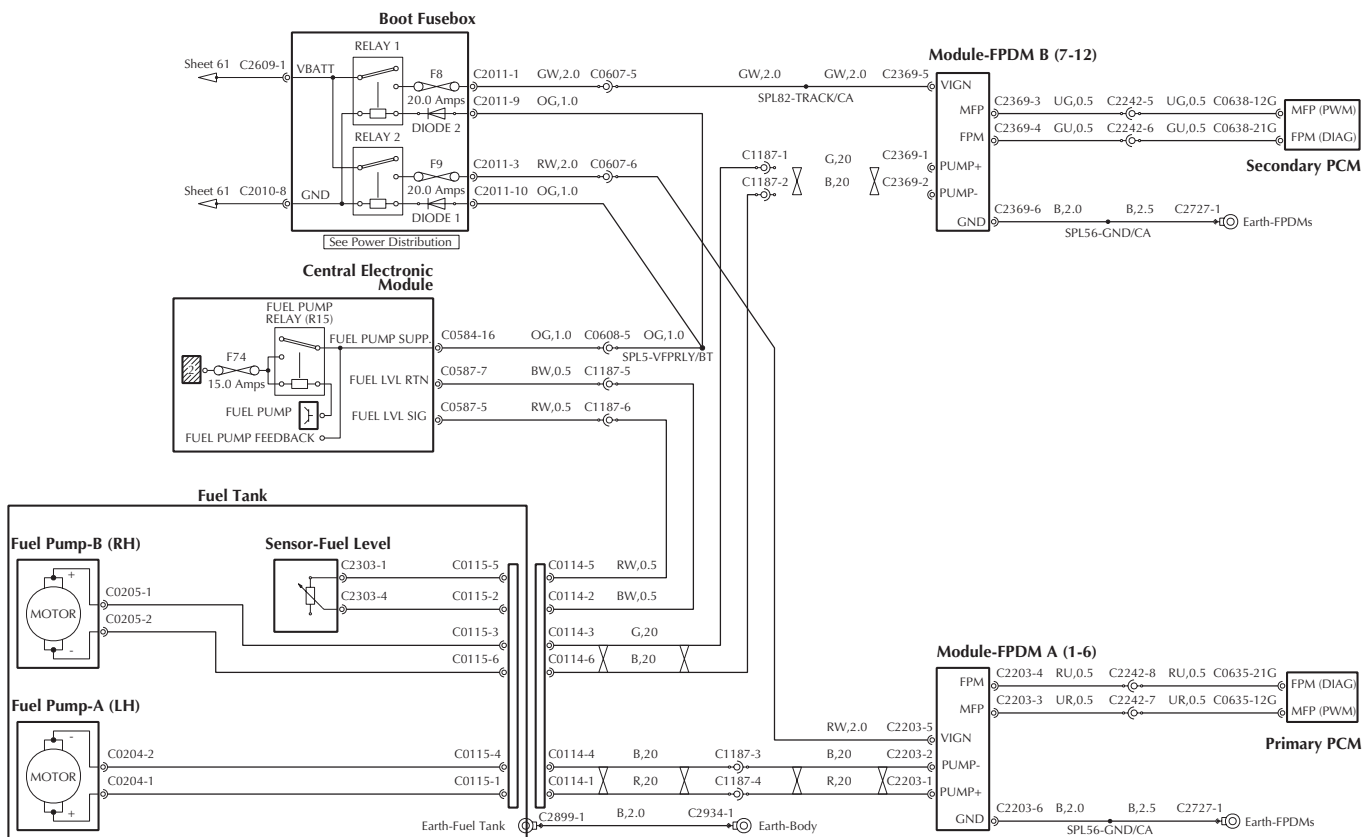
Figure 2. Fuel Pump Circuits

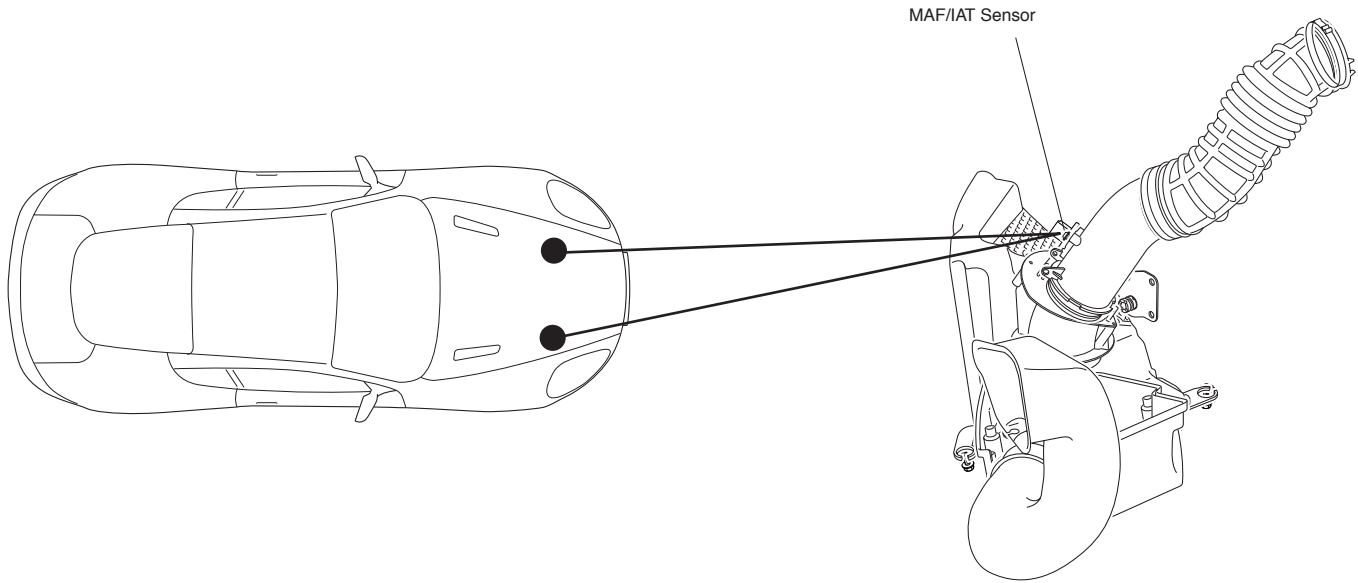
Figure 1. MAFS Location

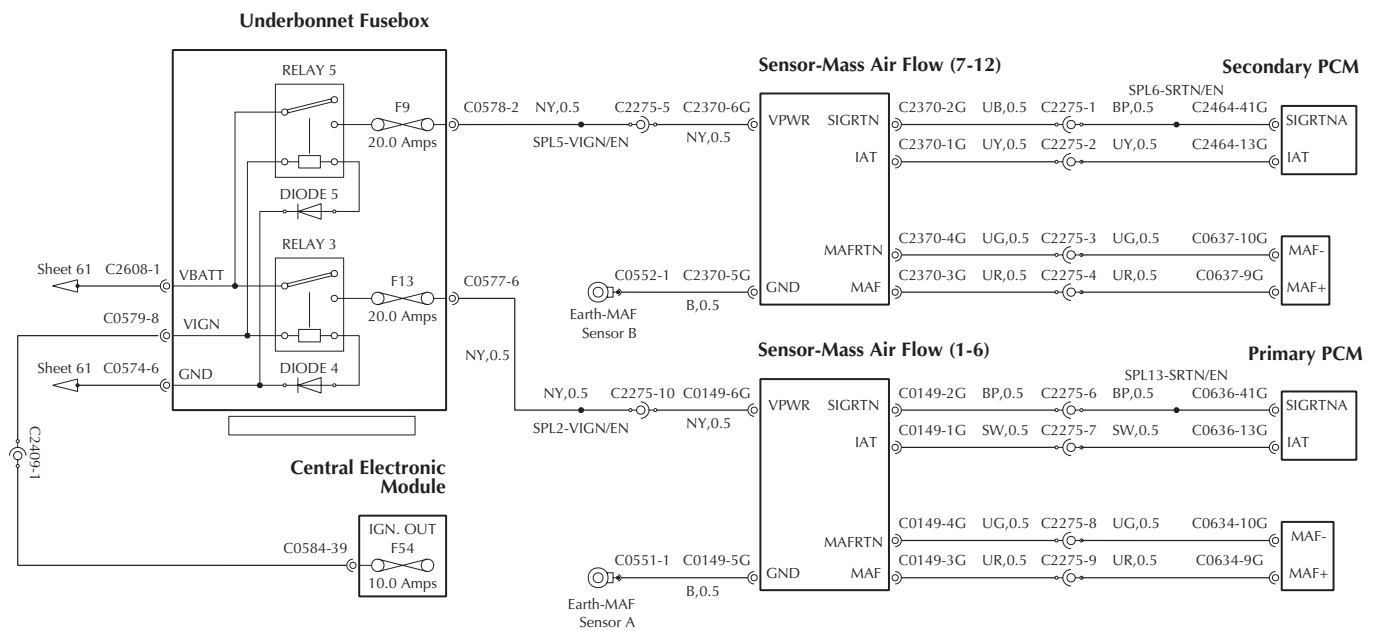
Figure 2. MAFS - PCM Interface Circuit

If either MAF voltage is below 0.24 volts, go to step 4.
4. Check the VPWR voltage on MAF sensor pin 6. If the supply voltage is below 10.5 volts, key off. Remove underbonnet fuses F18 (MAF 1-6) or F6 (MAF 7-12). Check the fuse continuity and replace if necessary.

If the voltage is in the range 10.5-13.5V, troubleshoot and repair the open circuit in the 12V supply from F18 or F6 to MAF sensor connector pin C2370-6 or C0149-6. Replace F18 and F6. Switch on the ignition and clear the P0102 code. Repeat the KOER test to ensure that the P0102 problem is resolved.
5. Key off, disconnect the MAF Sensor, key on engine off. Measure the voltage across MAF harness connector pin 6 +12V EMS supply and pin 5

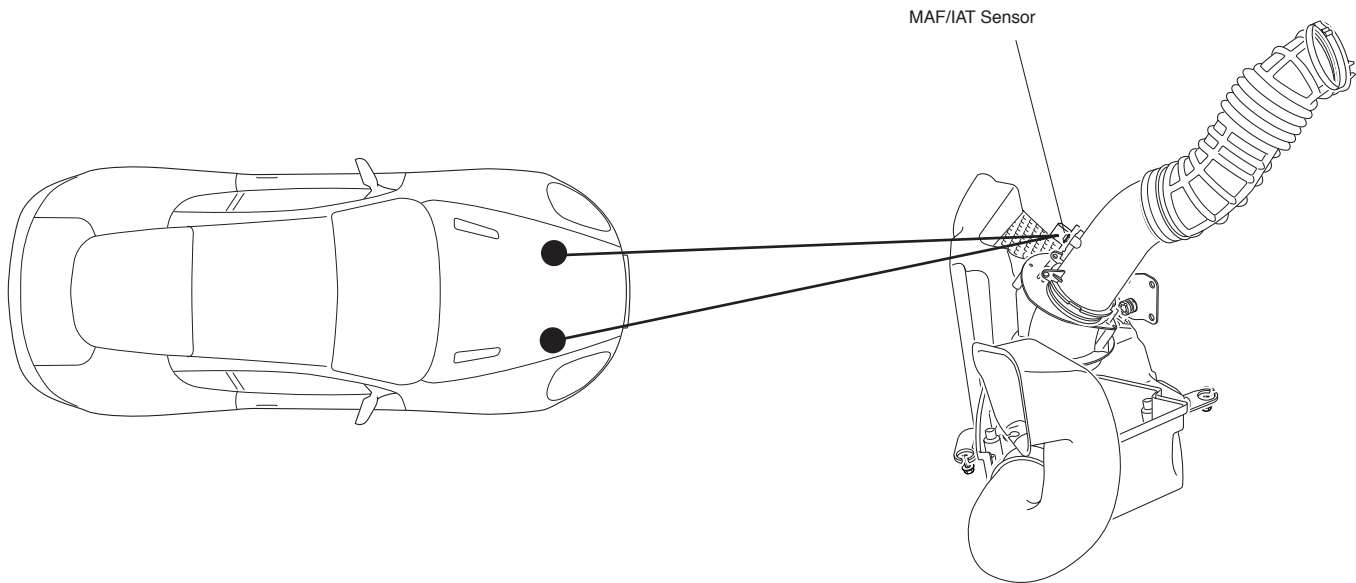
Figure 1. MAF Location

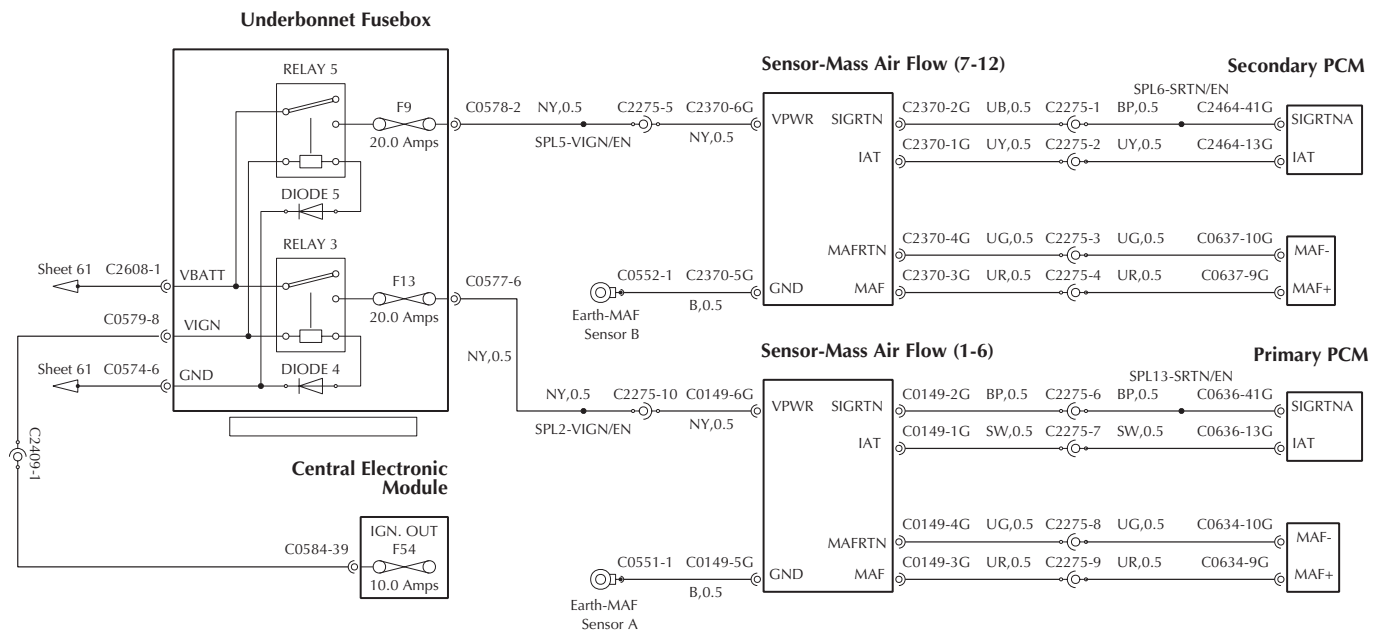
Figure 2. MAF - PCM Interface Circuit

If the voltage is still above 4.60V, there is a short between +12V Power and the MAF signal line to Primary PCM pin C0634-9 or Secondary PCM pin C0637-9. Repair the short circuit and go to step 5.

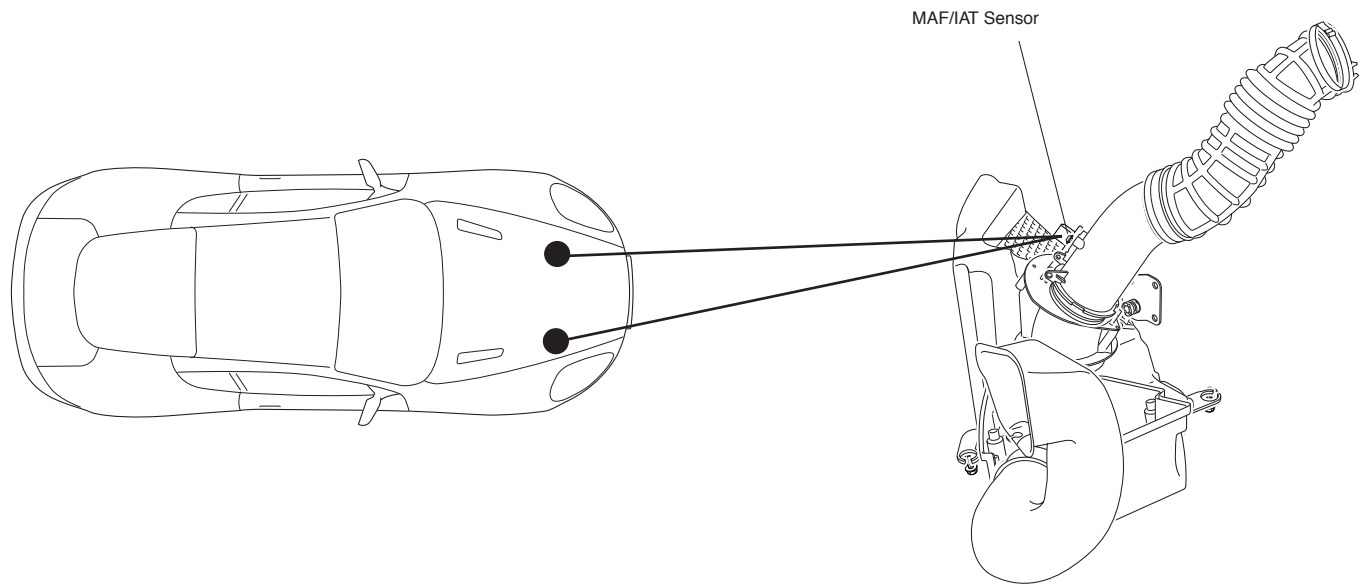
Figure 1. MAF Location

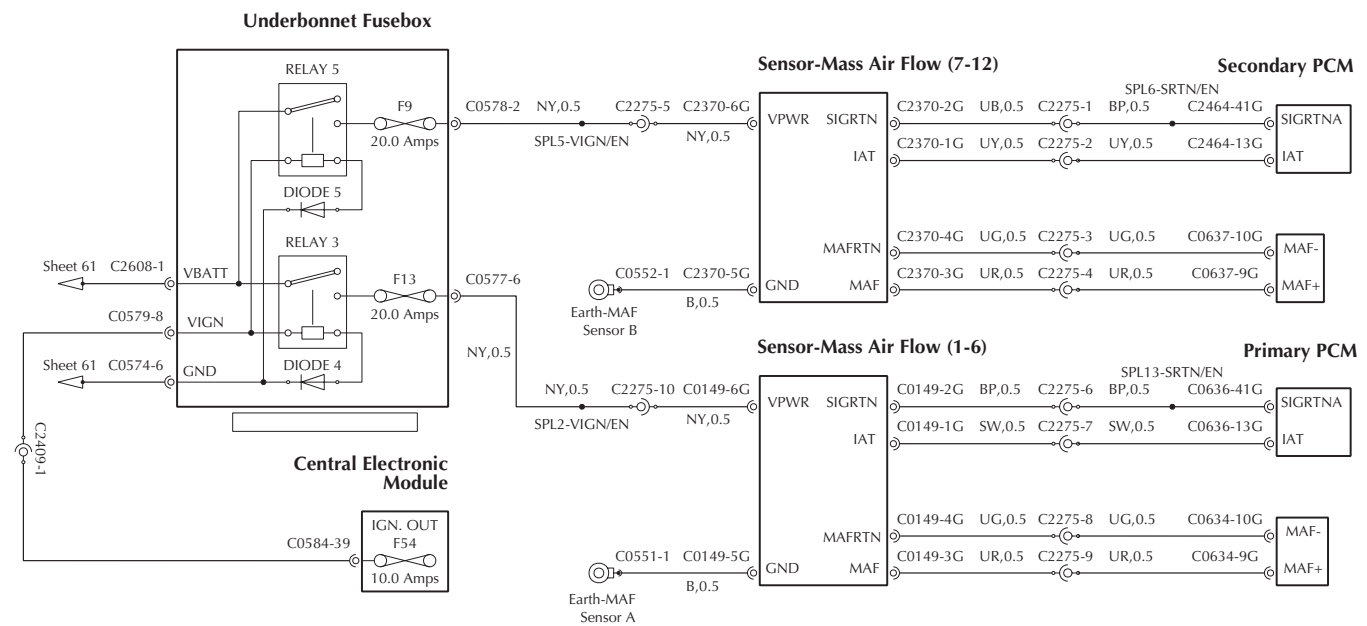
Figure 2. MAF - PCM Interface Circuit

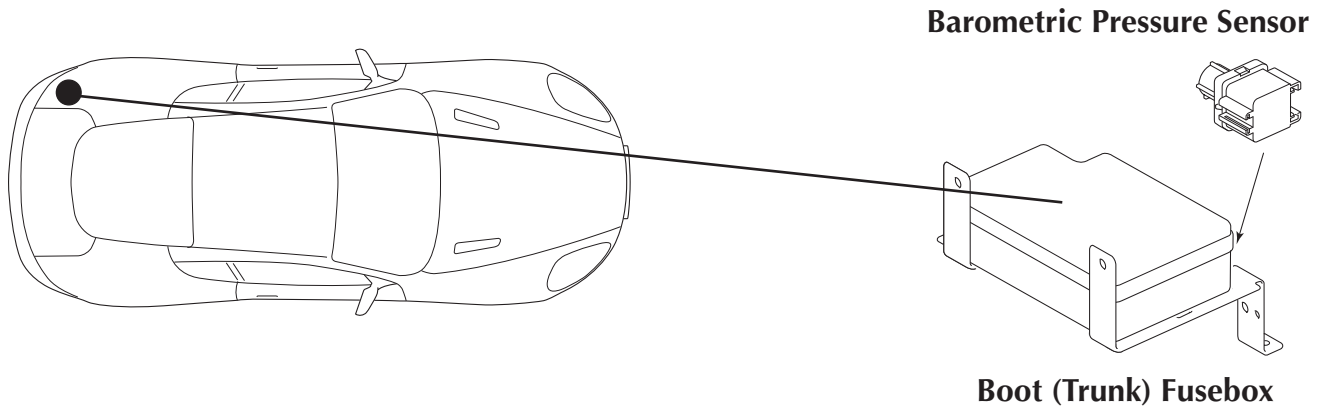
Figure 1. Barometric Pressure Sensor Location

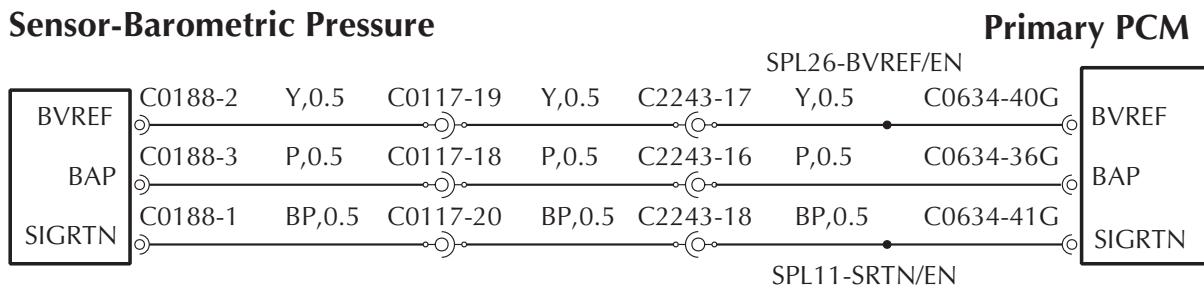
Figure 2. BFS - PCM Interface Circuit

If +5 volts is measured, the BVREF signal is good. There is an open circuit in the BVREF or Signal return lines to the barometric pressure sensor. Service the wiring as necessary. Clear the P0107 code and run a KOER test to ensure that the problem is resolved.

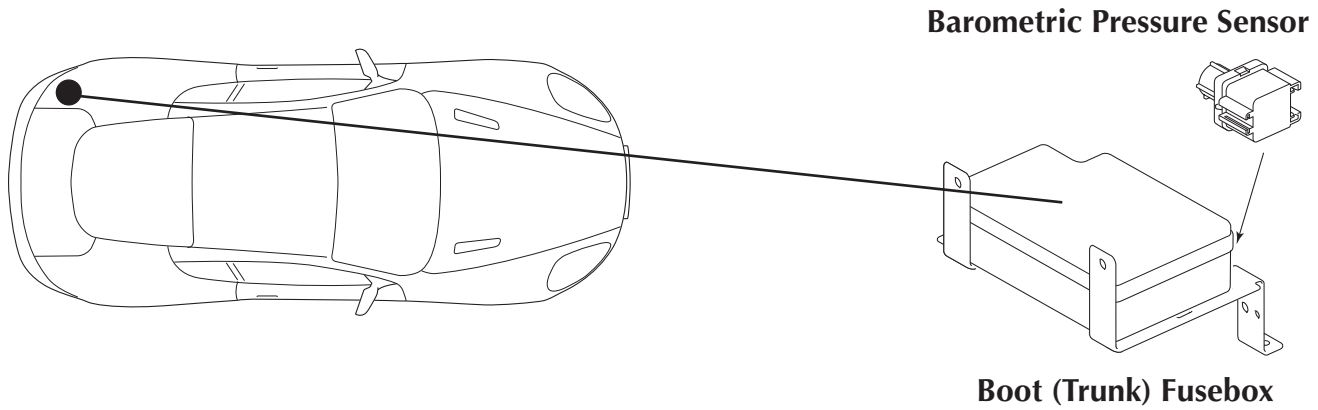
Figure 1. Barometric Pressure Sensor Location

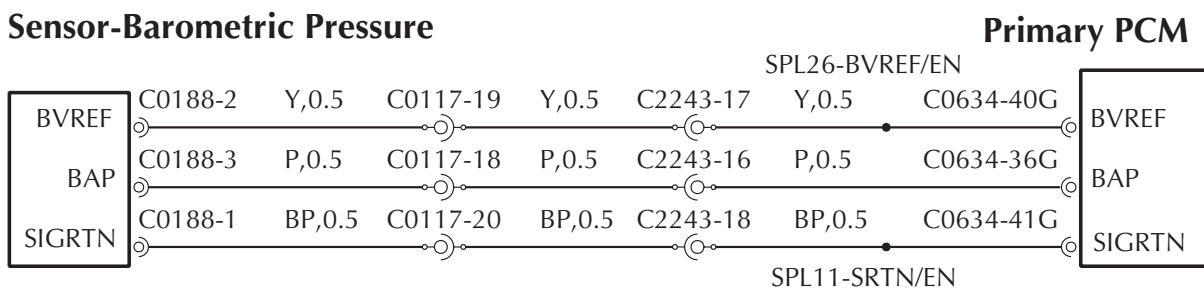
Figure 2. BFS - PCM Interface Circuit

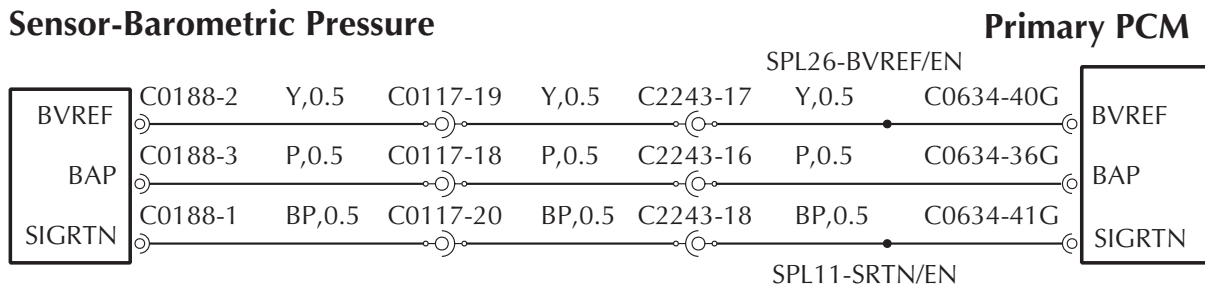
Figure 2. BFS - PCM Interface Circuit

5. Check and service the short circuit from +12 volts to the BAP signal line. Clear the P0109 code. Run a KOER test to ensure that the problem is resolved.
