DB9

OBD II Diagnostic Manual
Preliminary Issue

ASTON MARTIN LAGONDA LIMITED

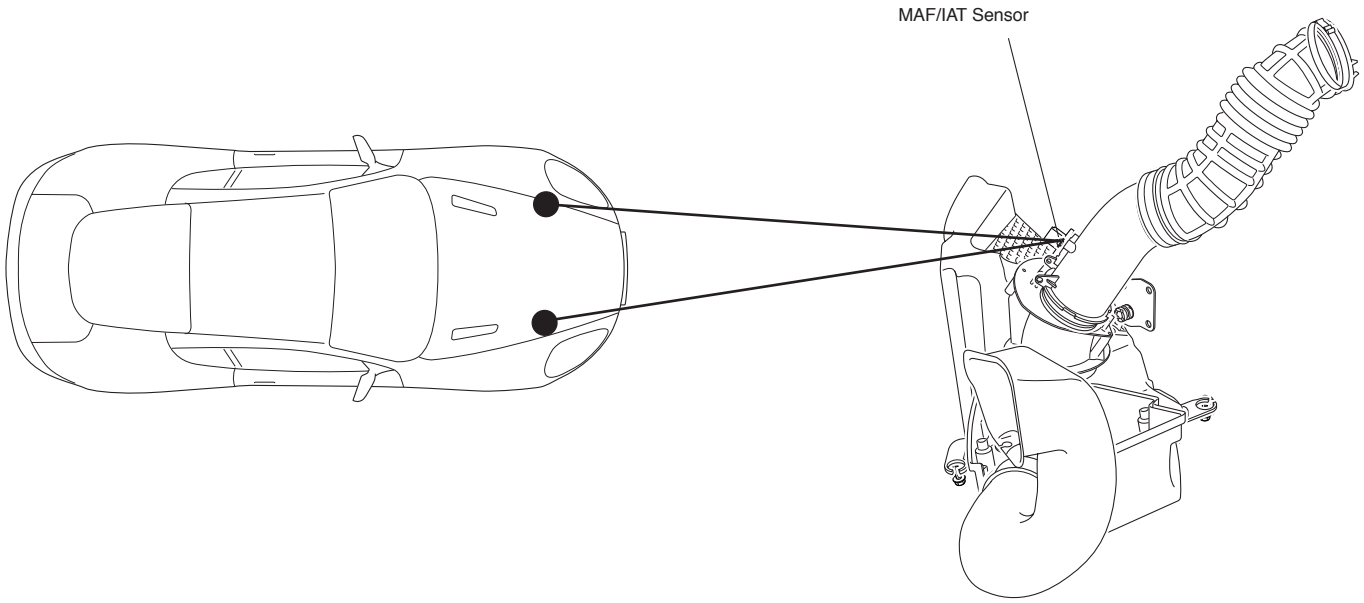
Note: The intake air temperature sensors are located in the MAF sensor assemblies

Figure 1. IAT Location

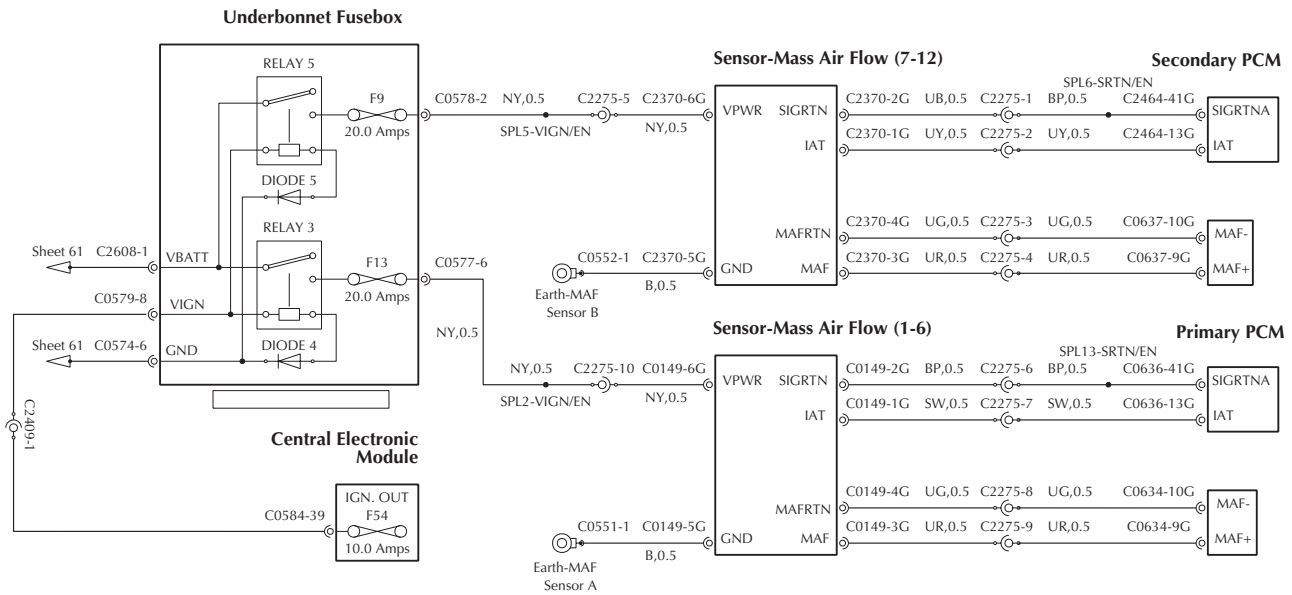
Figure 2. IAT - PCM Interface Circuit

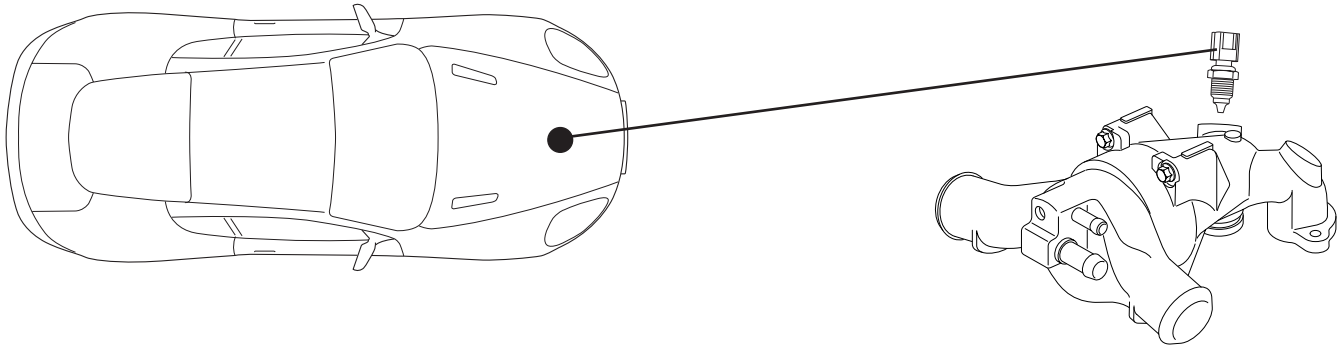
Figure 1. ECT Location

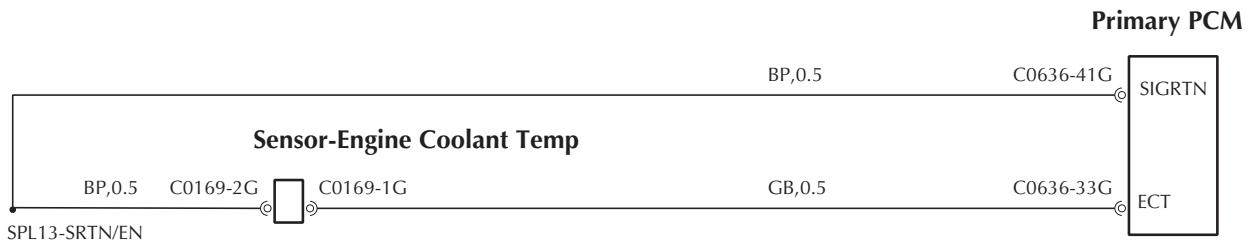
Figure 2. ECT - PCM Interface Circuit

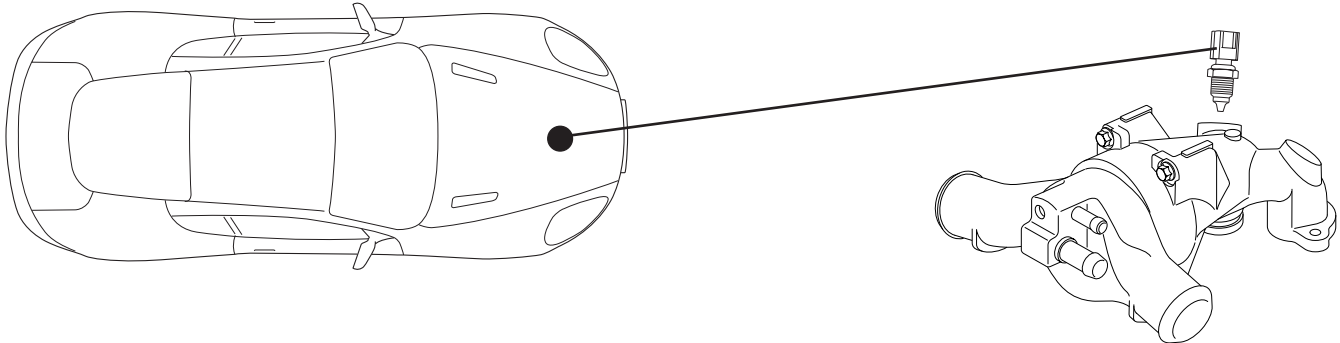
Figure 1. ECT Location

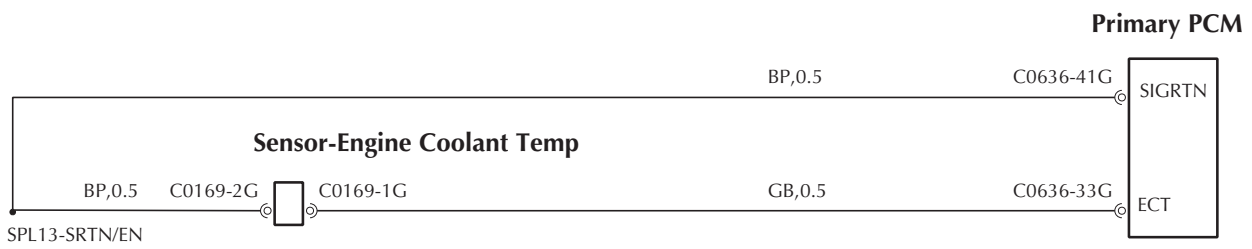
Figure 2. ECT - PCM Interface Circuit

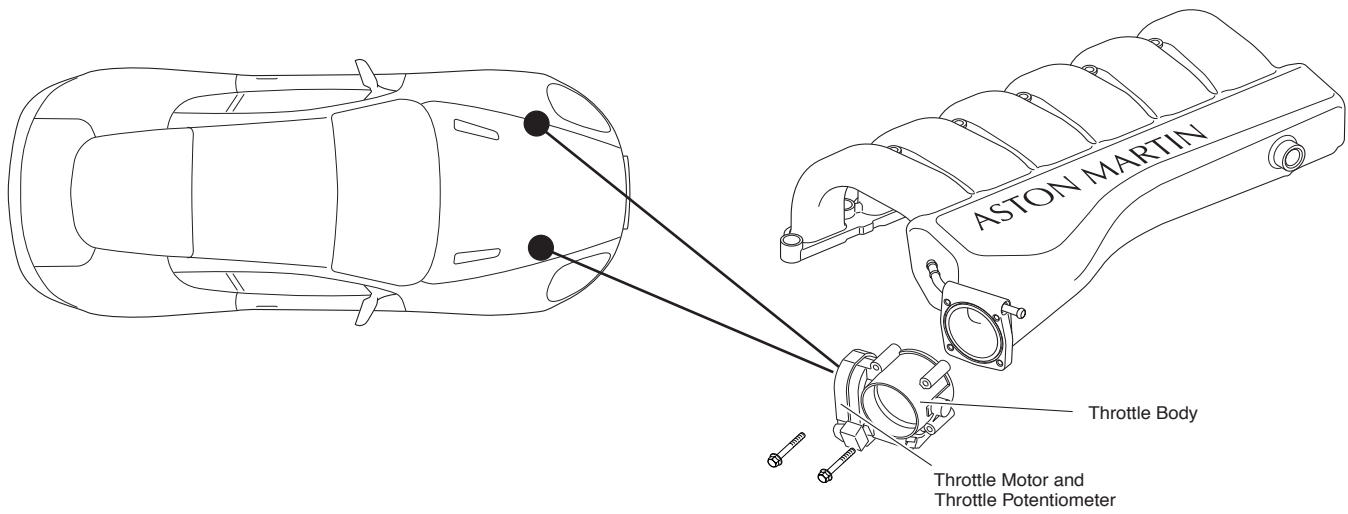
Note: The throttle position sensors are located on the inner side of each throttle body assembly.

Figure 1. TP Location

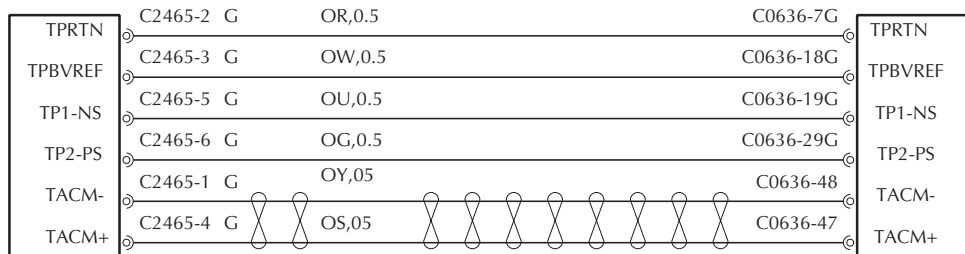
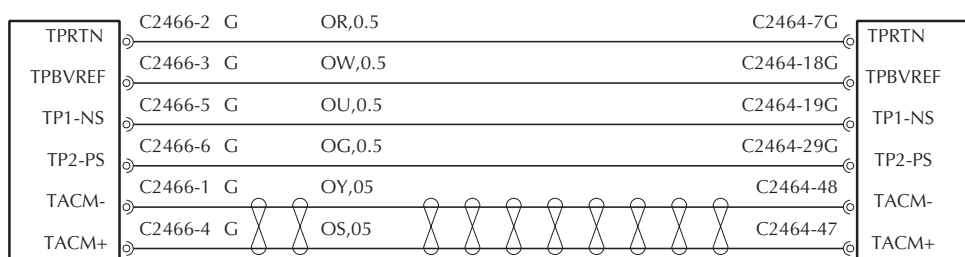
Electronic Throttle A Bank

Primary PCM

Electronic Throttle B Bank

Secondary PCM

Figure 2. TP - PCM Interface Circuit

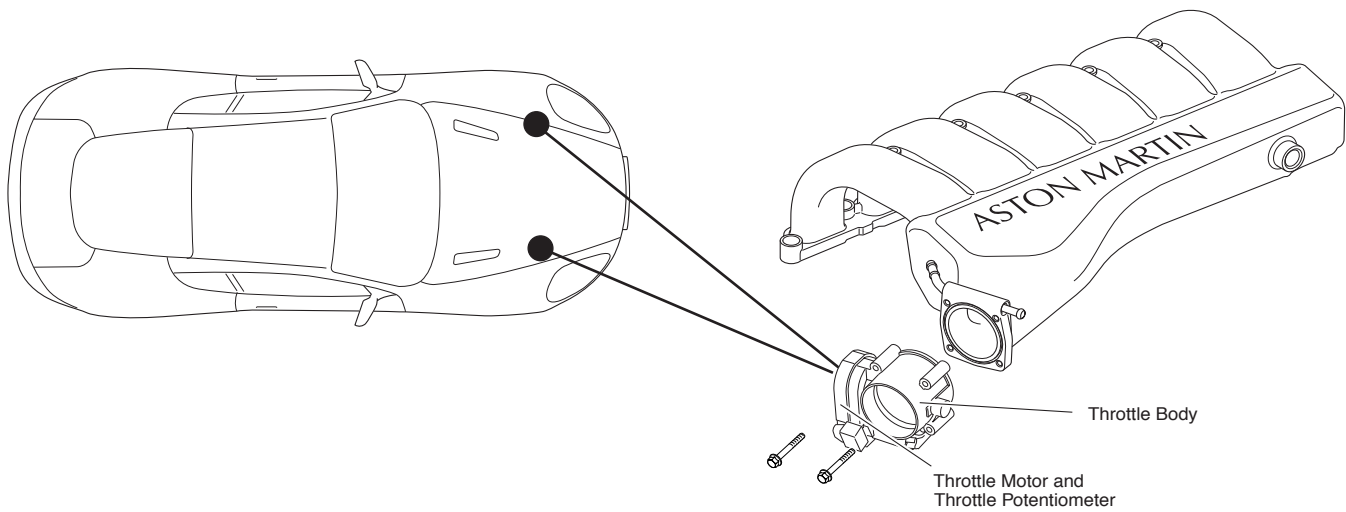
Note: The throttle position sensors are located on the inner side of each throttle body assembly.

Figure 1. TP Location

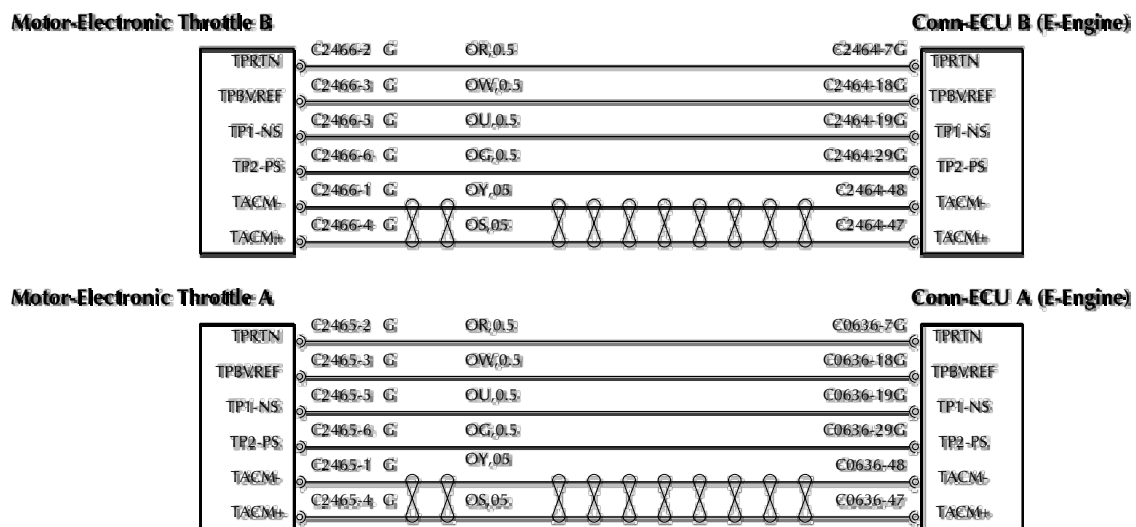
Figure 2. TP - PCM Interface Circuit

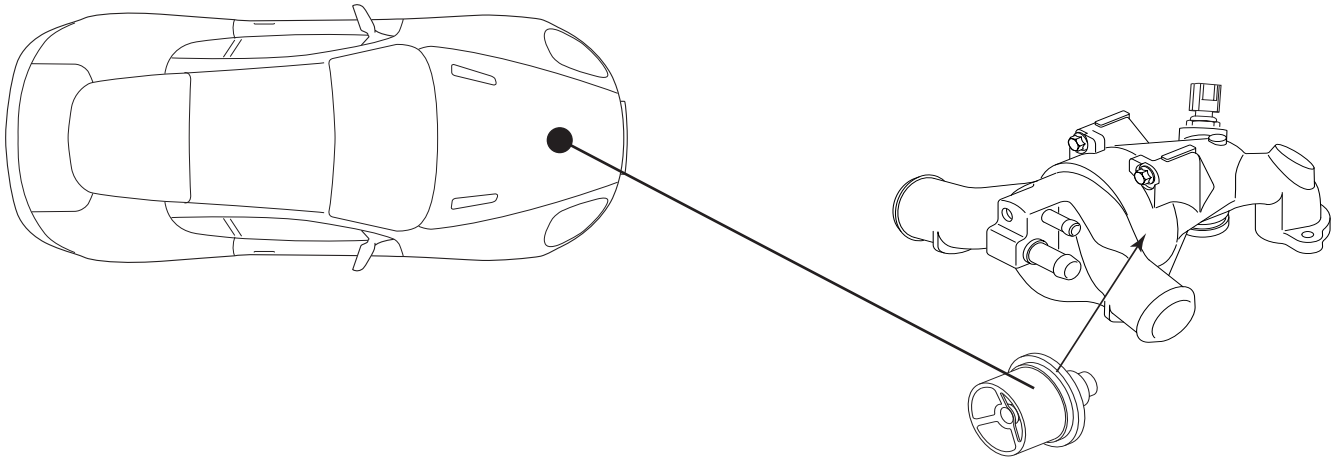
Figure 1. Coolant Thermostat Location

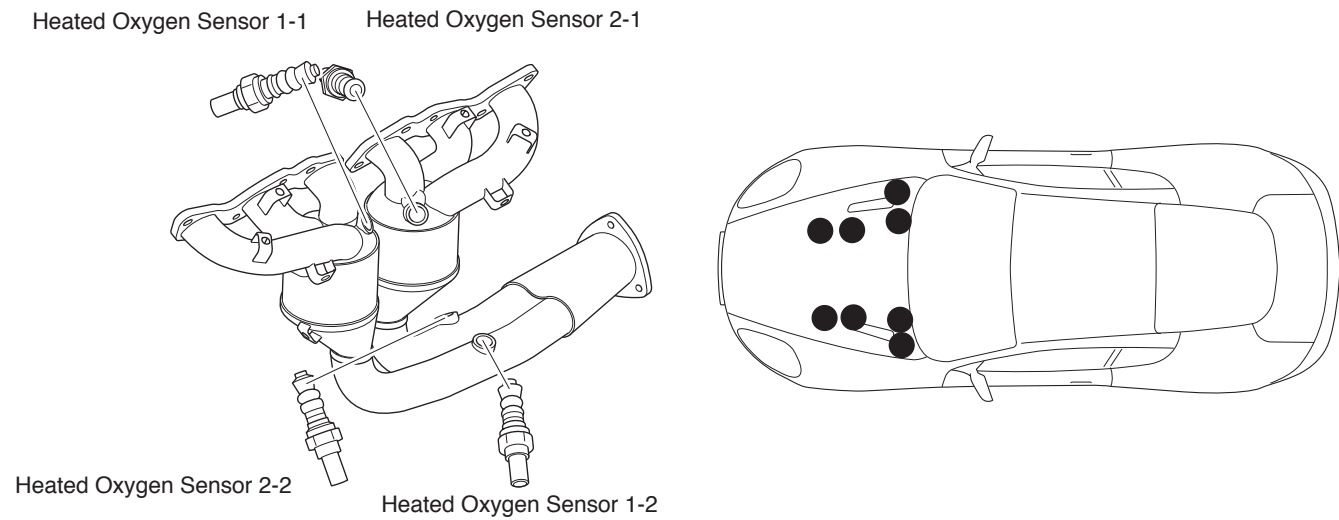
Figure 1. HO2S Location

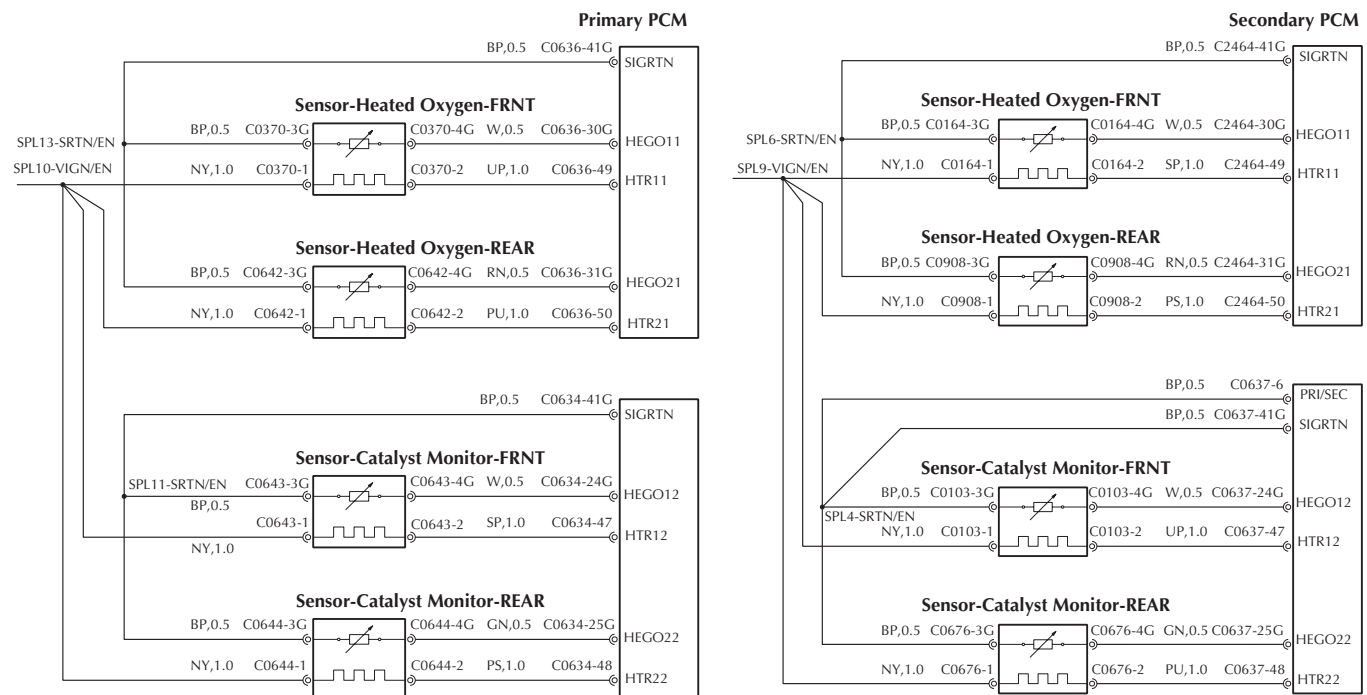
Figure 2. Oxygen Sensor Circuits

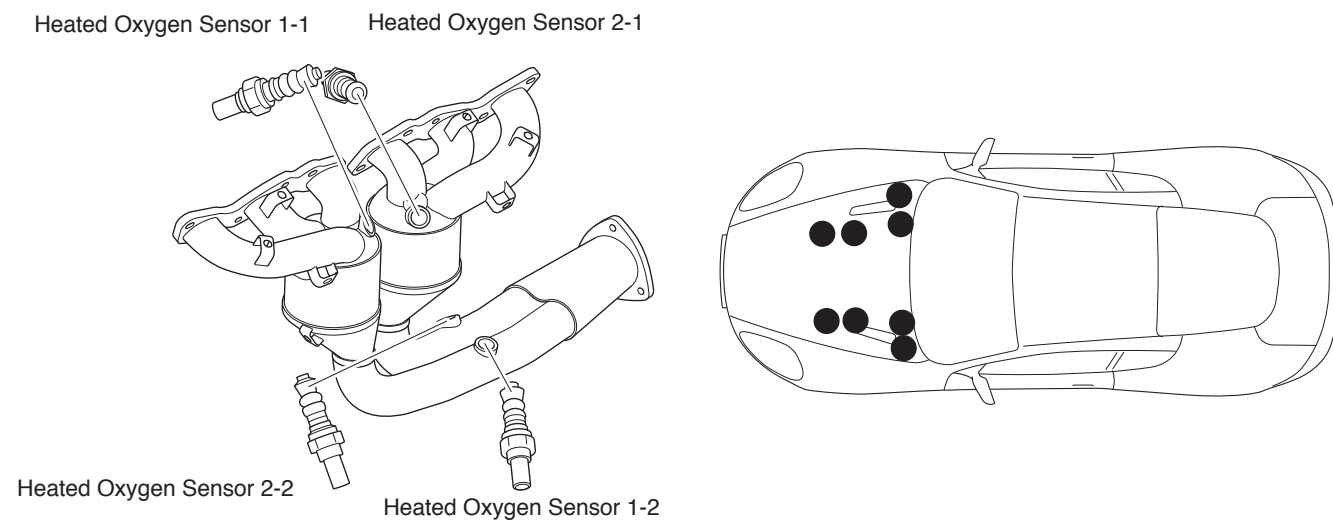
Figure 1. HO2S Location

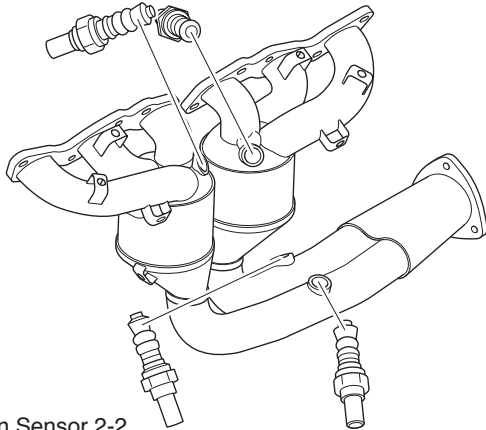
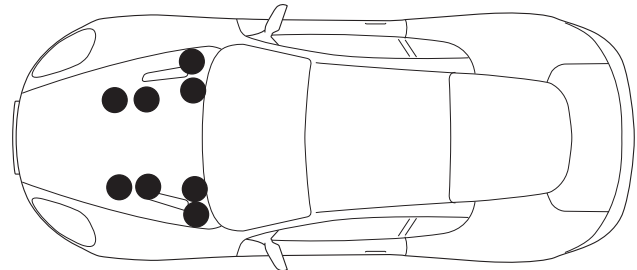
Heated Oxygen Sensor 1-1

Heated Oxygen Sensor 2-1

Heated Oxygen Sensor 2-2

Heated Oxygen Sensor 1-2

Figure 1. HO2S Location

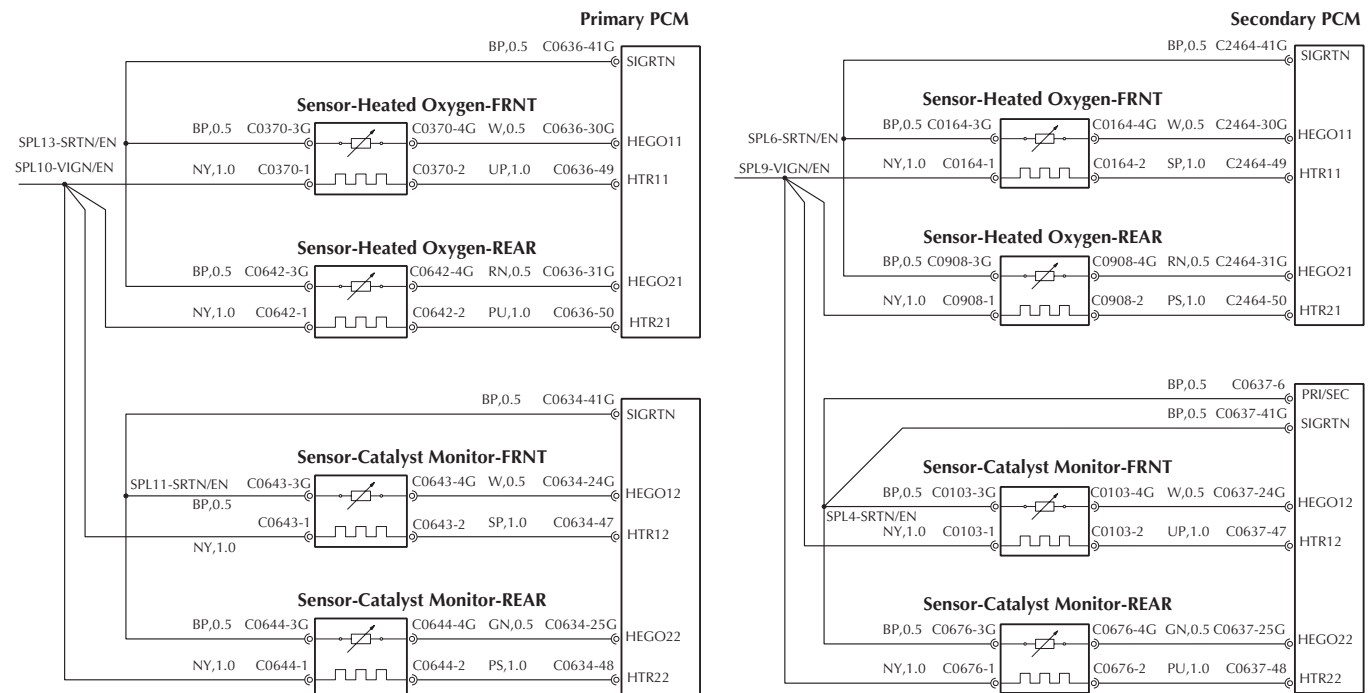
Figure 2. HO2S - PCM Interface Circuit

6. If the applied voltage measured in step 4 is above 10.5 volts, check the resistance of the HO2S heater which should be between 3 and 5 Ω when cold. If the heater resistance is not within range, replace the oxygen sensor.

7. If the heater resistance is in specification, check for a short circuit to ground within the sensor. Measure from the sensor power connection to the sensor case. If the resistance is less than 10k Ω , replace the sensor.

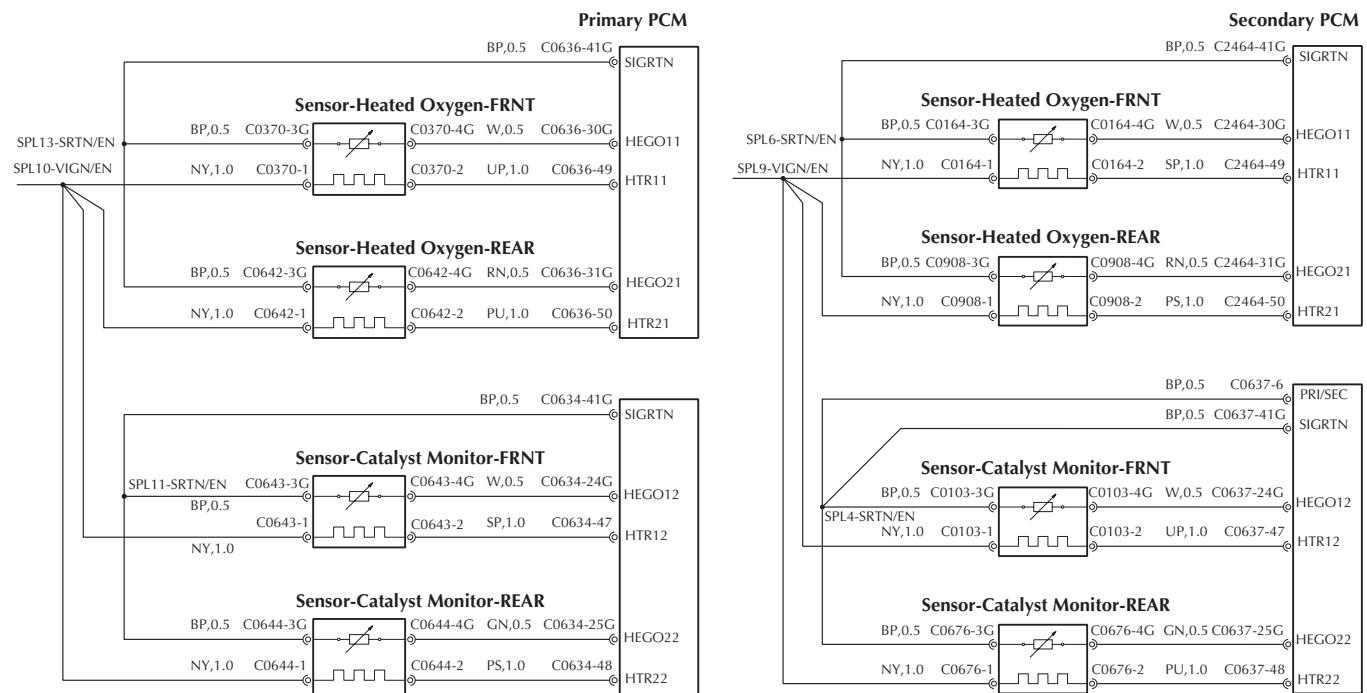
Figure 2. Oxygen Sensor Circuits

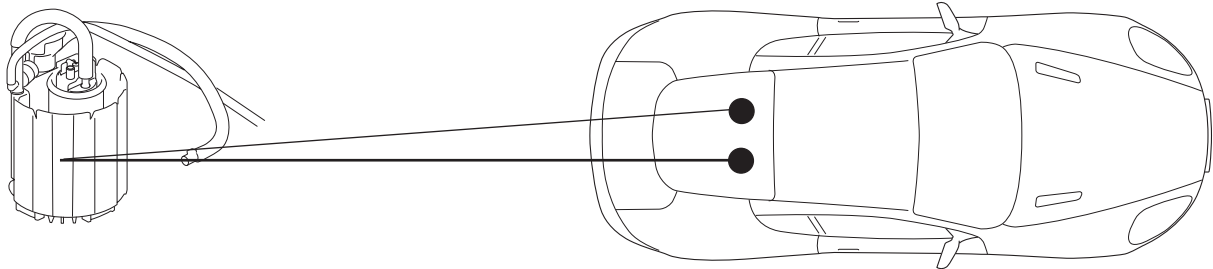
Figure 1. Fuel Pump Location

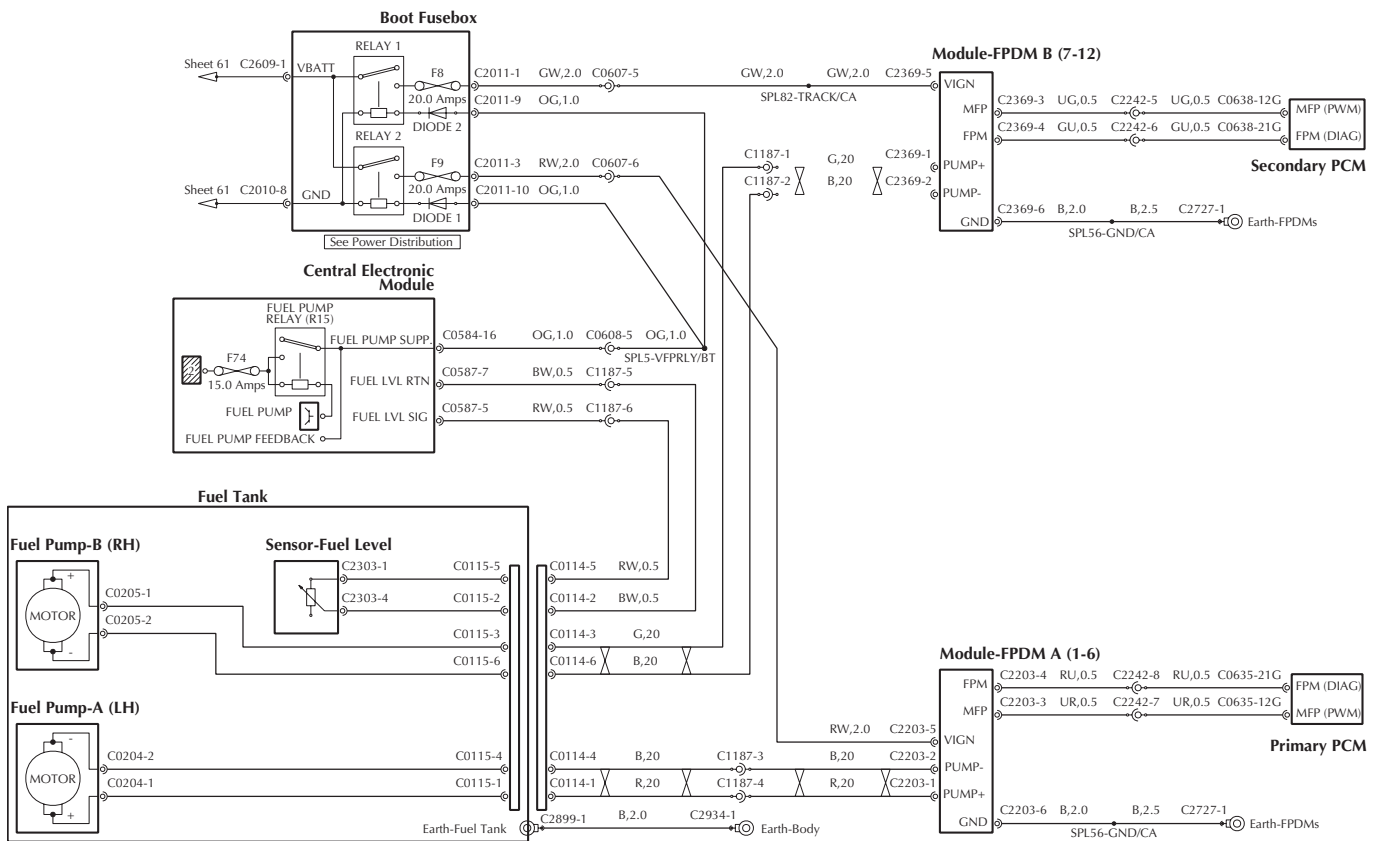
Figure 2. Fuel Pump Circuits

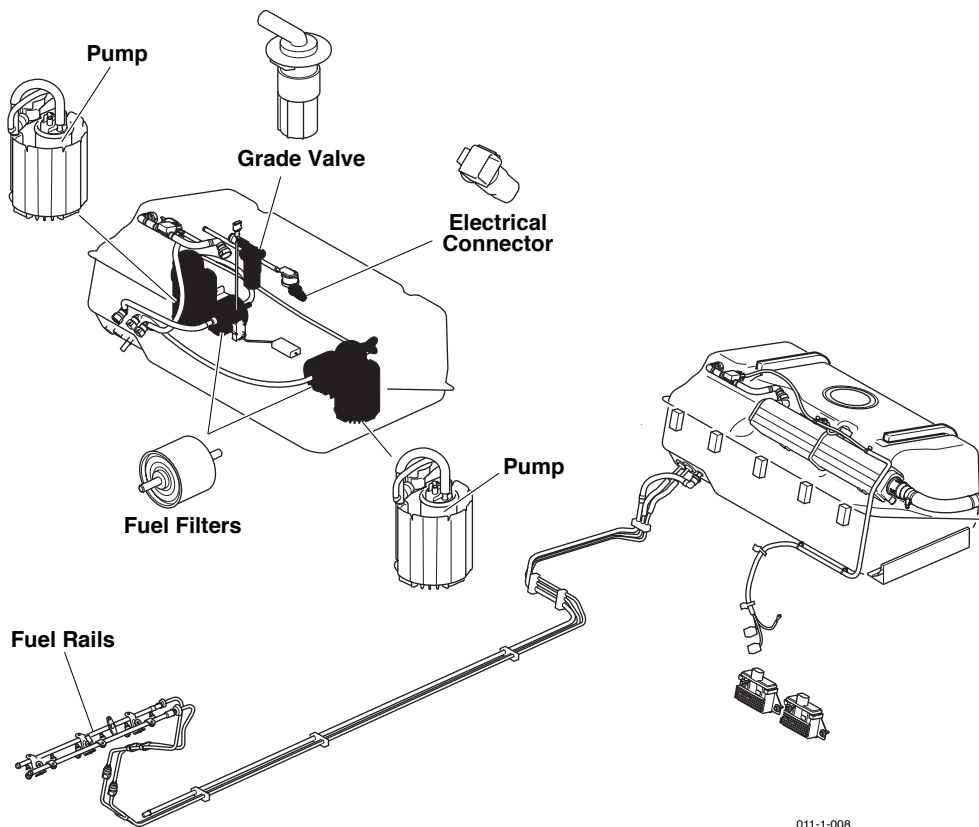
011-1-008

Figure 1. Fuel System Components

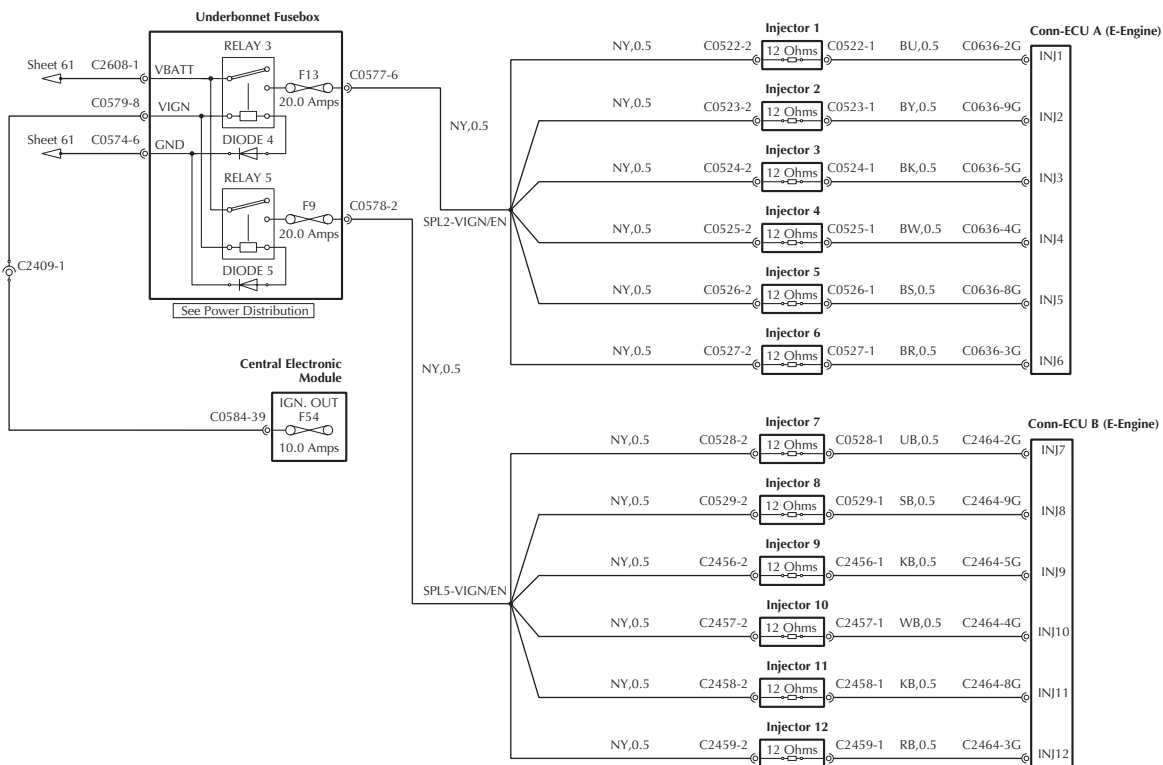
Figure 2. Fuel Injector Circuits

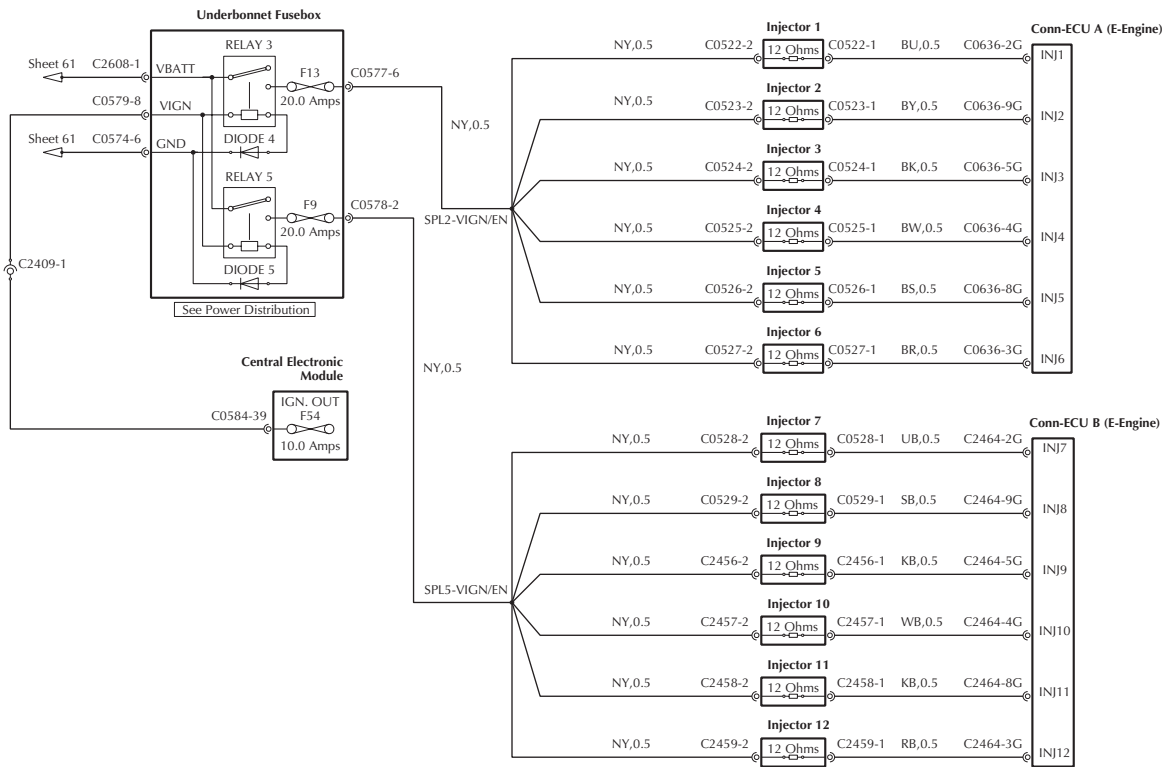
Figure 3. Fuel Injector Circuits

If any injector resistance is out of range, replace the injector.

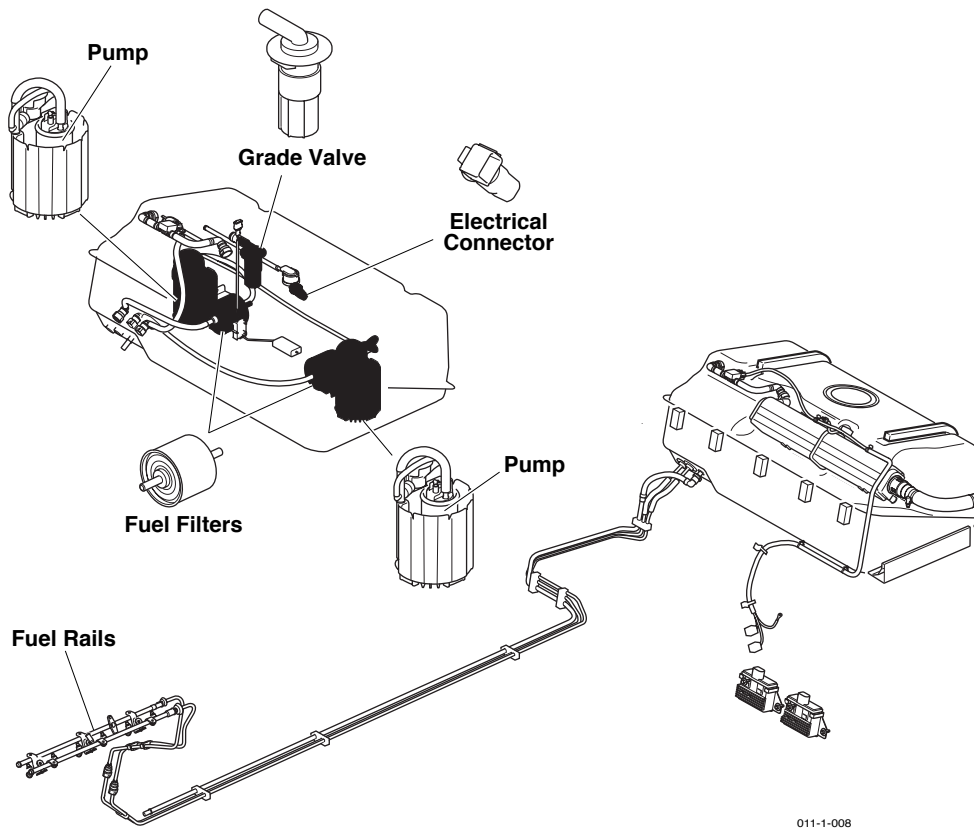
Figure 1. Fuel System Components

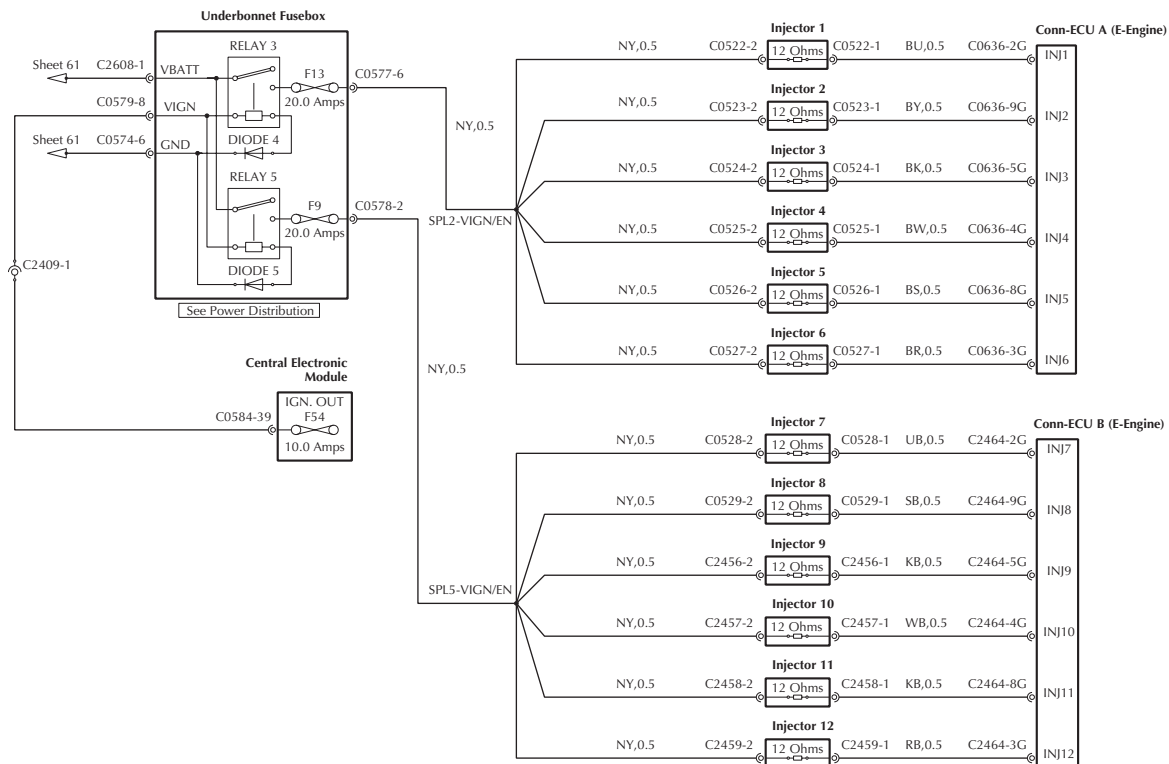
Figure 2. Fuel Injector Circuits

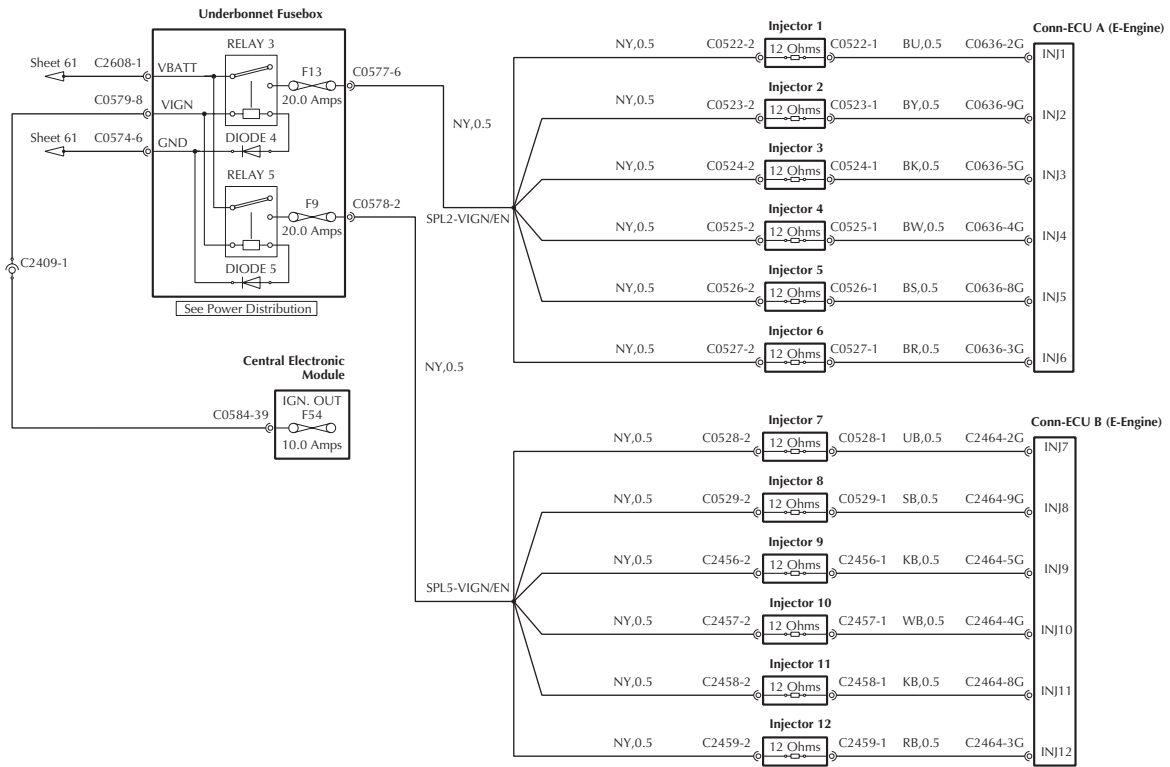
Figure 3. Fuel Injector Circuits

6. Key off. Disconnect the fuel injector connectors. Check the resistance of the fuel injectors.

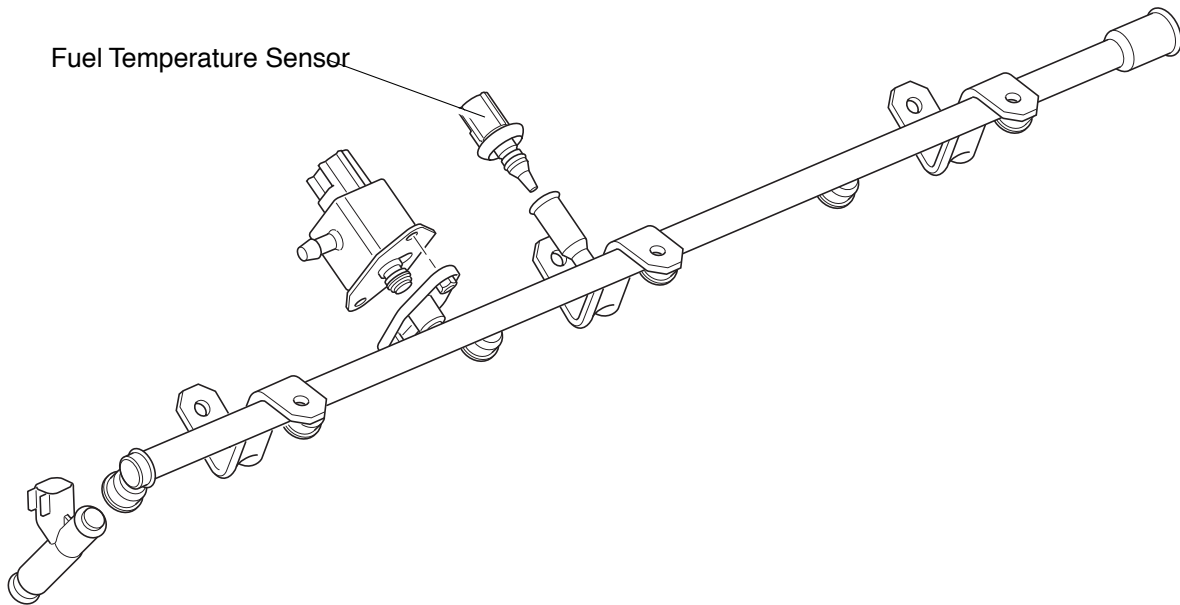
Figure 1. Fuel Temperature Sensor Location

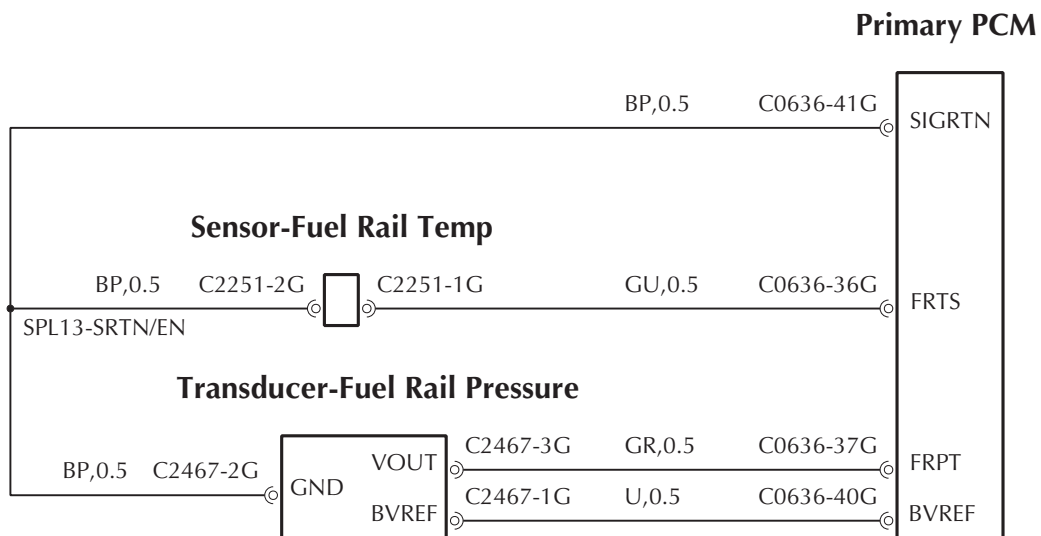
Figure 2. Fuel Temperature Sensor Circuit

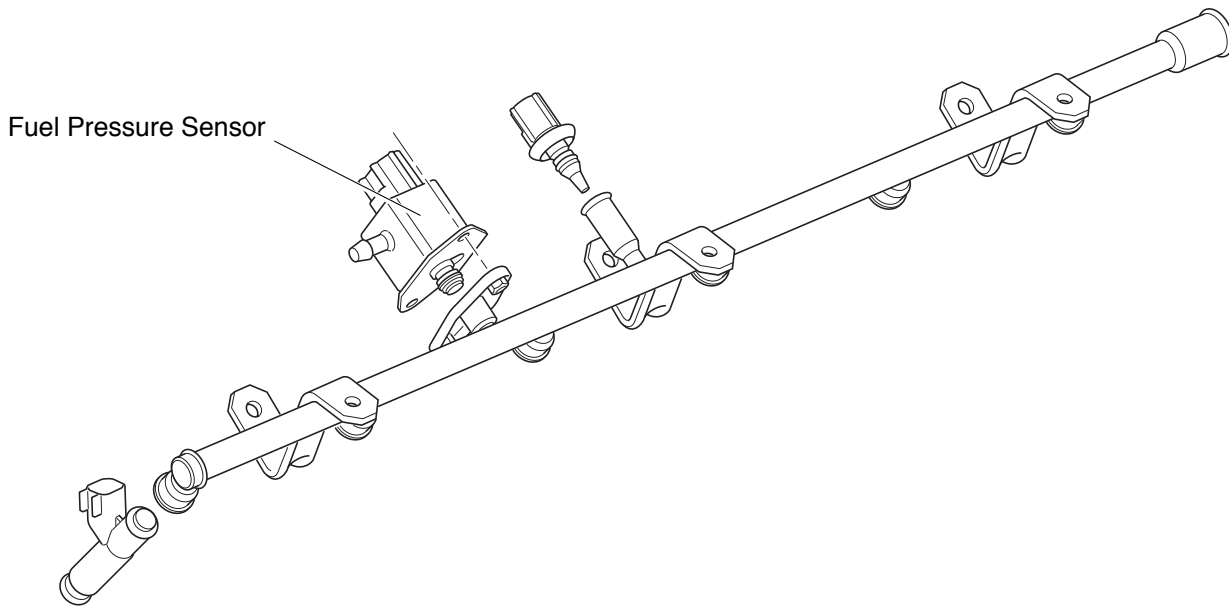
Figure 1. Fuel Pressure Sensor Location

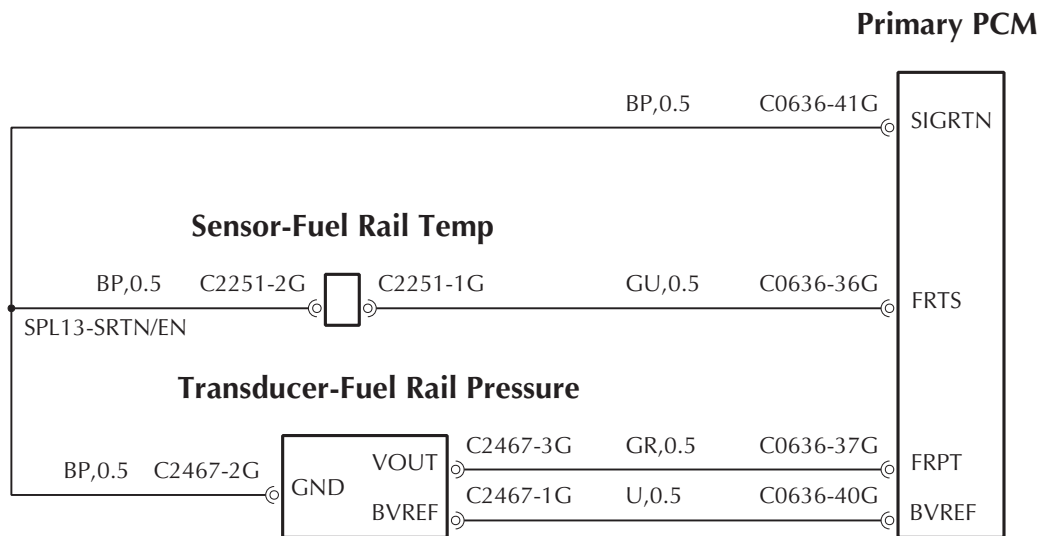
Figure 1. Fuel Pressure Sensor Circuit

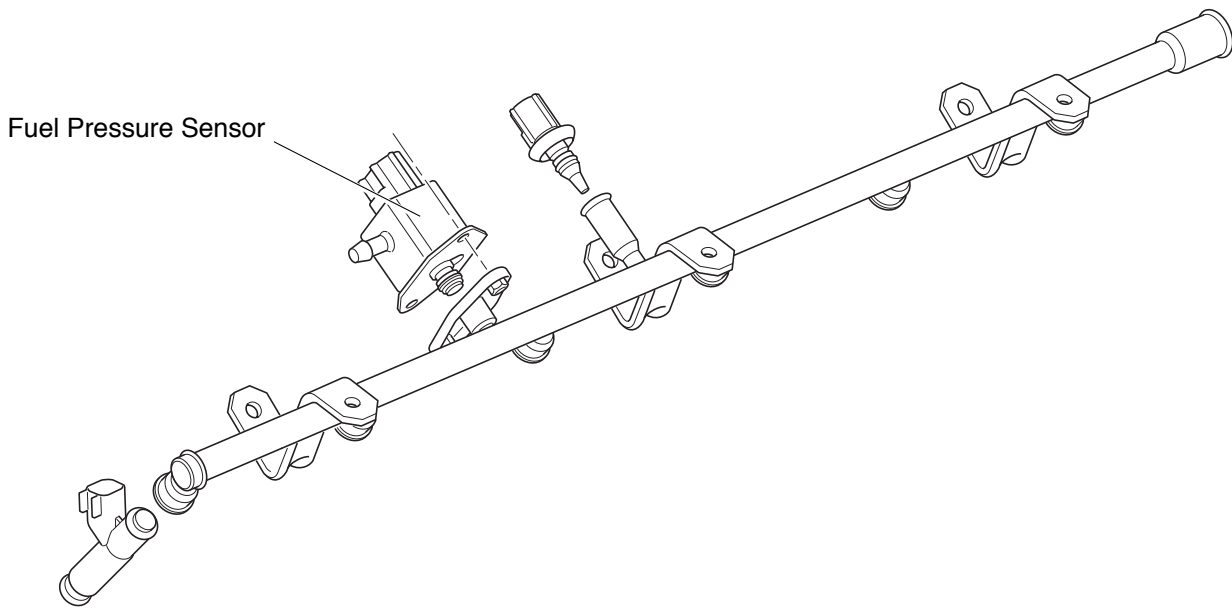
Figure 1. Fuel Pressure Sensor Location

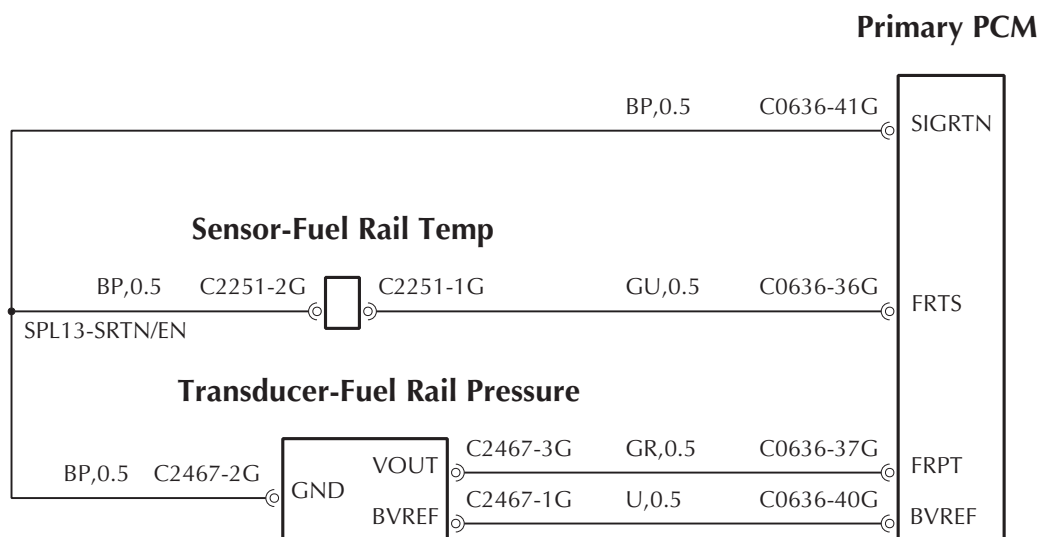
Figure 1. Fuel Pressure Sensor Circuit

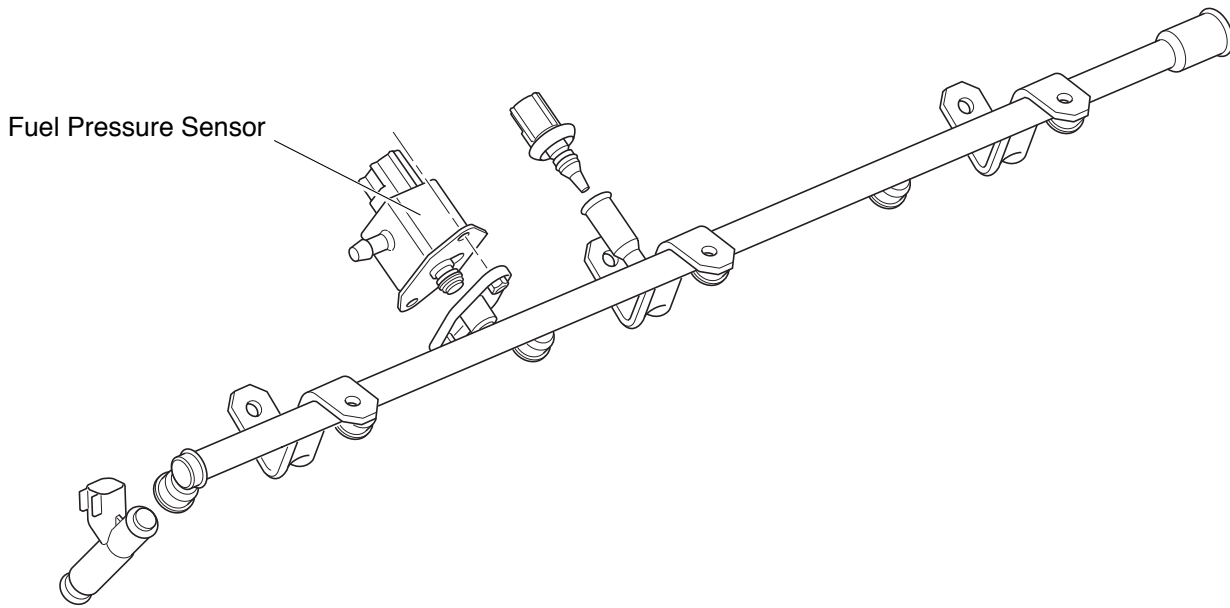
Figure 1. Fuel Pressure Sensor Location

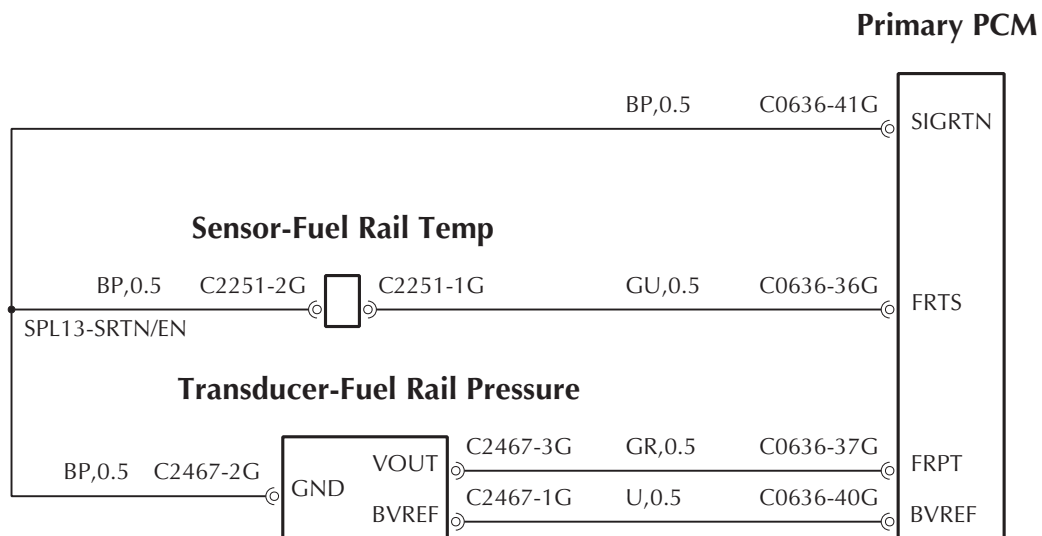
Figure 1. Fuel Pressure Sensor Circuit
