DB9

OBD II Diagnostic Manual
Preliminary Issue

ASTON MARTIN LAGONDA LIMITED

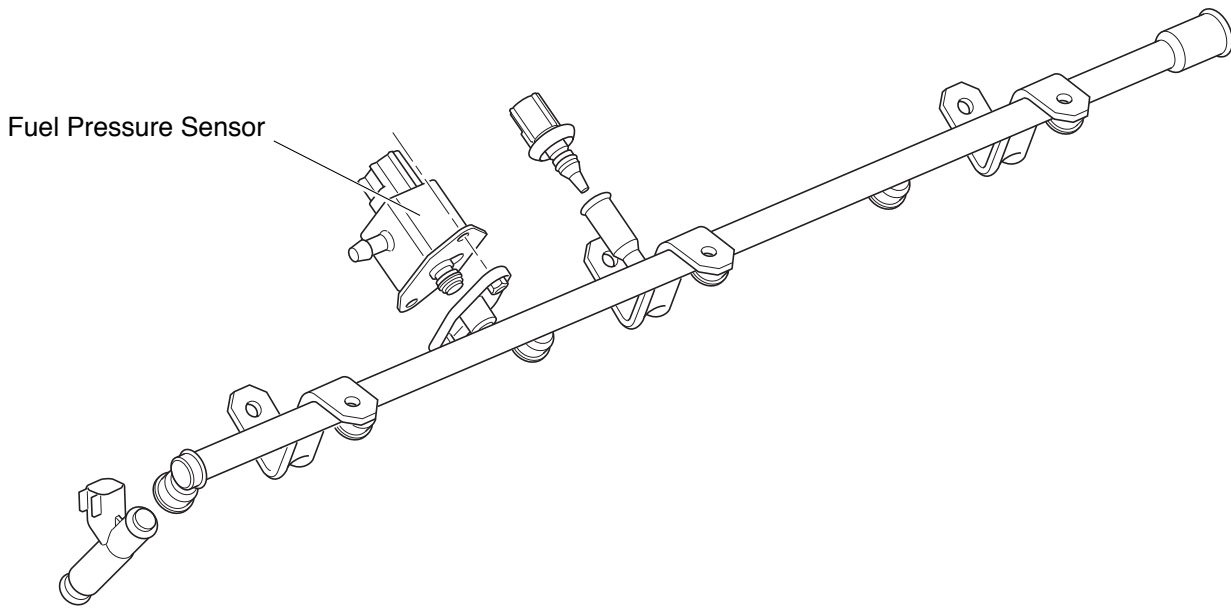
Figure 1. Fuel Pressure Sensor Location

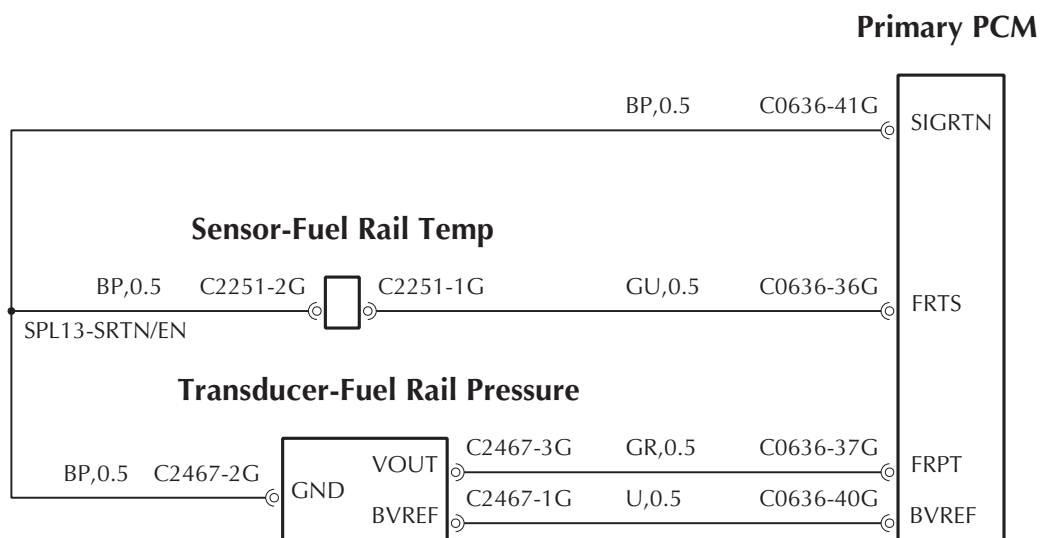
Figure 1. Fuel Pressure Sensor Circuit

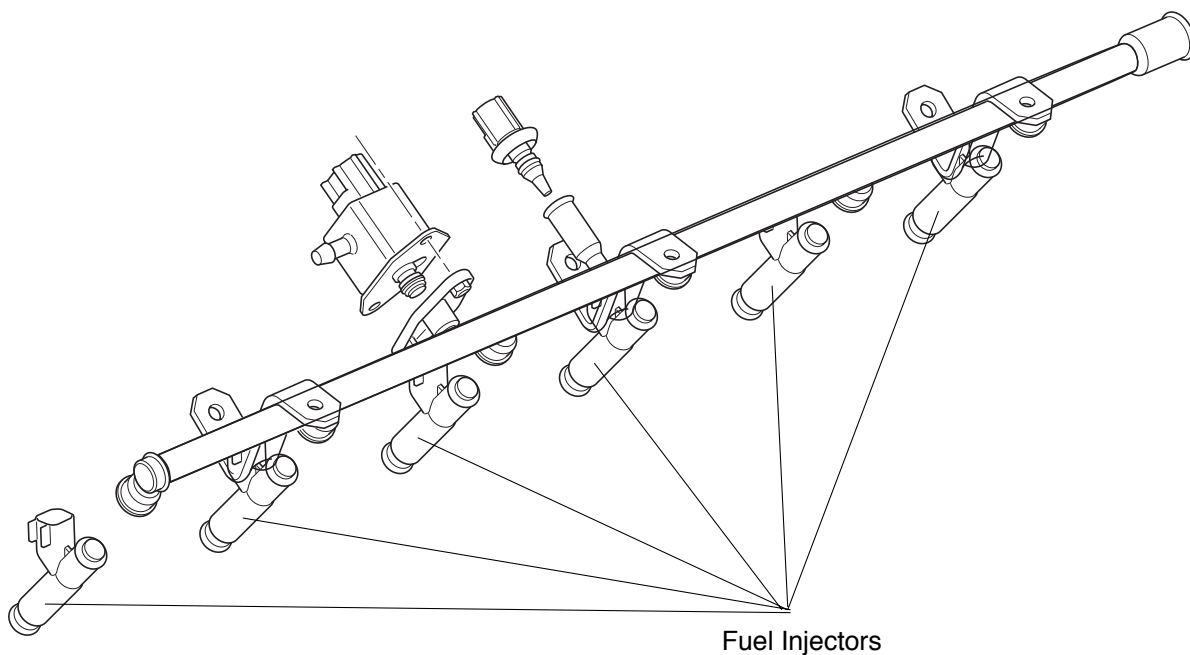
Figure 1. Fuel Injector Location

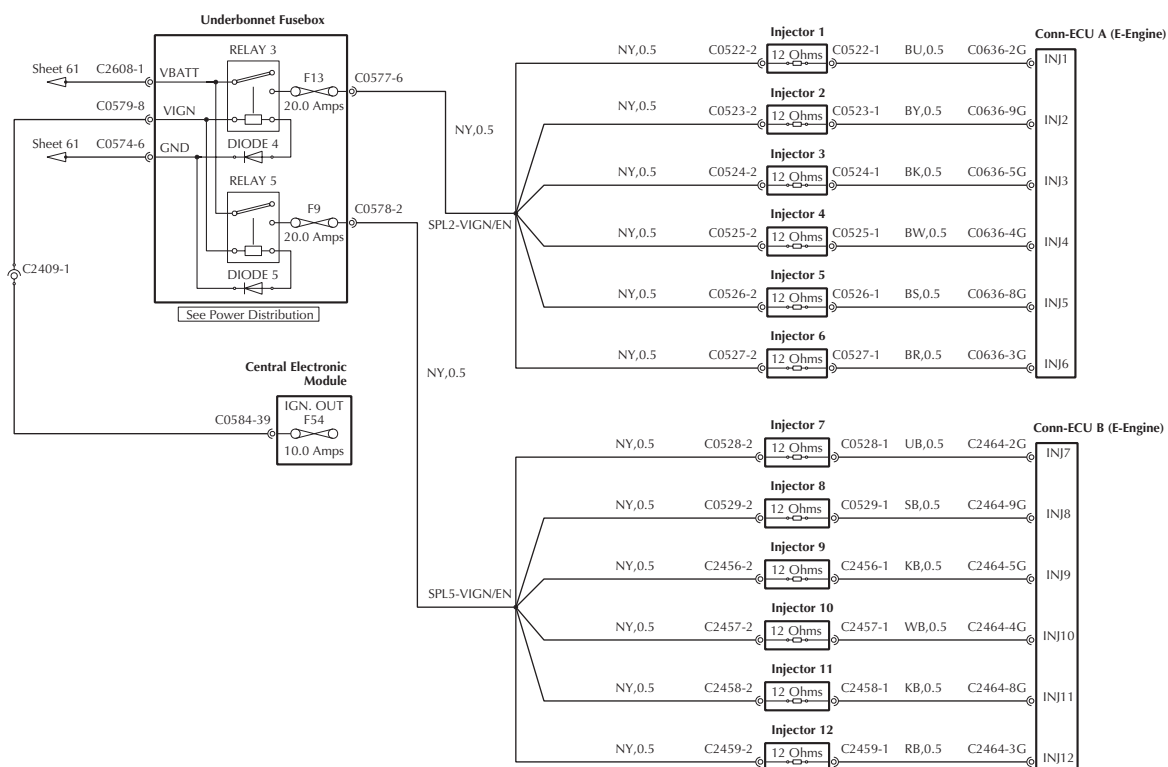
Figure 2 Fuel Injector Circuits

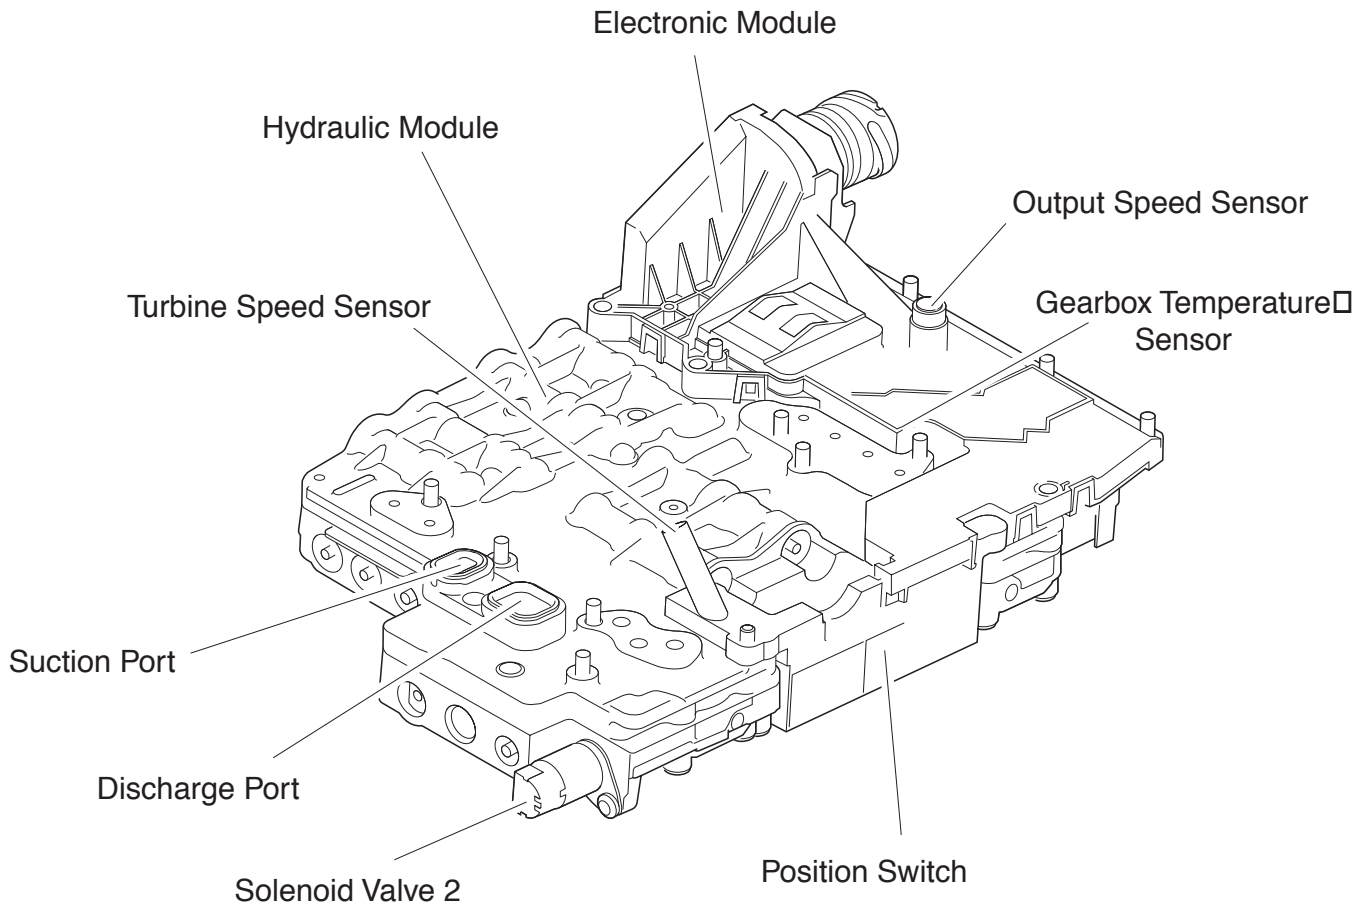
Figure 1. Transmission Fluid Temperature Sensor

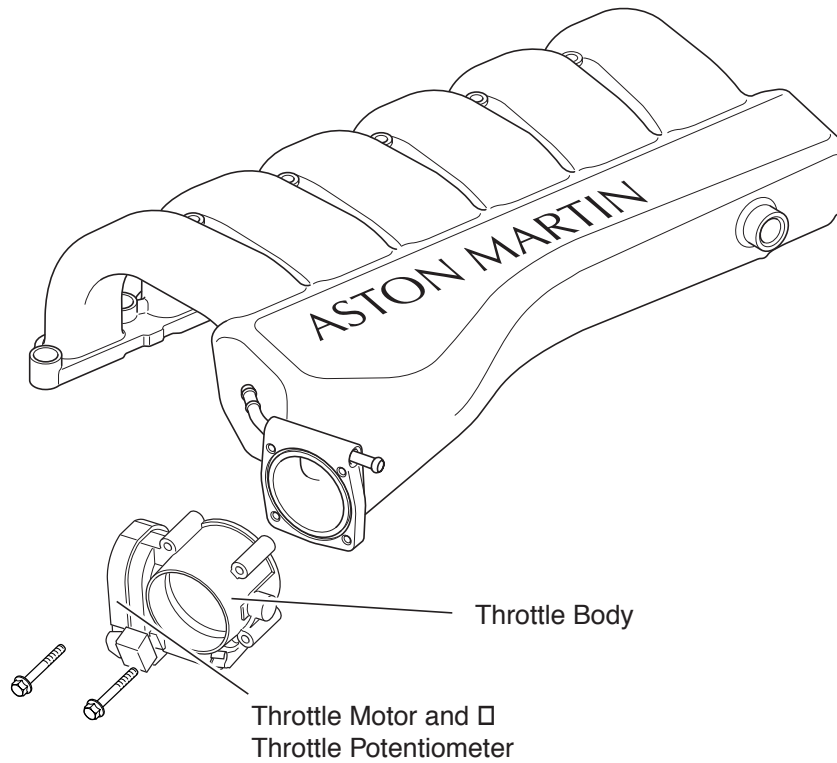
Figure 1. Throttle Position Sensor Location

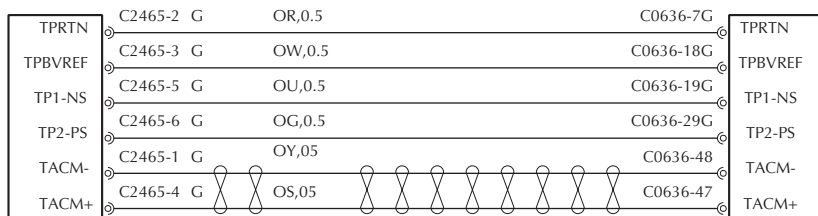
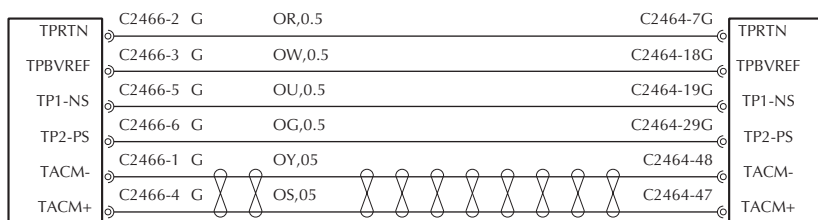
Motor-Electronic Throttle A

Primary PCM

Motor-Electronic Throttle B

Secondary PCM

Figure 2. Throttle Position Sensor Circuits

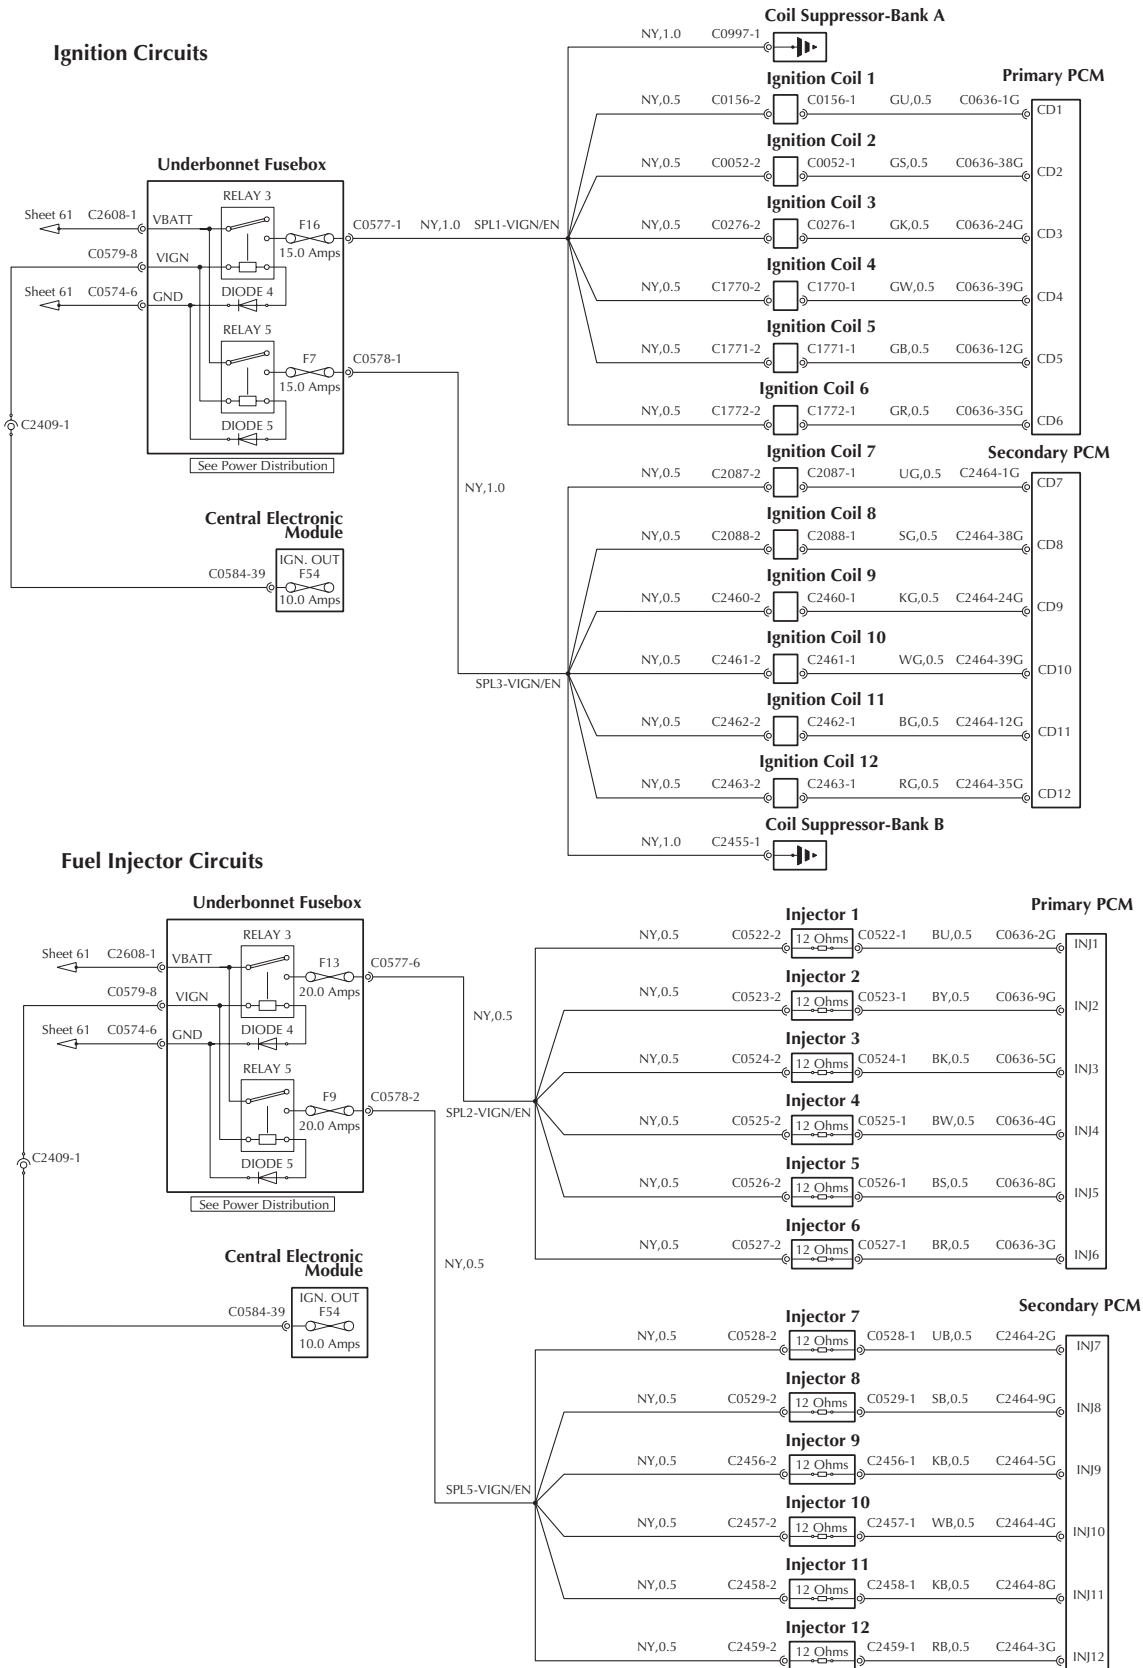
Figure 1. Ignition and Fuel Injector Wiring

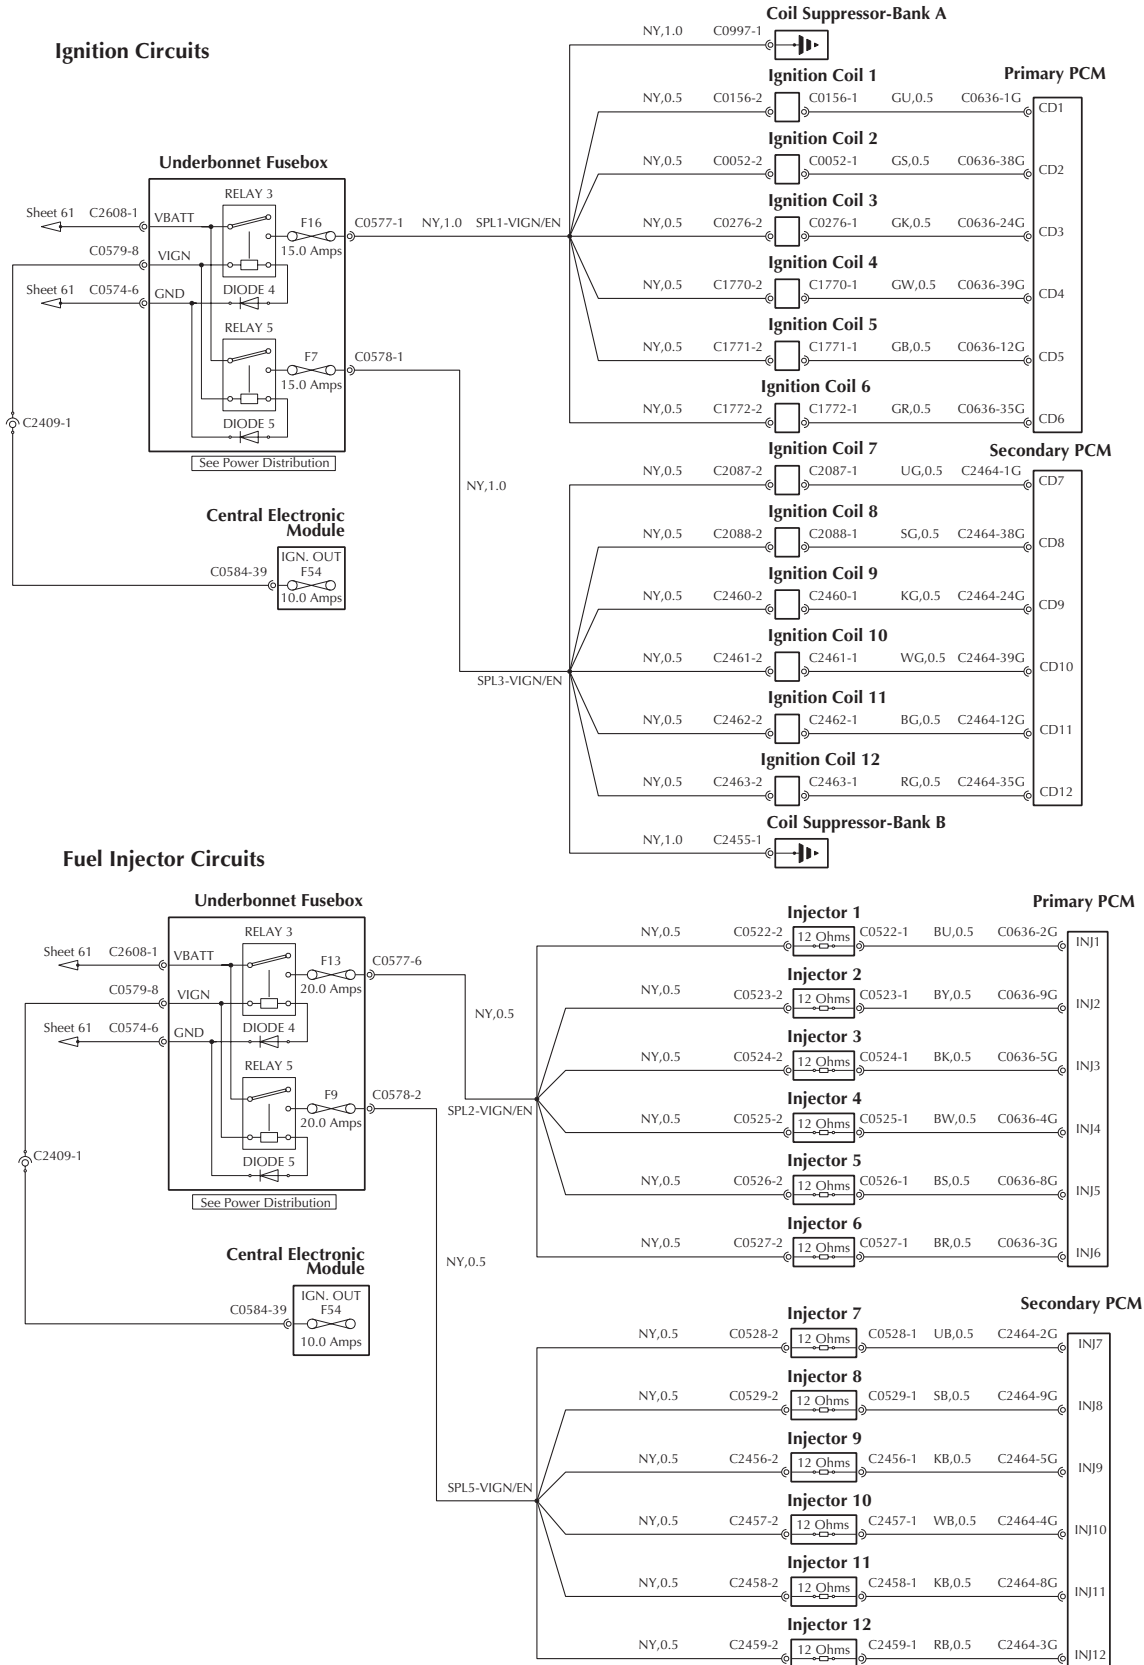
Figure 1. Ignition and Fuel Injector Wiring

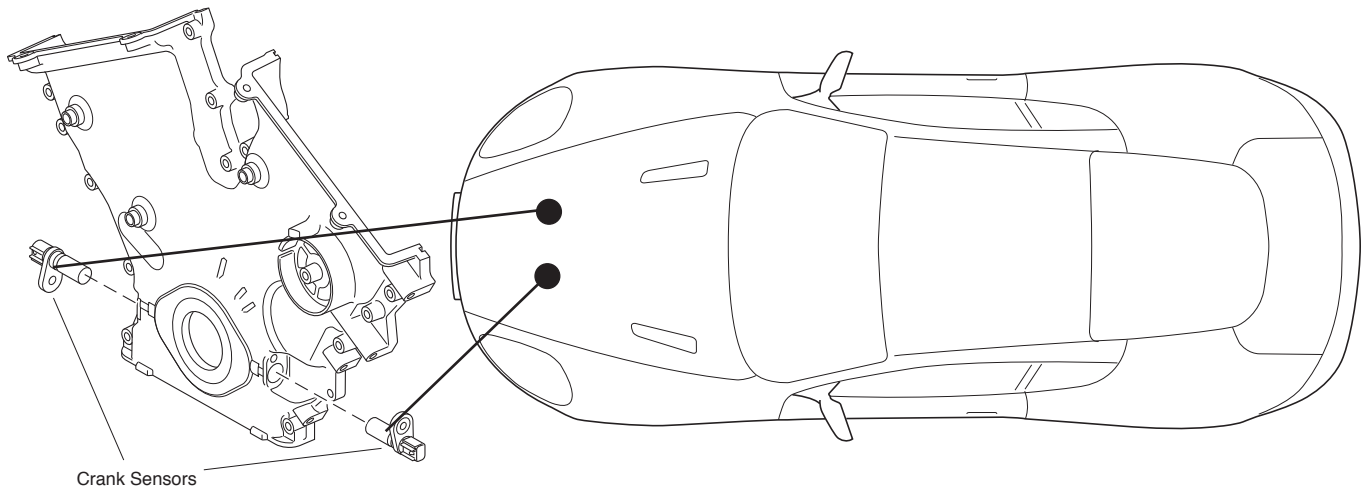
Figure 1. Crankshaft Position Sensor Location

Sensor-Crank Position

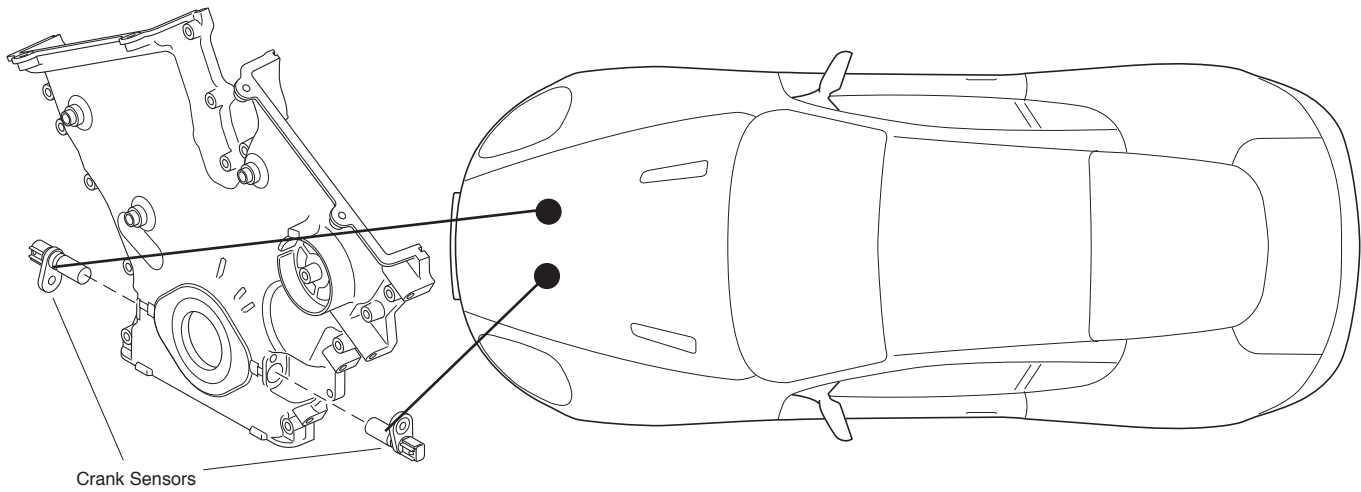
Figure 1. Crankshaft Position Sensor Location

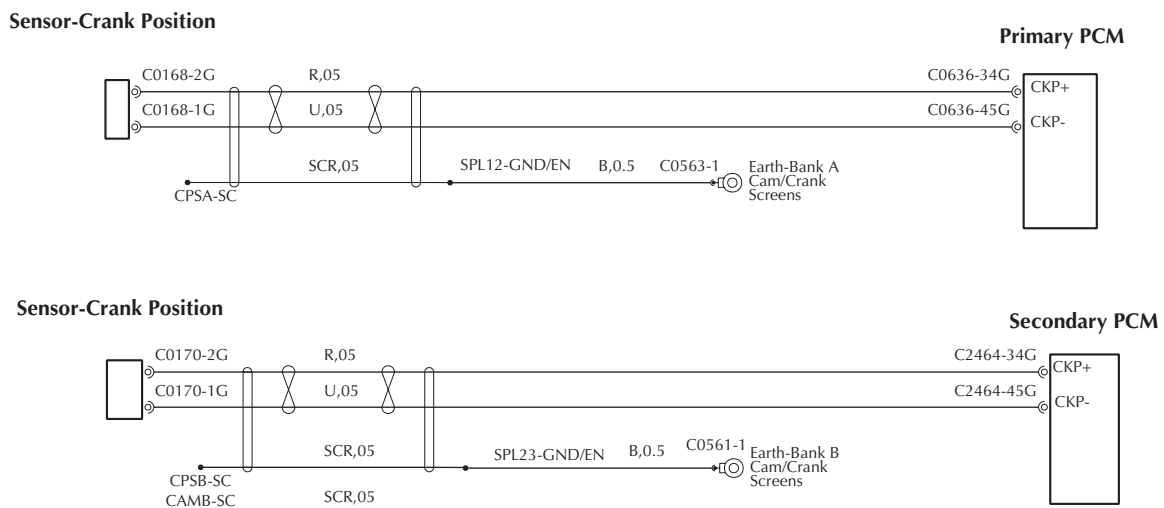
Figure 2. Crankshaft Position Sensor - Wiring

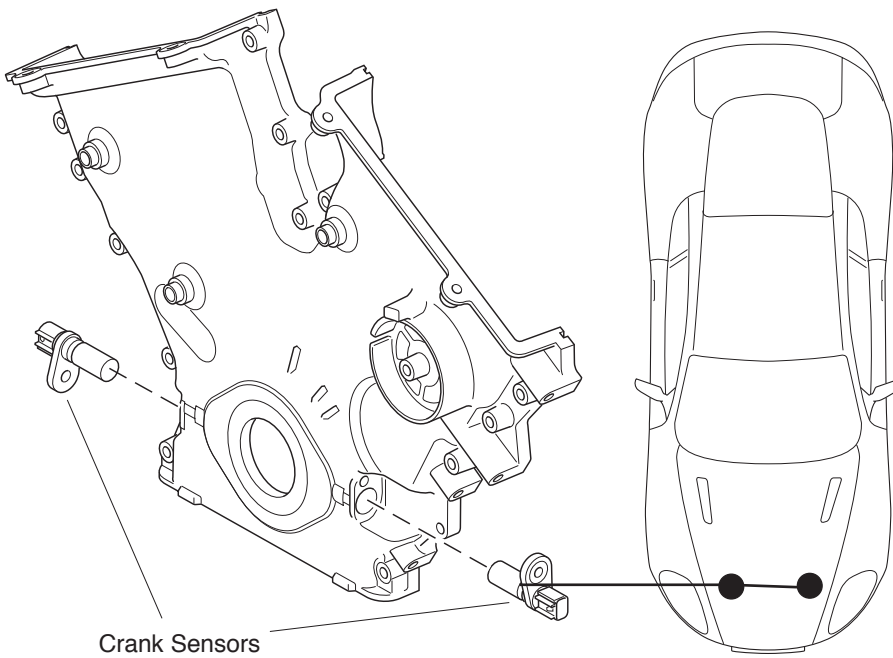
Figure 1. Crankshaft and Camshaft Sensor Locations

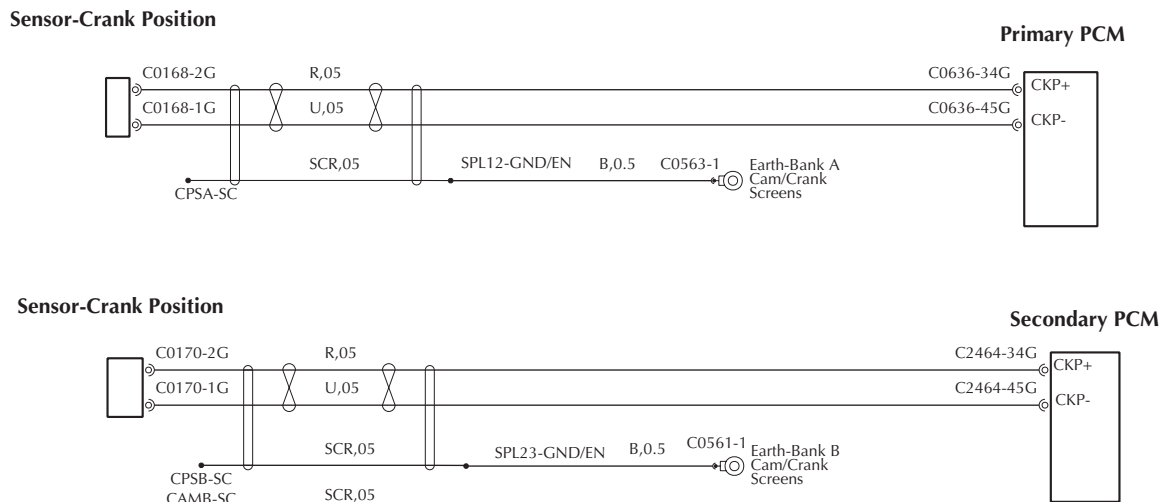
Figure 2. Crankshaft Sensor Circuit

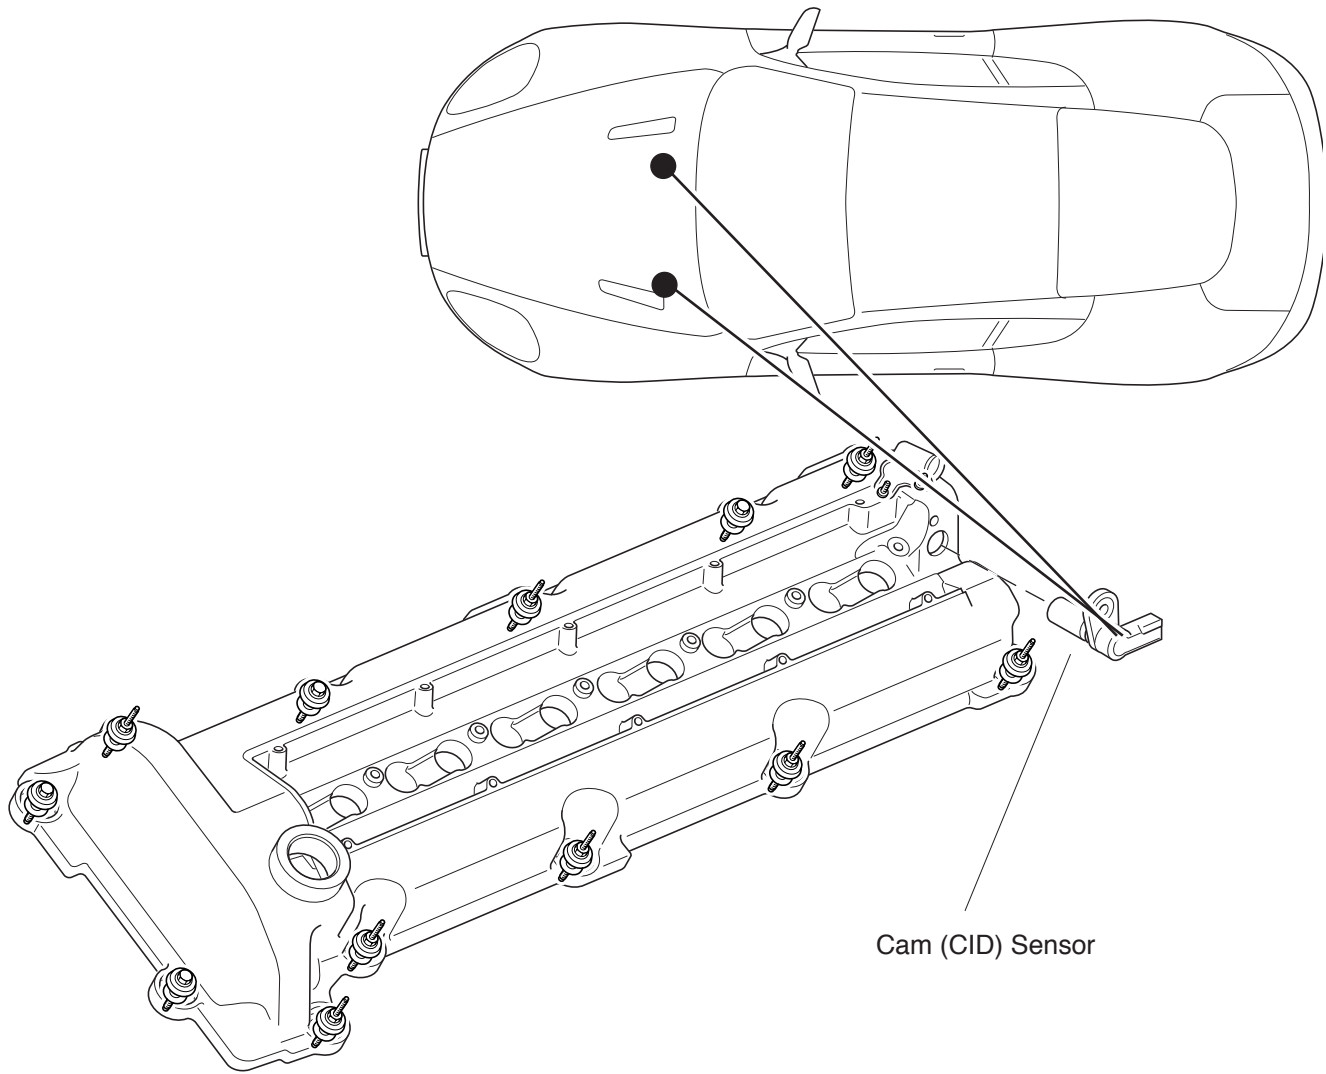
Figure 1. Camshaft (Cylinder Identification - CID) Sensor Location

5. Check the security of the cylinder identification sensor physical mounting. If loose, secure and retest. If the sensor is already secure, replace the sensor and retest. If the fault continues, contact Aston Martin Technical Support.

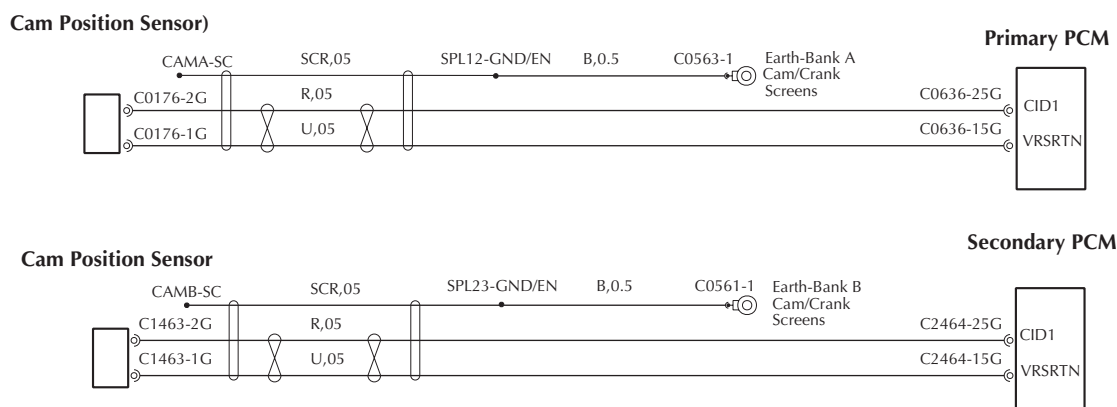
Figure 2. Cylinder Identification Sensor Wiring

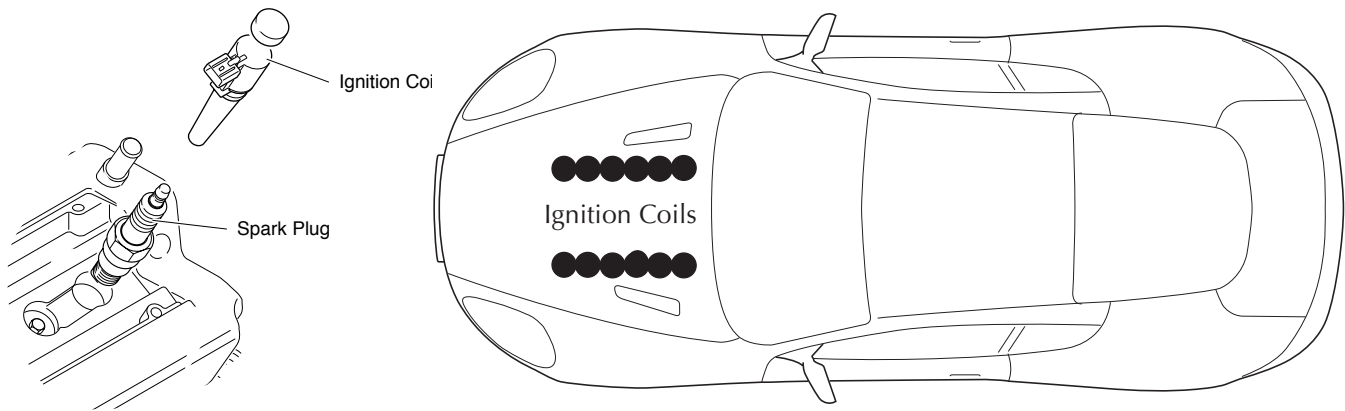
Figure 1. Ignition Coil location

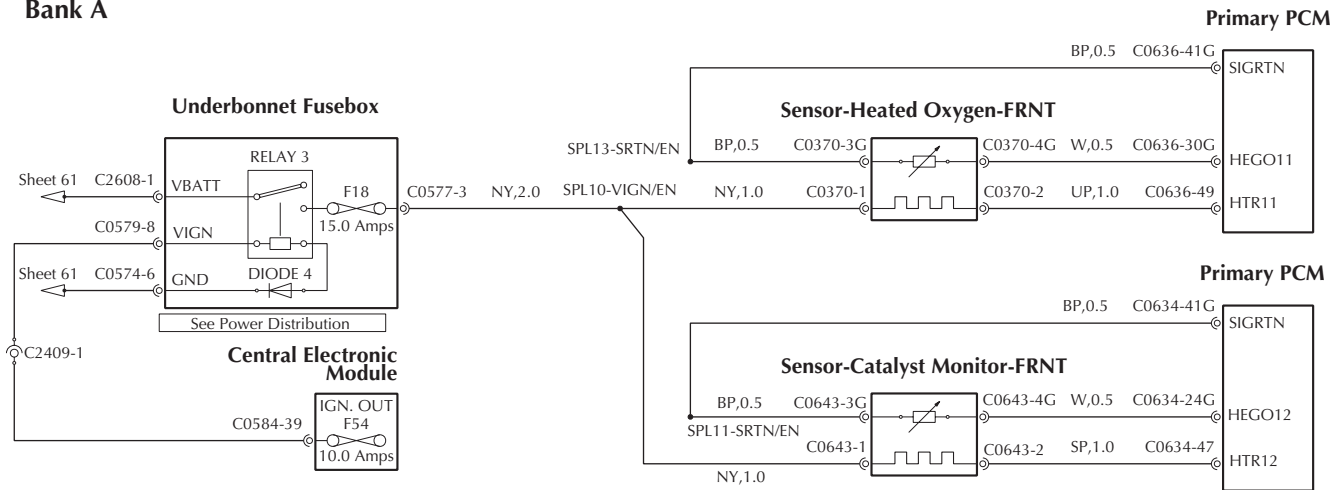
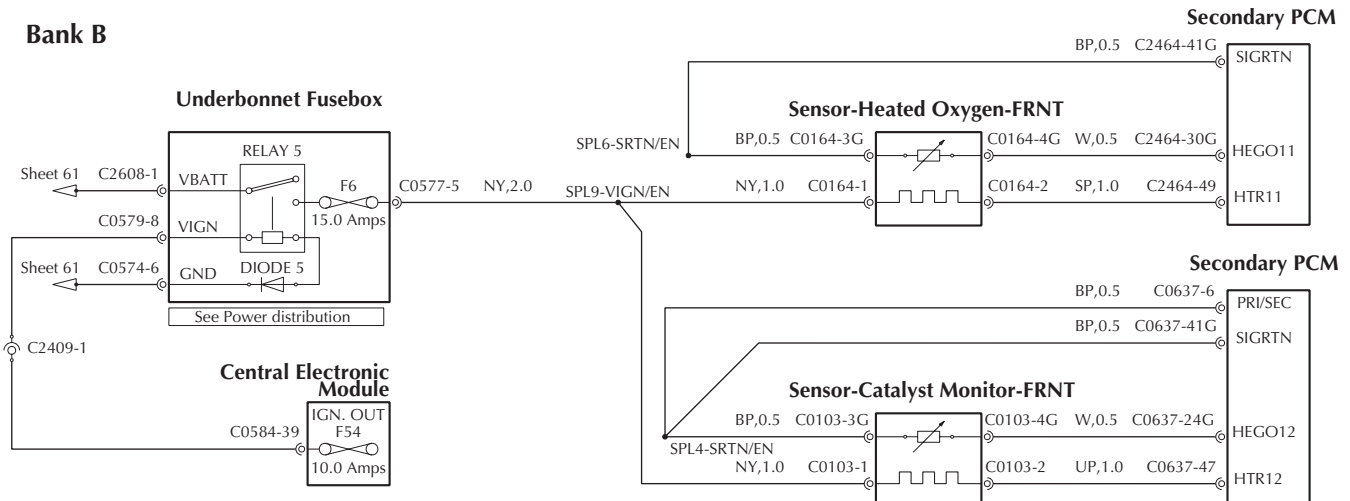
Figure 2. Heated Oxygen Sensor HO2S-2 Wiring

Bank A

Bank B

If the upstream and downstream signals on either bank are identical, the catalyst on that bank is defective and must be replaced. Investigate for possible causes before running the engine on the new catalyst.
6. Using datalogger, monitor the fuel pressure in both fuel rails.

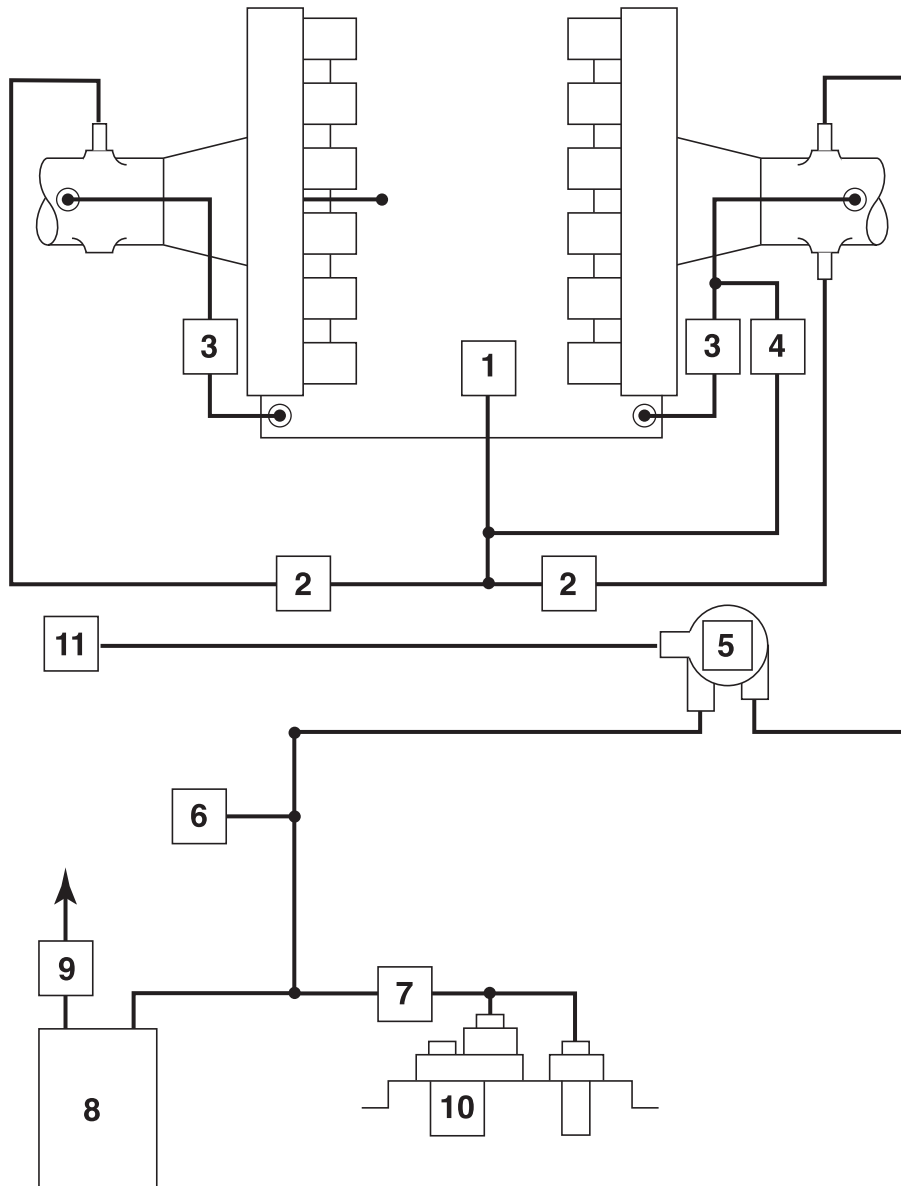
P0442 - Evaporative Loss - Vapour Recovery System

| 1. Oil Separator | 6. Service Port |

The system checks for small leaks (P0442) or for gross leaks (P0455).

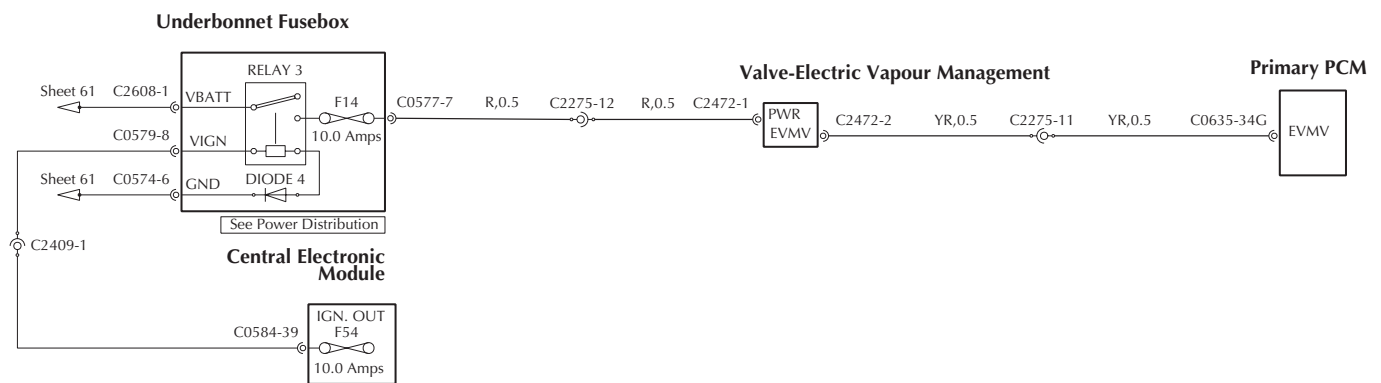
Figure 2. Vapour Management Valve Circuit

P0443 - This code indicates a failure in the VMV solenoid circuit.

If the resistance is outside the range 30-90 Ω , replace the vapour management valve. Reset the PCM and rerun the KOER Test to verify that the problem is cleared.

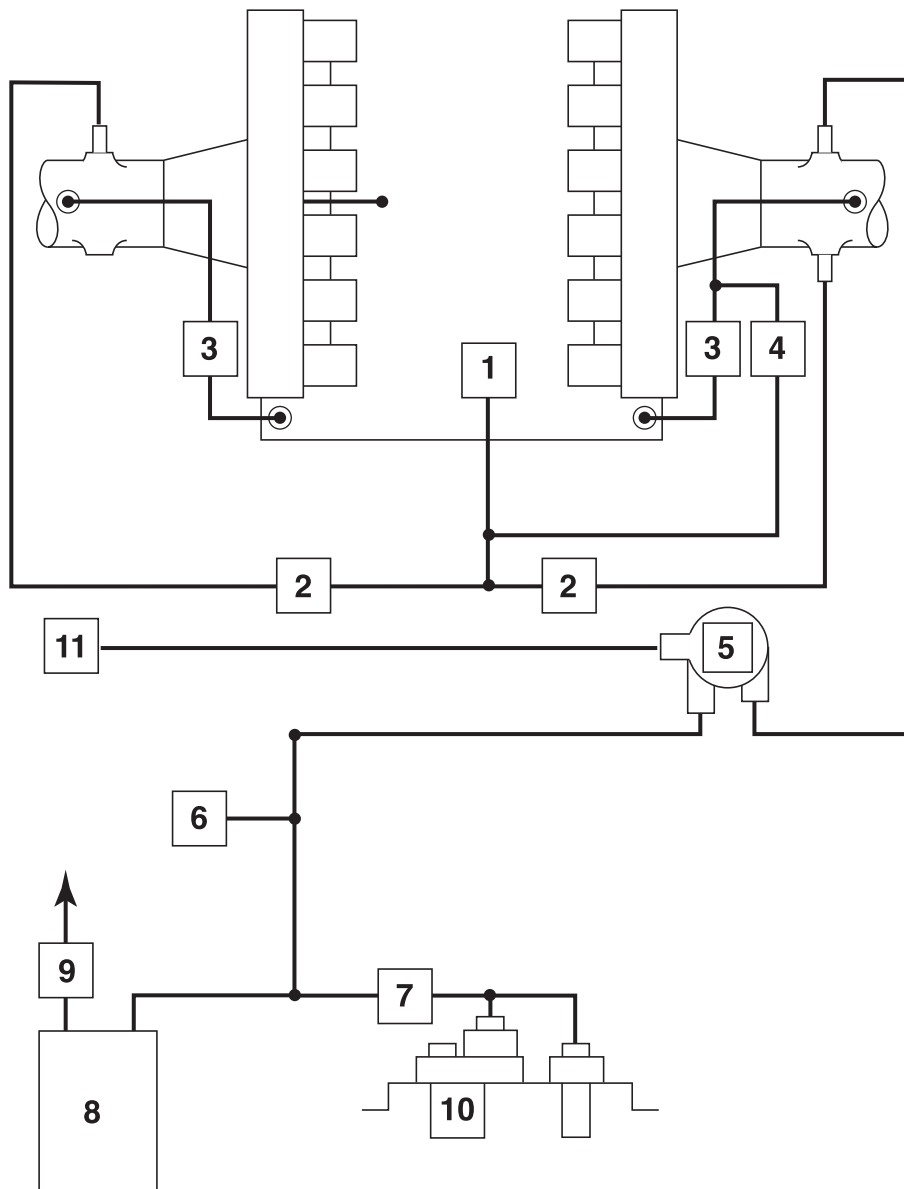
P0455 - Evaporative Loss - Vapour Recovery System

| 1. Oil Separator | 6. Service Port |

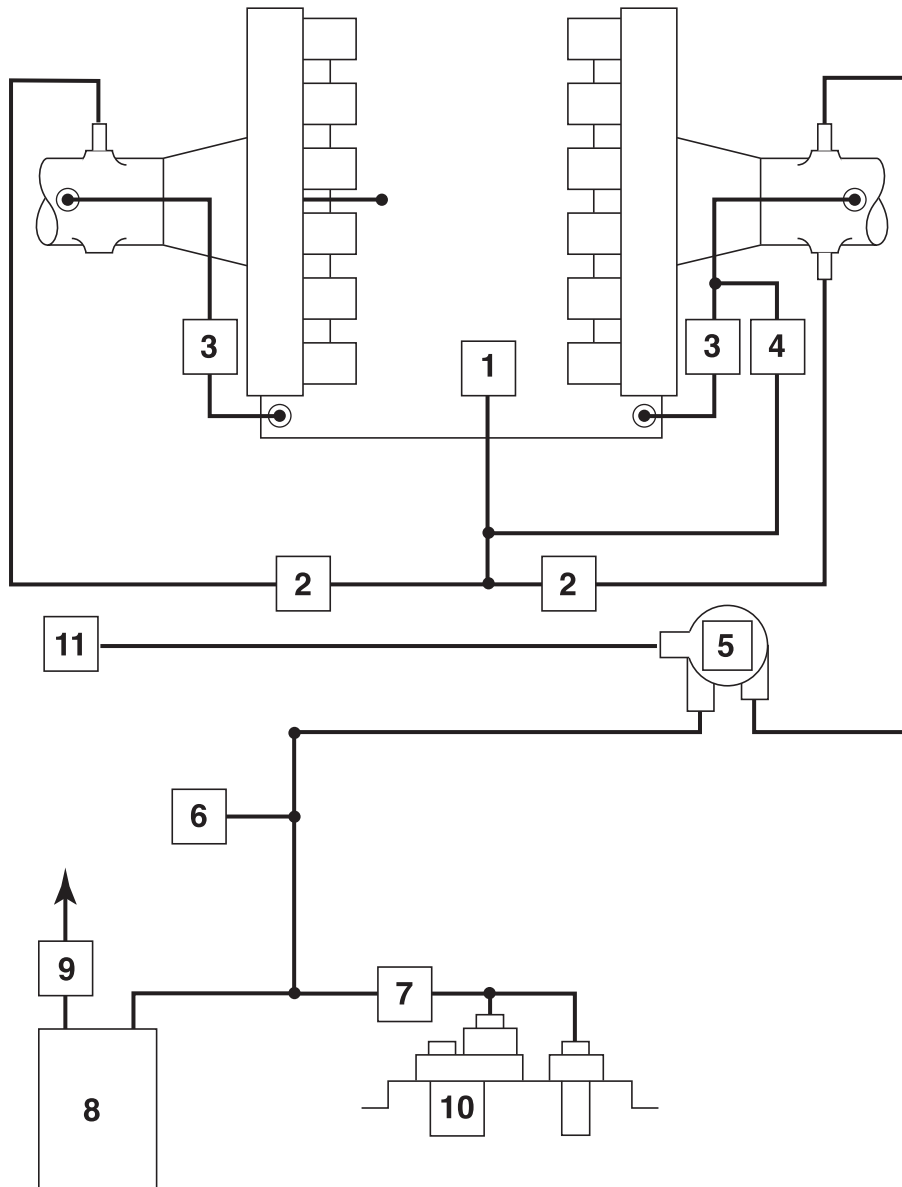
P0456 - Evaporative Loss - Vapour Recovery System

| 1. Oil Separator | 6. Service Port |

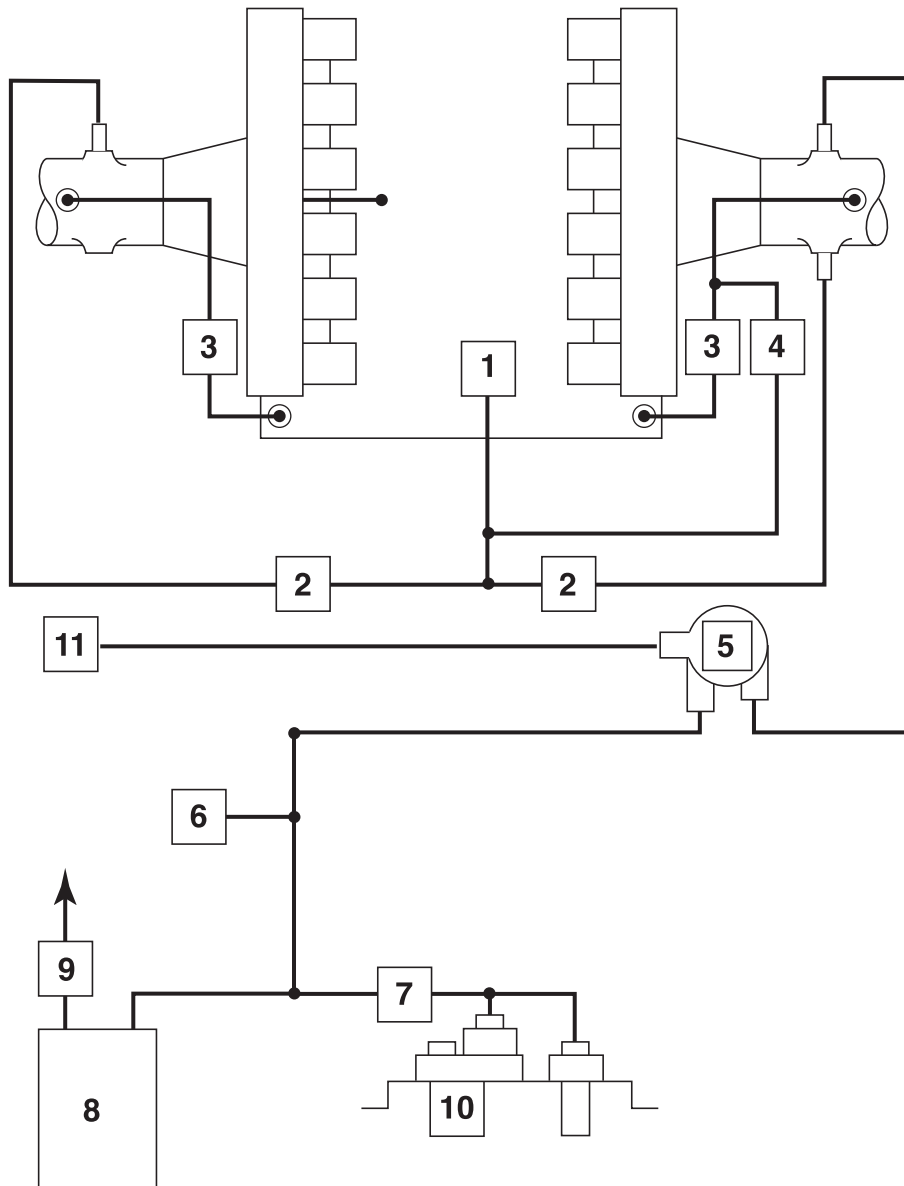
P0457 - Evaporative Loss - Vapour Recovery System

| 1. Oil Separator | 6. Service Port |

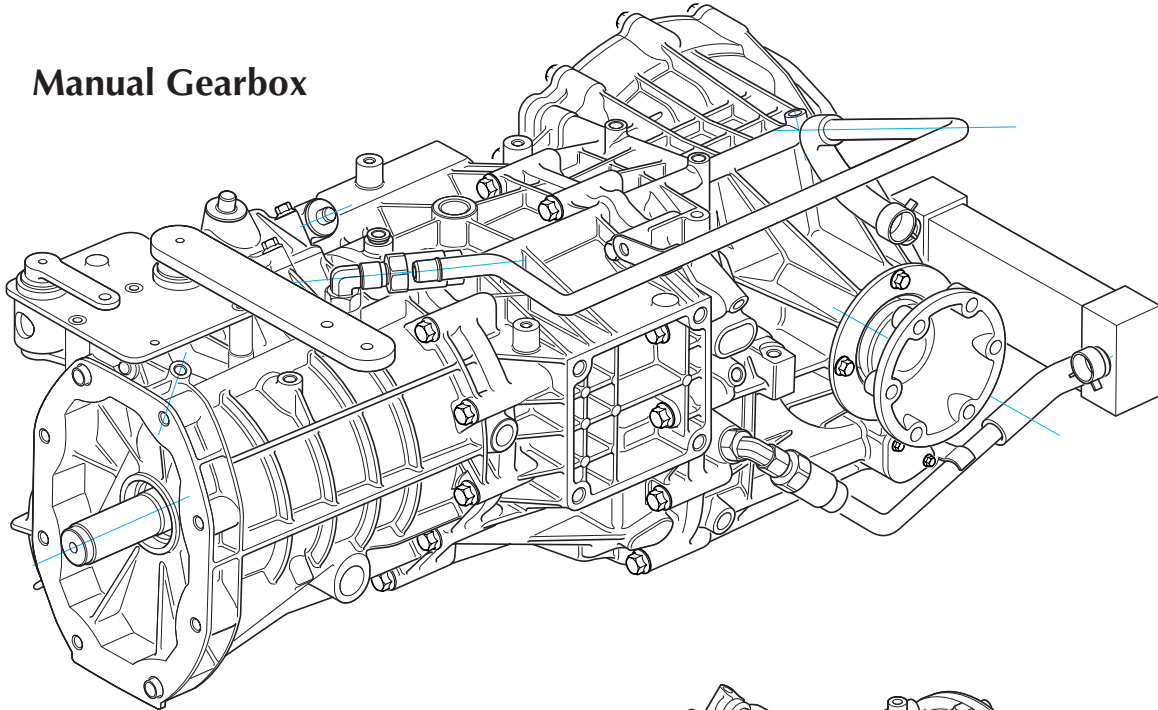
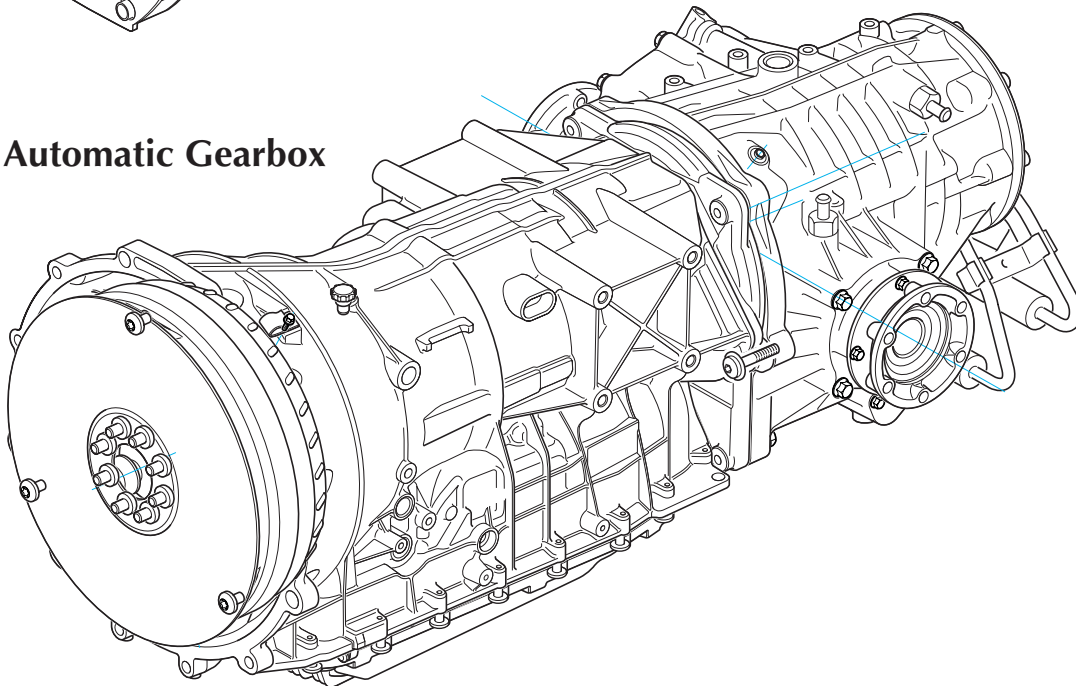
Figure 1. Speed Sensor Locations

Manual Gearbox

Automatic Gearbox

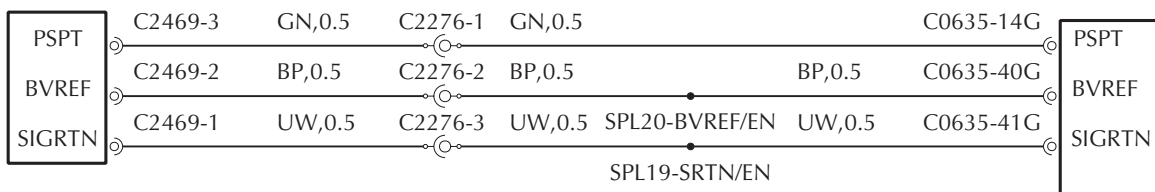
Figure 2. Power Steering Pressure Sensor Circuit

Transducer-Power Steering Pressure

Primary PCM

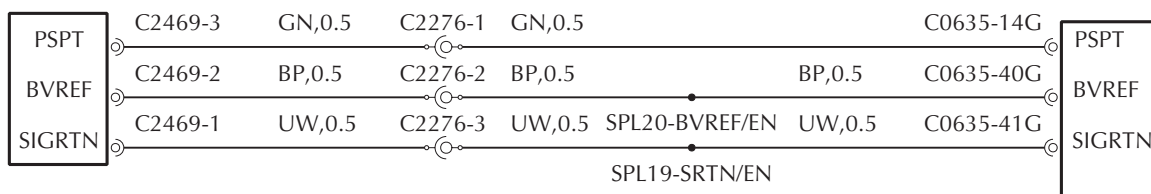
Figure 2. Power Steering Pressure Sensor Circuit

Transducer-Power Steering Pressure

Primary PCM
