DB9

OBD II Diagnostic Manual
Preliminary Issue

ASTON MARTIN LAGONDA LIMITED

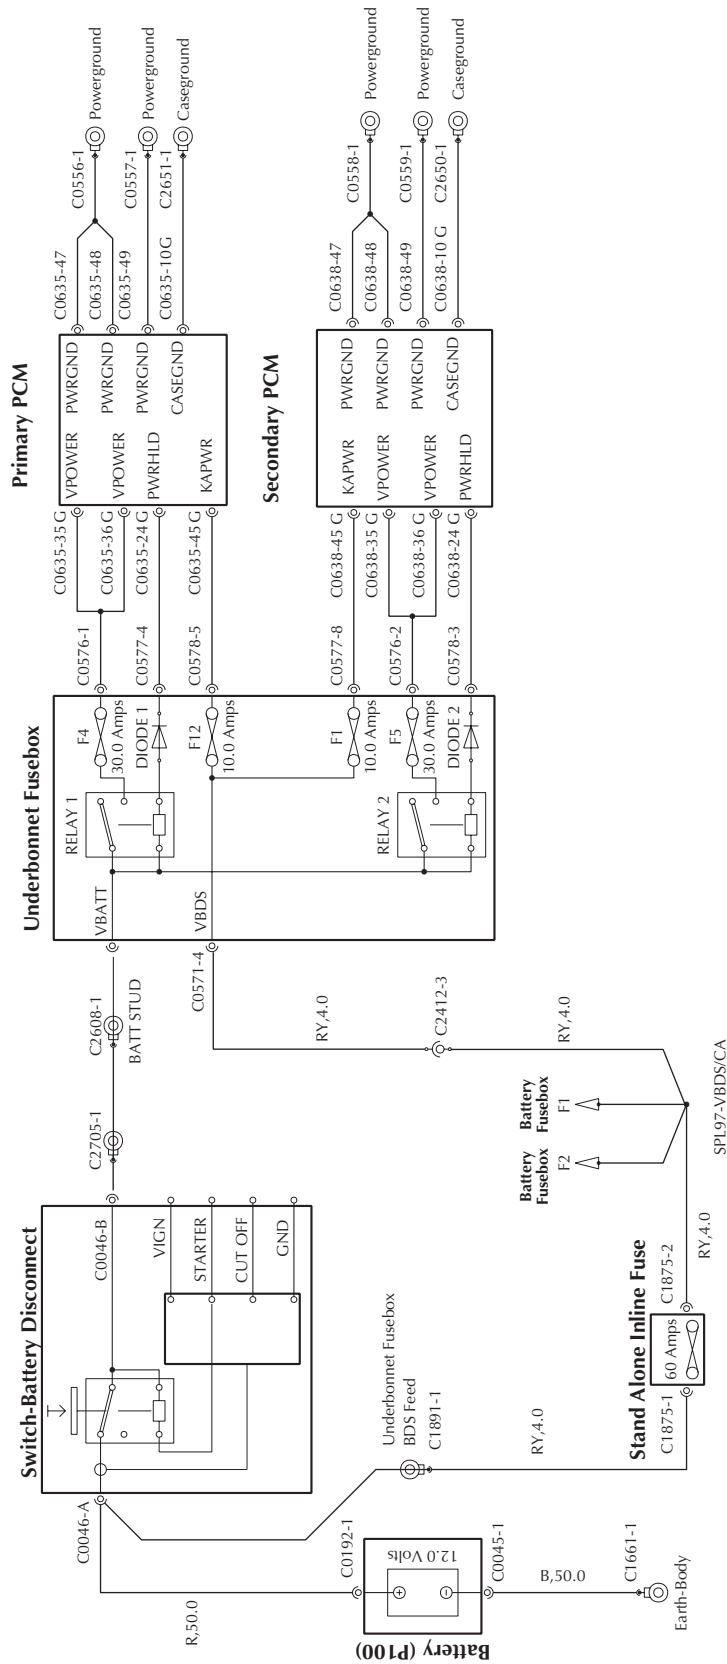
Figure 1. Keep Alive Power Circuit

P0603 - Keep Alive Power

1. Key off. Inspect the battery cables and VBAT supply circuit through the battery disconnect switch for loose connections, corrosion, etc. Repair as necessary.
2. Check the security of the keep alive power lines from the underbonnet fuses F1 and F12 to the PCMs.
3. Disconnect the PCMs, inspect the connectors for pushed out pins, damage, corrosion, etc. Repair if necessary.
4. Fit the PCM break-out box. Measure voltage between primary PCM harness connector C0635-45 and chassis ground (KAPWR). Repeat the check at secondary PCM connector C0638-45. Whilst measuring the voltage, grasp the PCM harness and wiggle, shake or bend small sections while working from the PCM to the underbonnet fusebox.

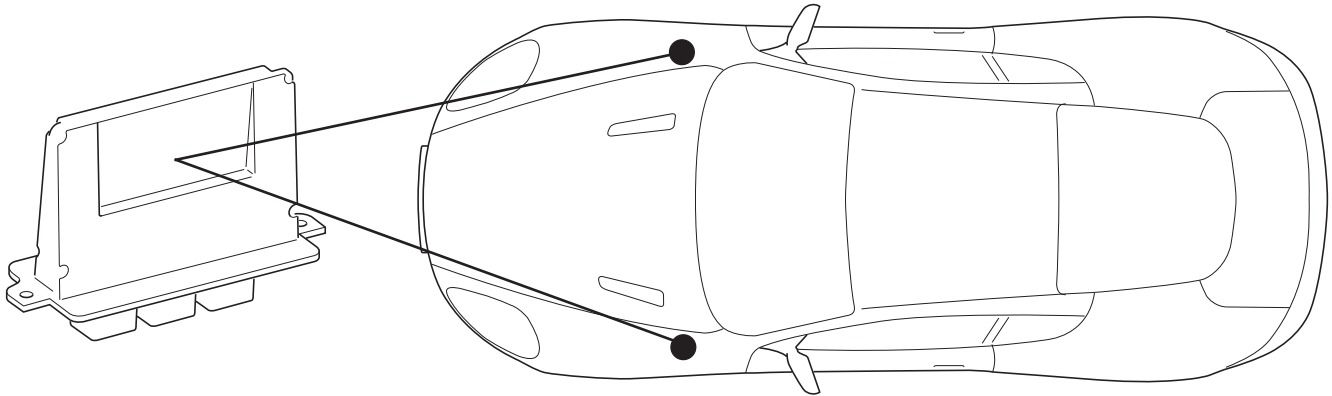
Figure 1. PCM Locations

P0605 - PCM / PCM Processor

1. Connect the WDS and confirm that P0605 is logged.
2. Run a KOER test. Recheck the logged fault codes
3. If P0605 is logged again, use WDS to reprogram (reflash) the PCM.
4. Repeat the KOER test and recheck for logged fault codes.
5. If P0605 is logged again, replace the PCM

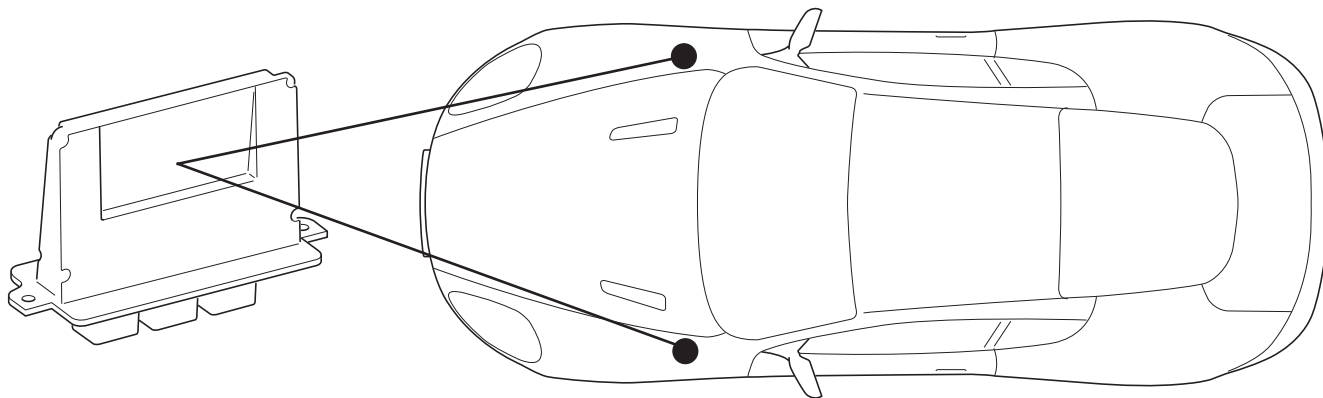
Figure 1. PCM Locations

P0606 - PCM / PCM Processor

1. Connect the WDS and confirm that P0606 is logged.
2. Run a KOER test. Recheck the logged fault codes
3. If P0606 is logged again, use WDS to reprogram (reflash) the PCM.
4. Repeat the KOER test and recheck for logged fault codes.
5. If P0606 is logged again, replace the PCM

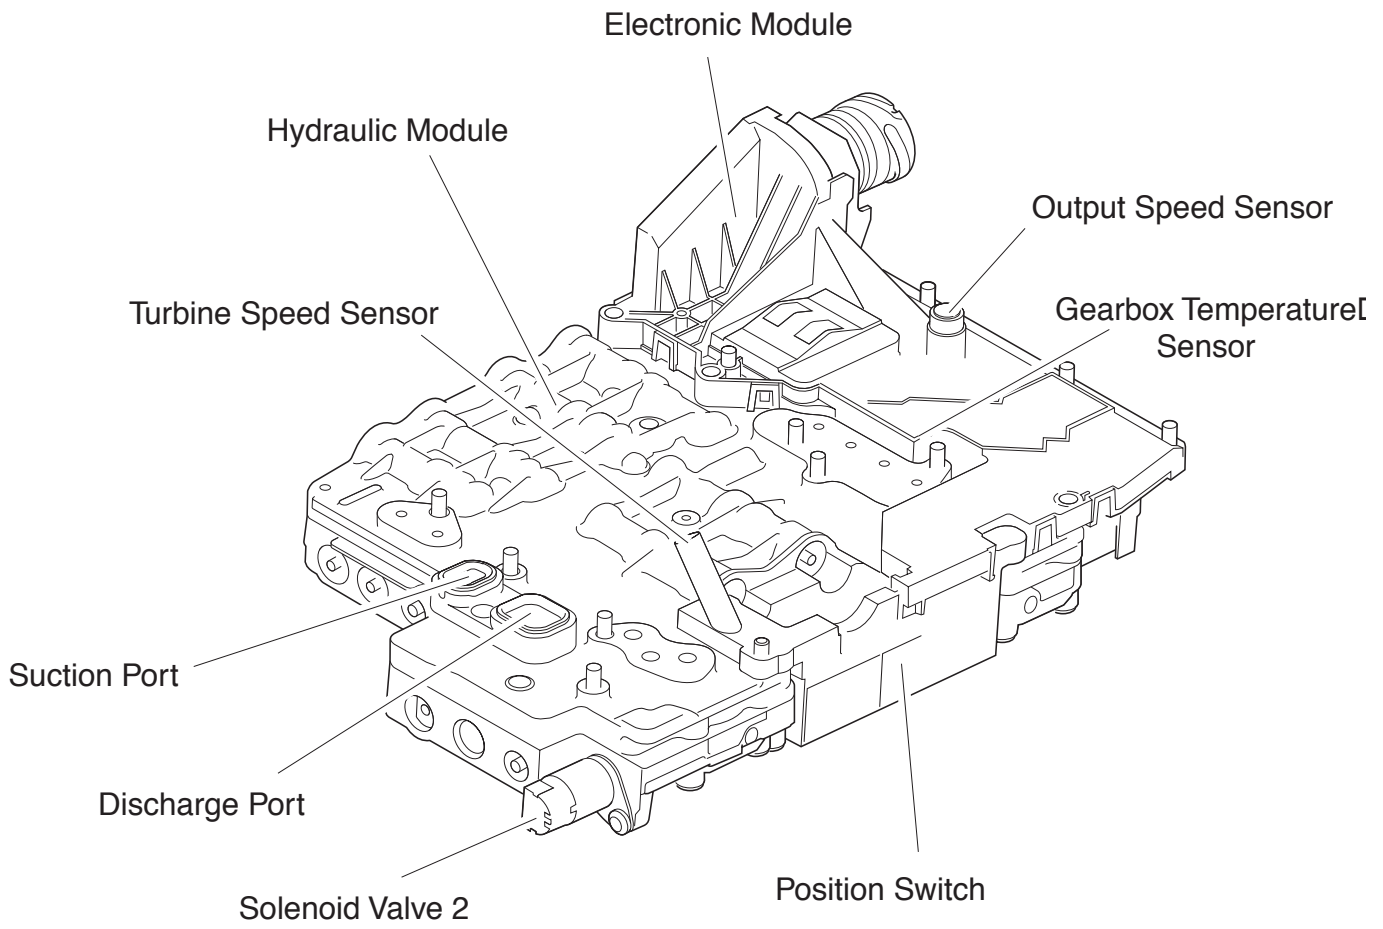
Figure 1. Mechatronic Unit

P0613 - TCM Watchdog Error

1. Connect the WDS and confirm that P0613 is logged. Clear the P0613 code
2. Run a KOER test. Recheck the logged fault codes
3. If P0613 is logged again, reflash the TCM. Run a further KOER test to check if the problem is resolved.
4. If p0613 is logged again, replace the mechatronic unit.

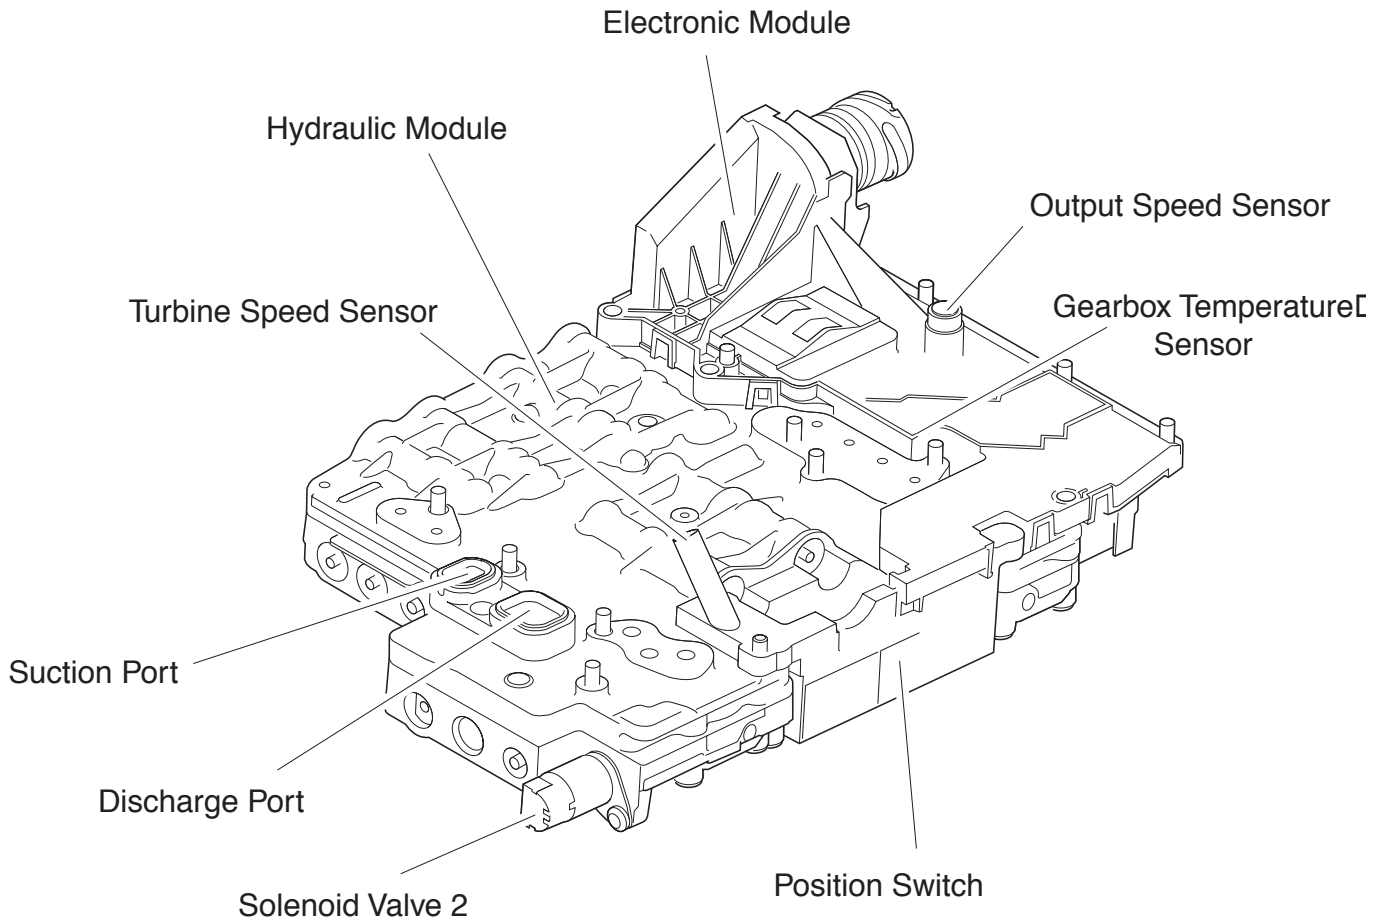
Figure 1. Mechatronic Unit Location

P0614 - CAN Level

1. Connect the WDS and confirm that P0614 is logged. Clear the P0614 code
2. Run a KOER test. Recheck the logged fault codes
3. If P0614 is logged again, check if the mechatronic unit has been replaced. If so the software level may be different to that logged for the vehicle.
4. Consult Aston Martin Technical Support.

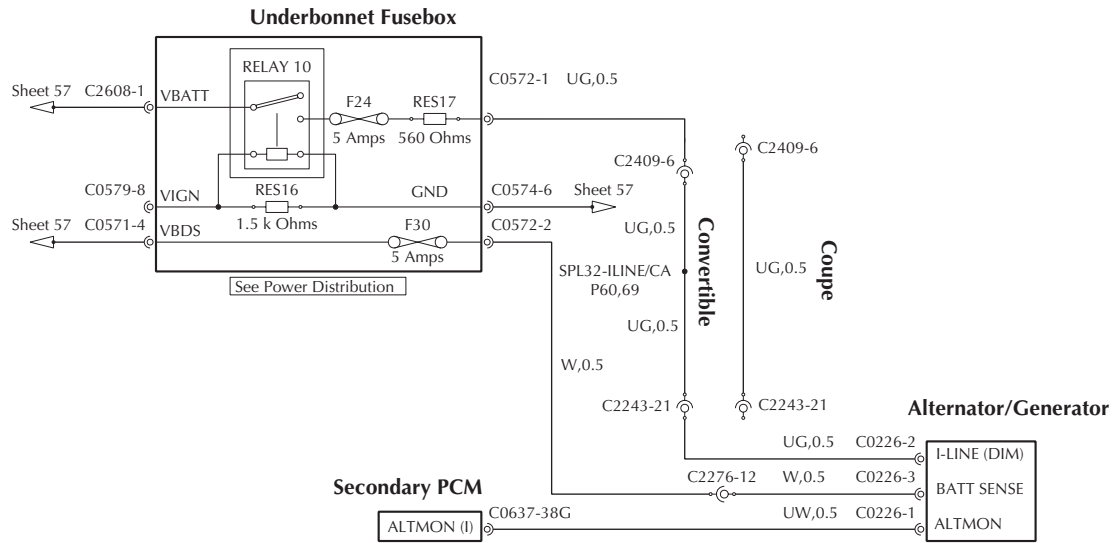
Figure 1. Generator Control Circuit

P0620, P0622 - Generator Control Circuit

3. For P0622, check that +12volts is present on alternator connector C0226-3 (BATT SENSE). If +12 volts is not present, service the battery sense circuit from underbonnet fusebox F30 to the alternator. Clear the P0622 code. Run the engine and check that the problem is resolved.

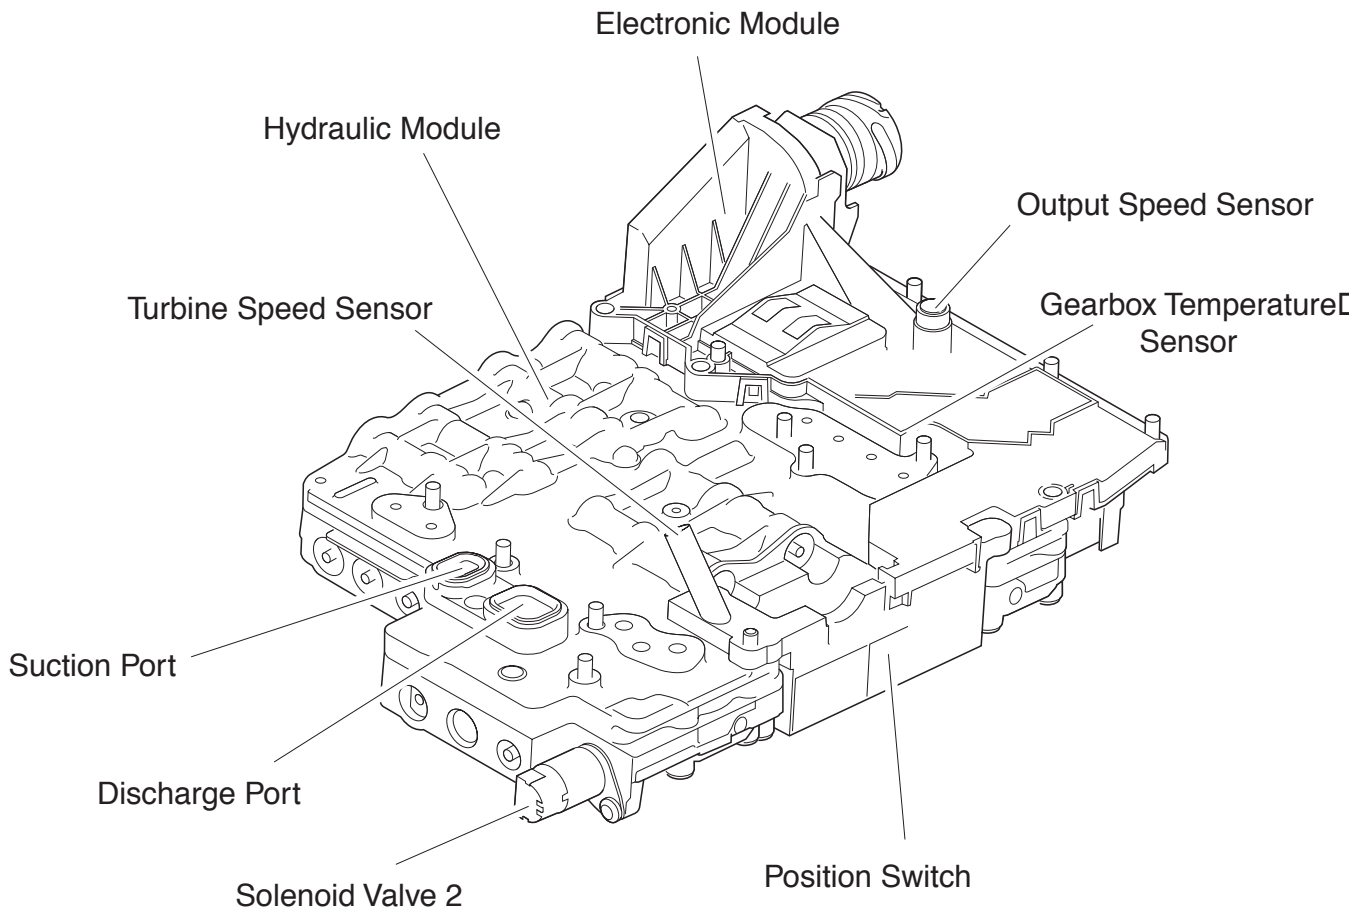
Figure 1. Mechatronic Unit

P062F - TCM EEPROM Emulation Lifetime Exceeded

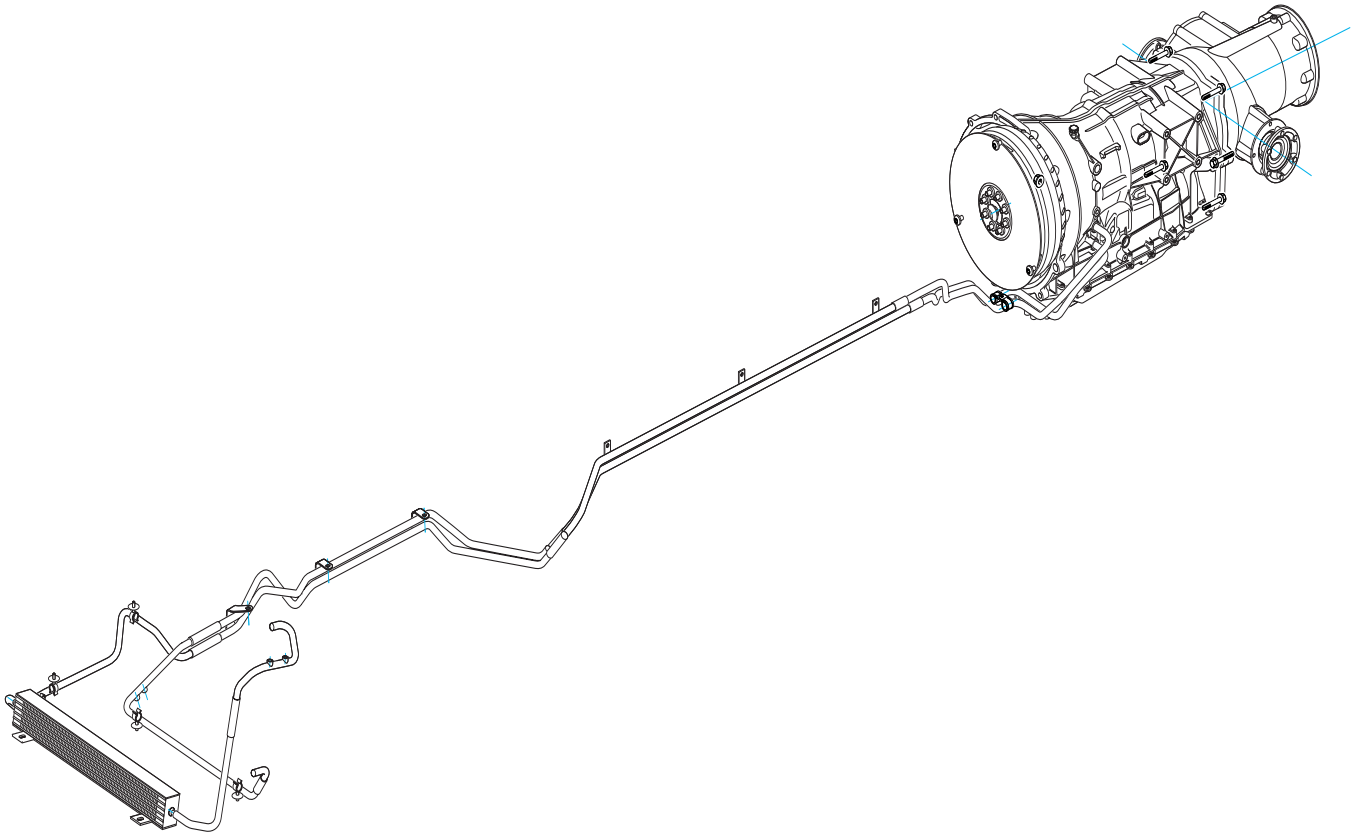
Figure 1. Automatic Gearbox Cooling Circuit

P0634 - Gearbox Overheat

4. Examine the transmission fluid cooling circuit for damage or restrictions which could inhibit the fluid cooling function.

10. The temperature sensor is integrated into the 'Mechatronic Unit' in the gearbox and is not serviceable. Change the mechatronic unit. Clear the fault code and run a KOER test to ensure that the problem is resolved.
11. Check for muck in the transmission fluid. i.e. blockages in the cooling system

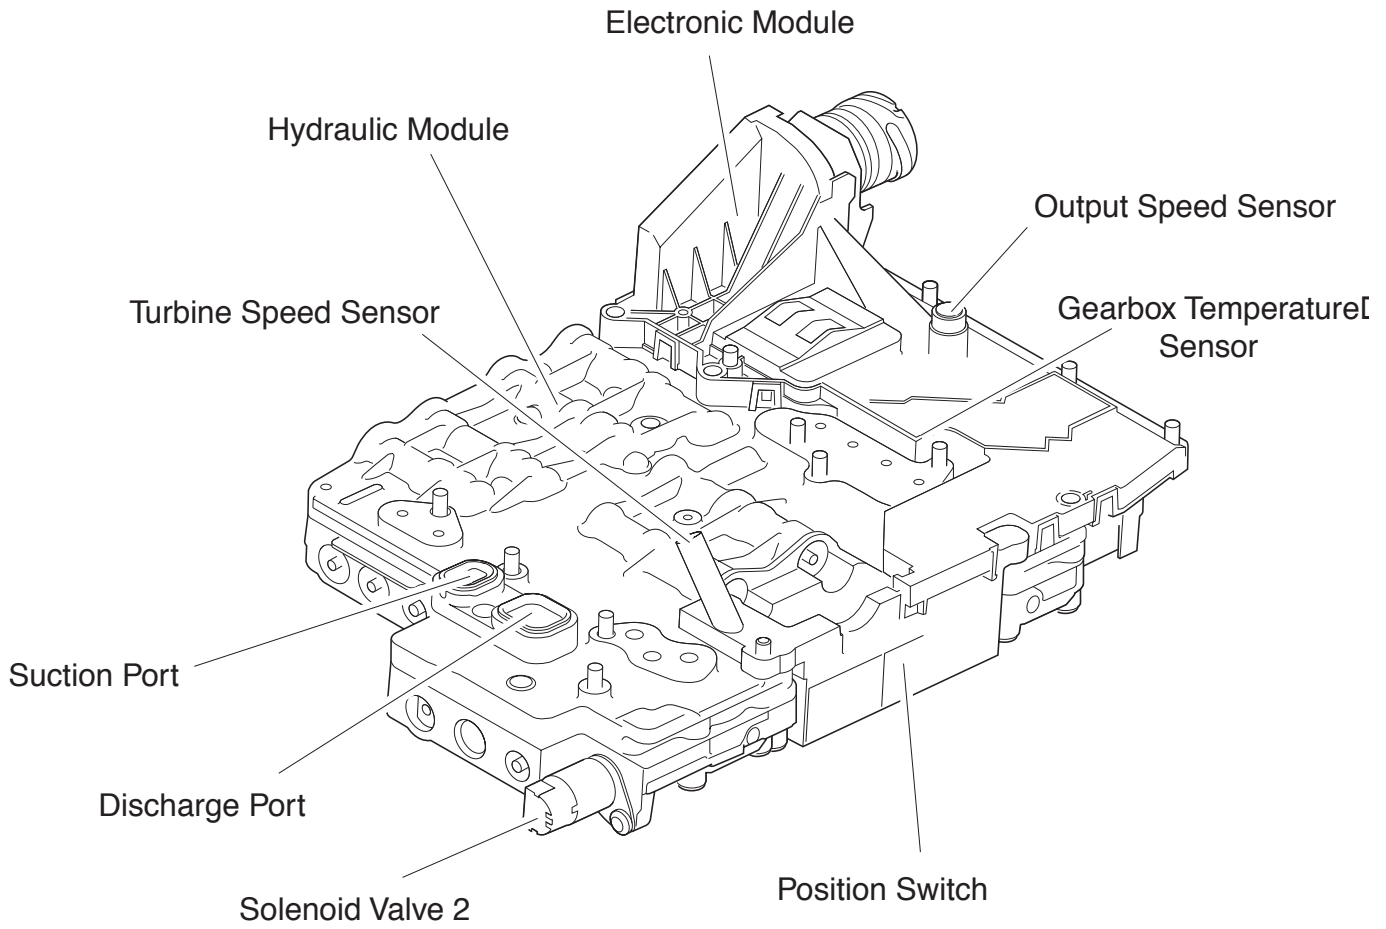
Figure 1. The Mechatronic Unit

P0641 - Transmission Sensor Supply Voltage

4. Check the condition of the pins and sockets in both halves of C0932.

If no fault is identified, replace the mechatronic unit. Clear the P0641 code and run a KOER test to ensure that the problem is resolved.

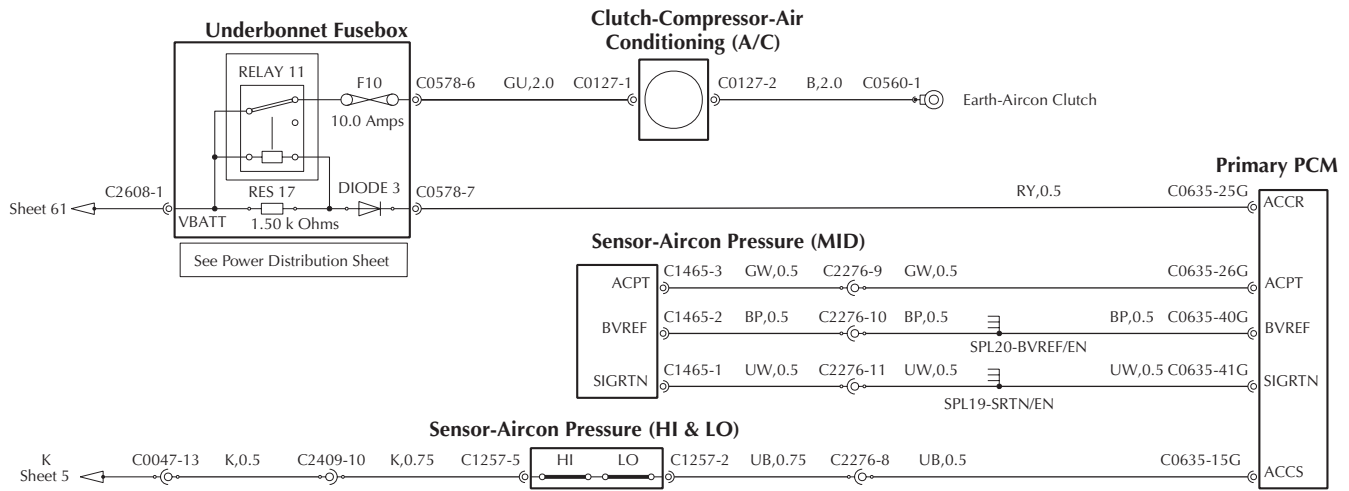
Figure 1. A/C Clutch Control Circuit

P0645 - A/C Clutch Relay

Remove the A/C clutch relay and check the coil resistance. Measure between relay pins 85 and 86. The coil resistance should be between 40 and 85Ω. If the coil resistance is incorrect, replace the relay. Reset the PTEC and rerun the KOER Test.

Measure resistance from relay pin 85 to pins 30, 87 and 87A. The resistance should be greater than 10kΩ. If the resistance is less than 10kΩ, replace the relay.

Measure the voltage at A/C clutch relay pin 87. If less than 10.5 volts with the A/C selected on, the clutch relay is defective. Replace the relay, reset the PCM and rerun the KOER Test.

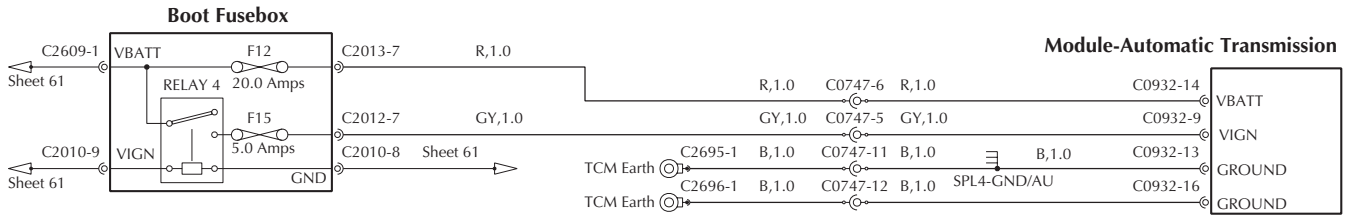
Figure 1. TCM Power Circuit

P0657/P0658/P0659 - Pressure Regulator Voltage Supply Fault

Add C0932-7 wiring.

Note: If P0657 is logged and the +12V supply is good, this may be an indication of an internal mechatronic unit fault. Replace the mechatronic unit and retest.

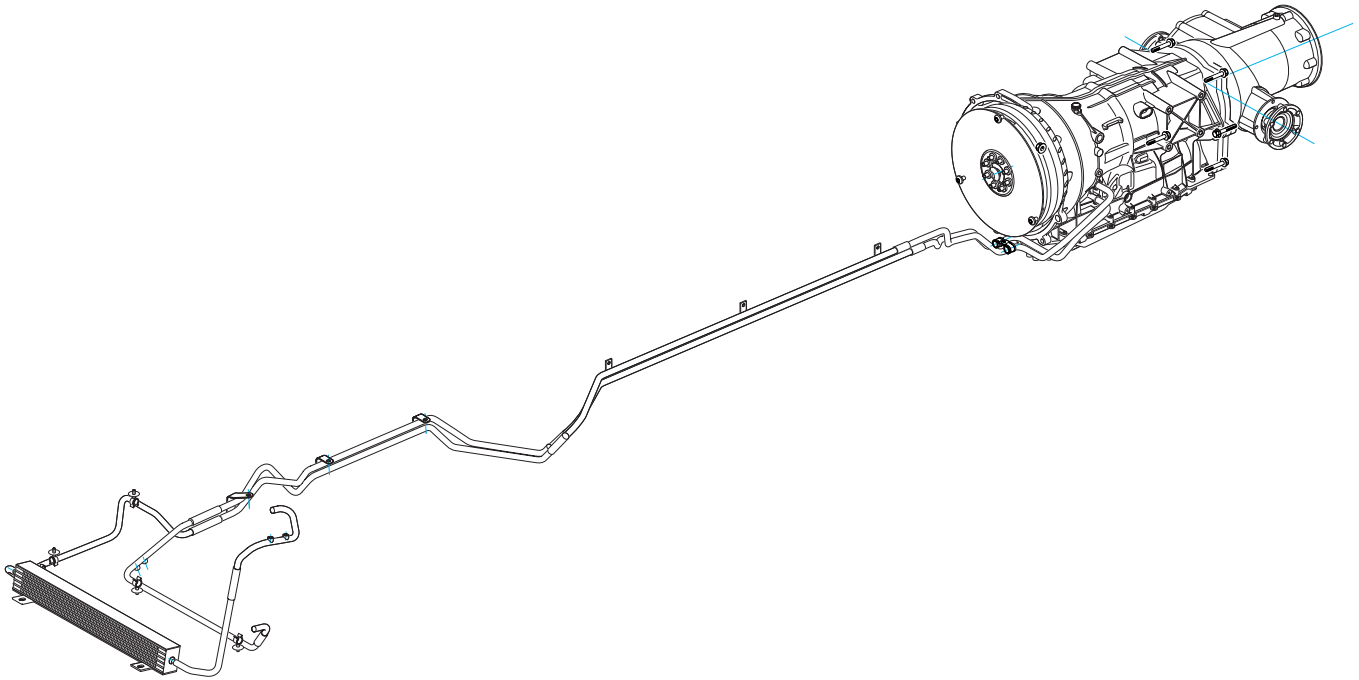
Figure 1. Automatic Gearbox Cooling Circuit

P0667 - Gearbox Temperature Sensor Chip

P0667 - Damaged control chip, gearbox temperature sensor.

1. Connect the WDS or scan tool. Confirm that P0667 is logged.
2. Clear the P00667 code. Run a KOER test. Check the logged fault codes.
3. If P0667 is logged again, change the mechatronic unit.
4. Run a further KOER test to ensure that the problem is resolved.

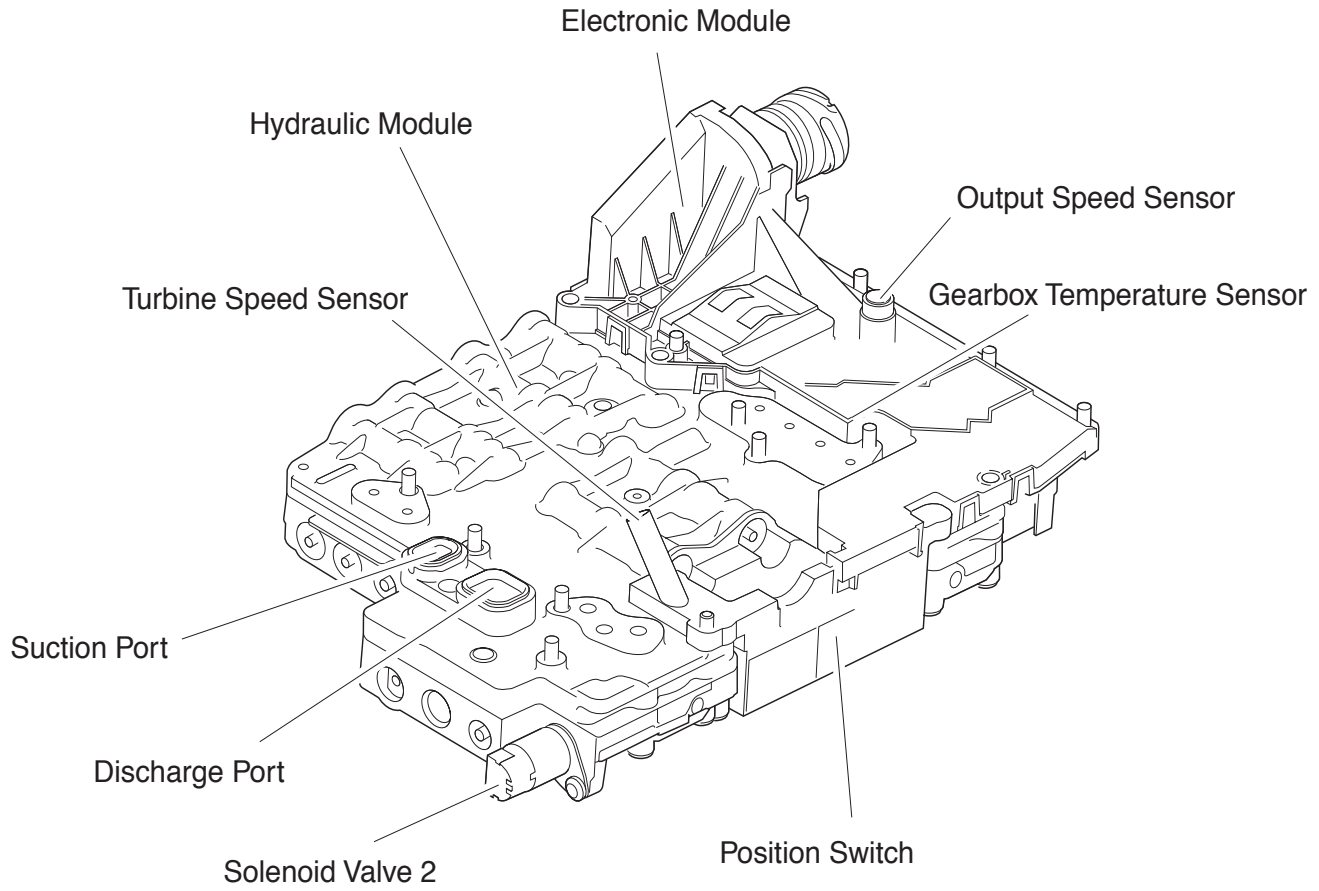
Figure 1. Transmission Fluid Temperature Sensor Location

P0701 - Sensor Fault

P0701 - Sensor Fault and Backup Strategy has also failed.

Note: This fault will be logged if a control sensor within the transmission fails and the backup strategy also fails.

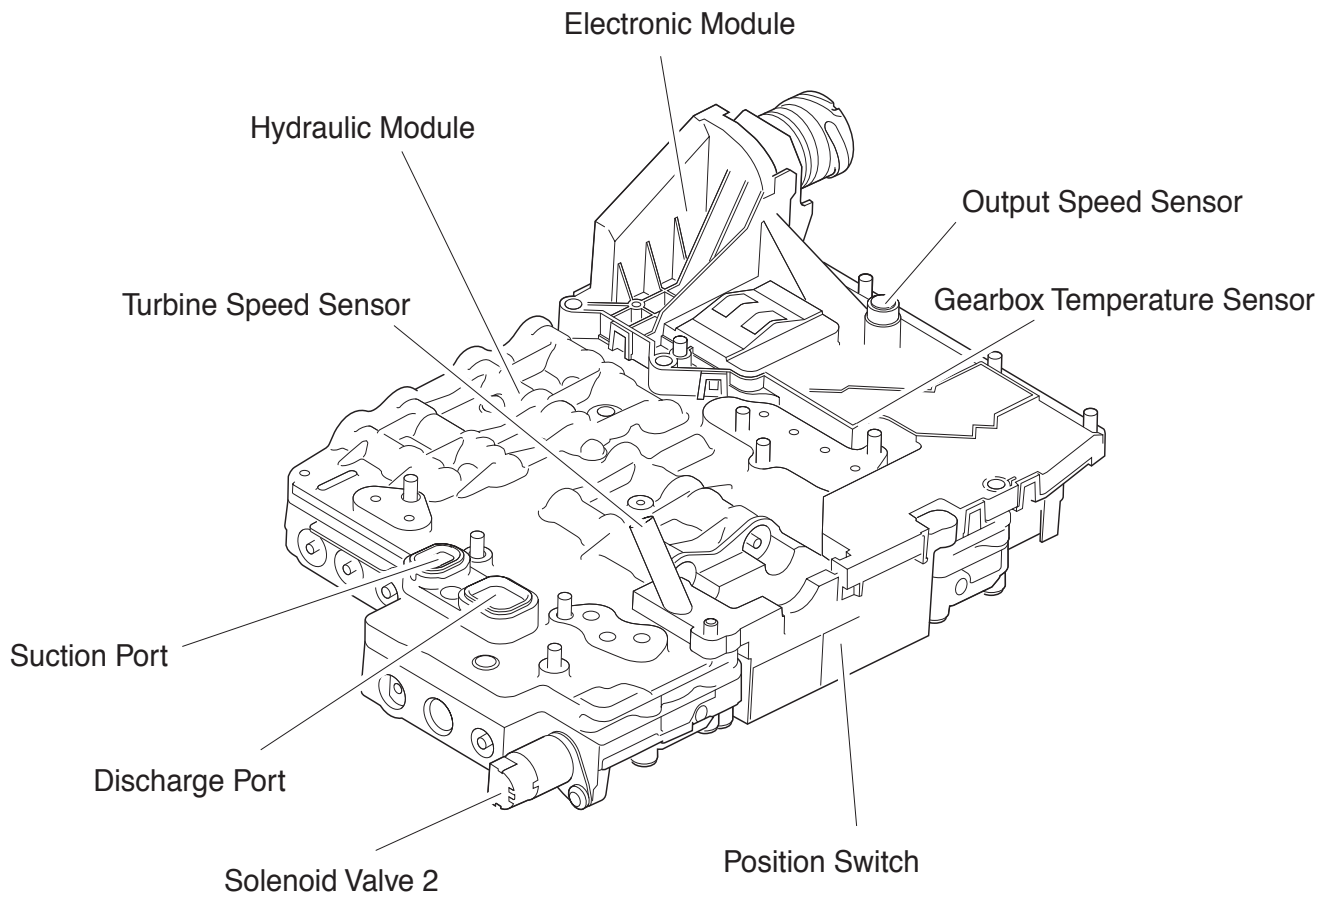
Figure 1. Transmission Mechatronic Unit

P0711/P0712/P0713/P0714 - Transmission Fluid Temperature

Run a test drive to confirm the replacement Mechatronic unit and to ensure that the problem is resolved.

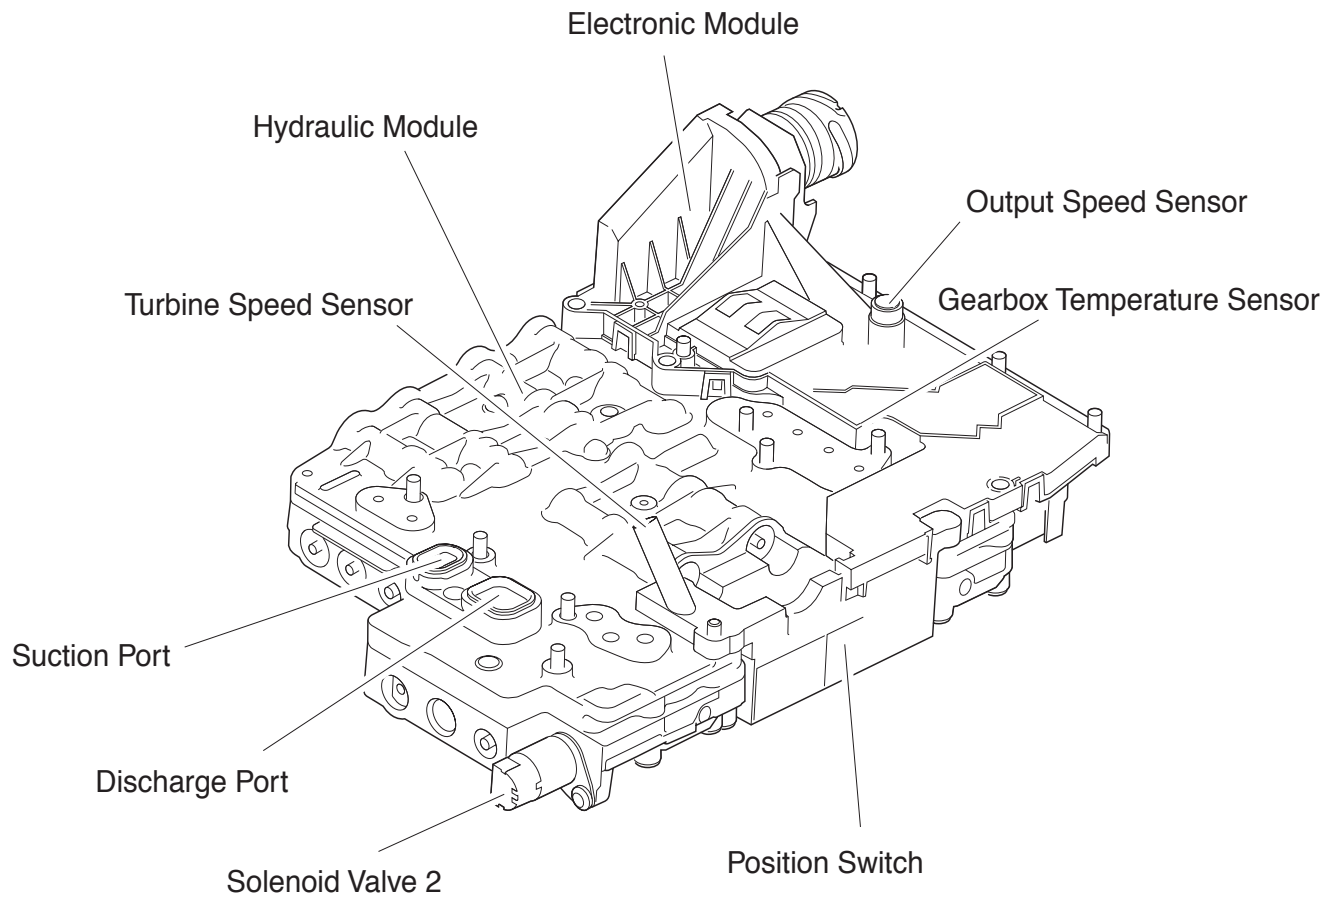
Figure 1. Output Speed Sensor Location

P0715, P0716, P0717 - Transmission Turbine Speed Sensor Fault

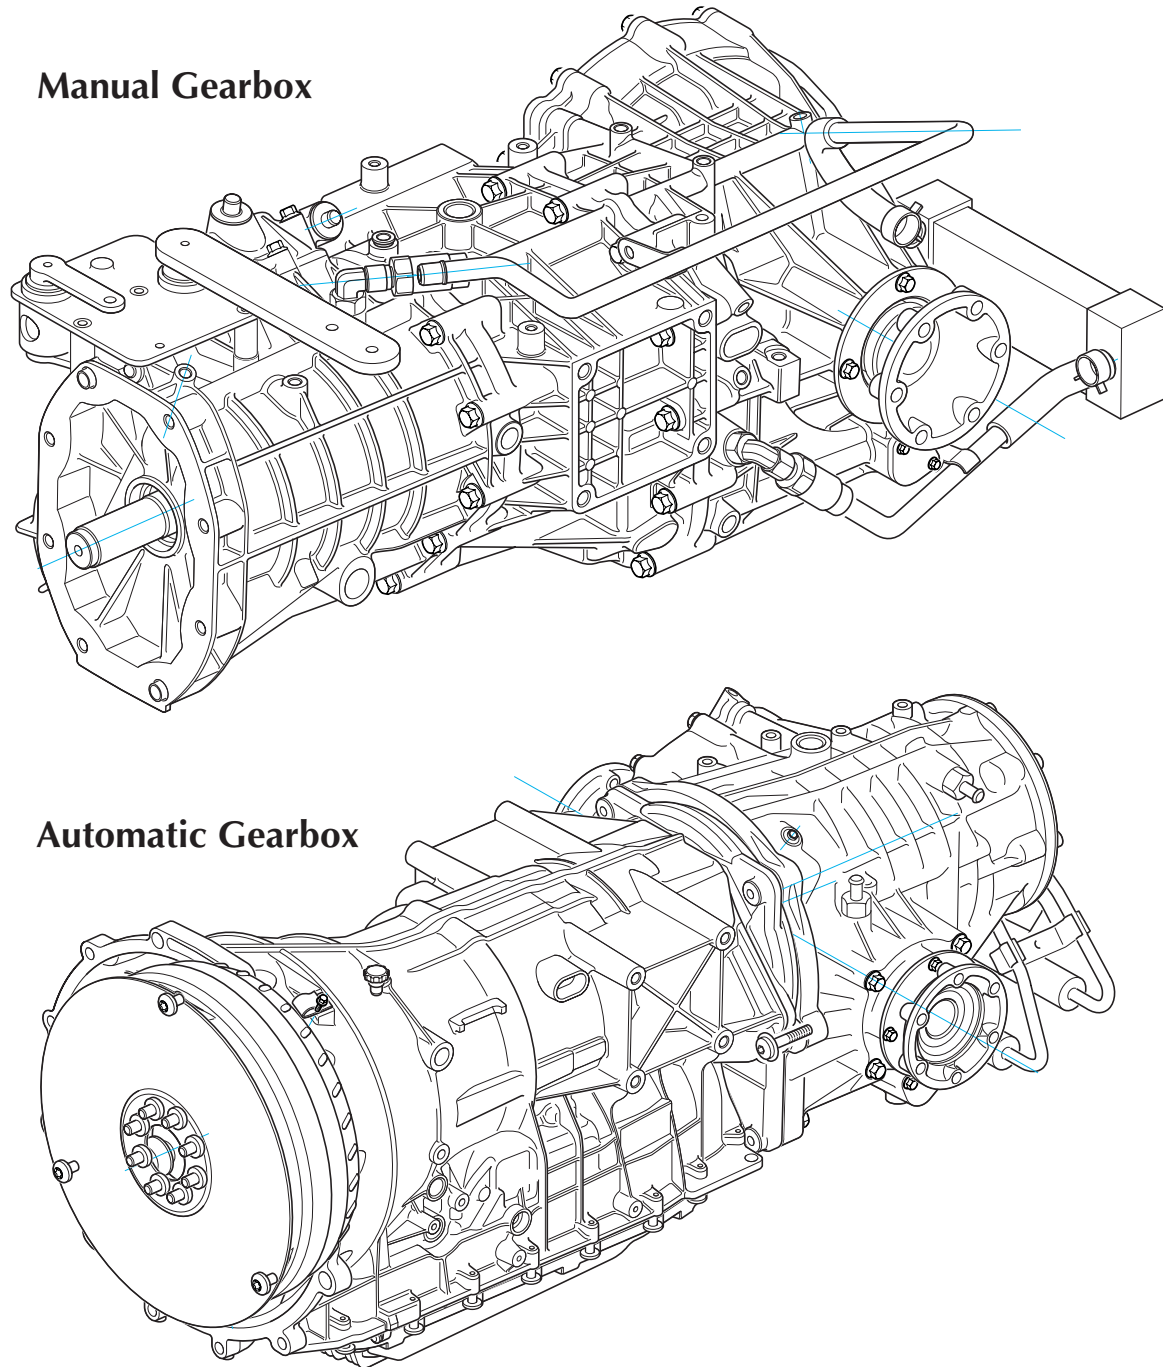
Figure 1. Speed Sensor Locations

P0720, P0721, P0722 - Vehicle Speed Sensor Fault

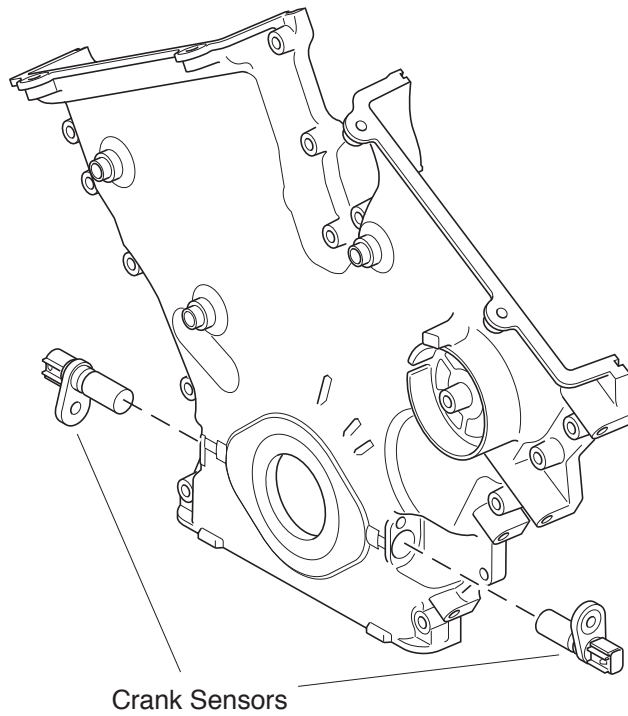
Figure 1. Crank Position (Engine Speed) Sensor Location

P0725 - Engine Speed/Tachometer Fault

5. Swap the crank sensors bank to bank and repeat the test. If the fault changes sides, replace the suspect sensor. Clear the P0725 code and run a KOER test to ensure that the problem is resolved.

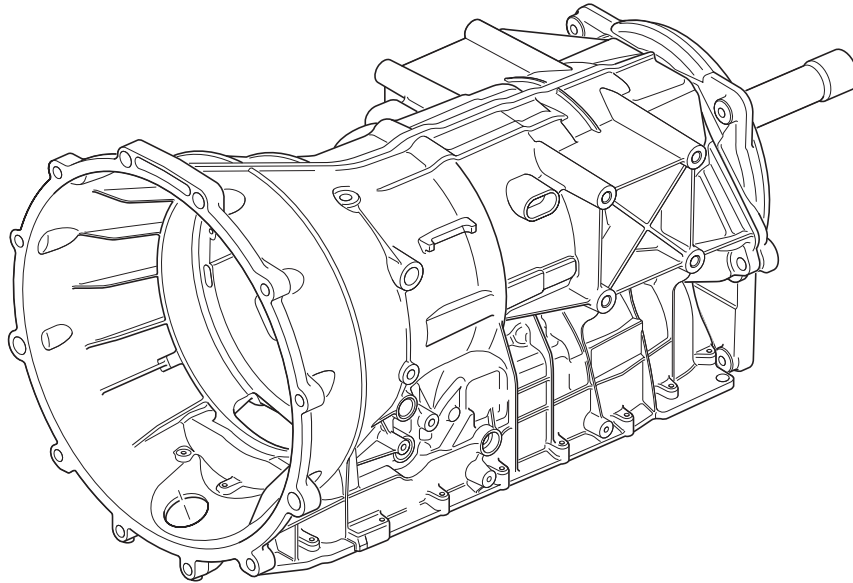
Figure 1. The Automatic Transmission

P0729 to P0735 - Gear Ratio Error

5. Check the condition of the transmission connector socket pin C0932-14.

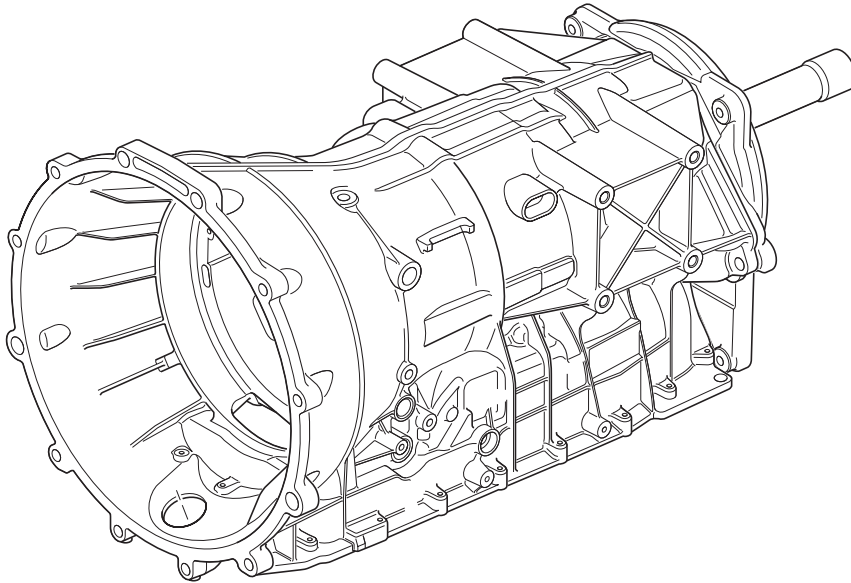
Figure 1. Gearbox Unit

P0736 - Gear Ratio Error - Reverse

1. Check the transmission fluid level. If the fluid level is low, top-up using the service manual procedure. Check that there are no leaks in the transmission cooling system. Clear the fault code and run a road test including use of reverse gear. Check for any logged fault codes.

4. Check the condition of the transmission connector socket pin C0932-14.

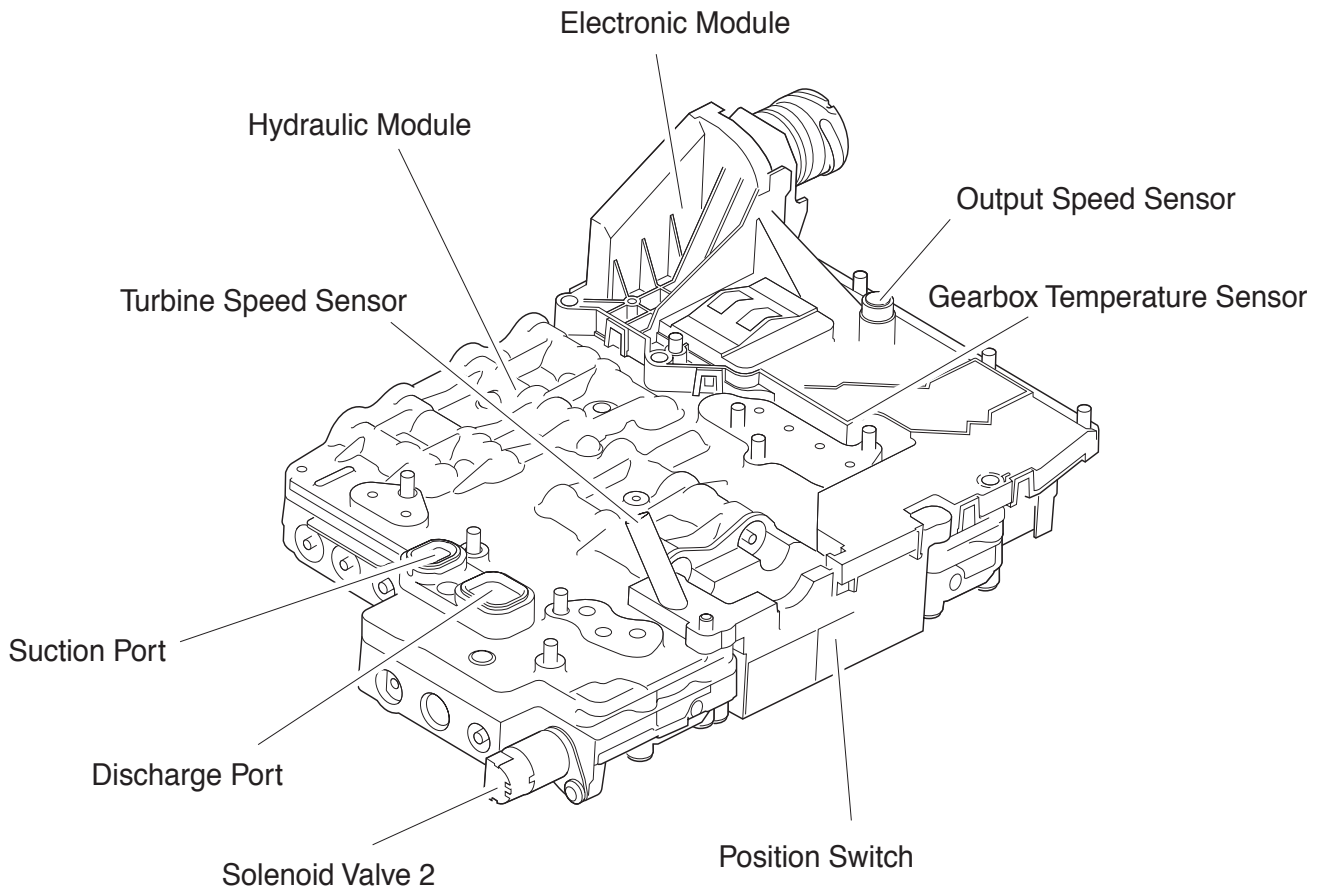
Figure 1. Mechatronic Unit

P0740 and P0960, 62, 73, 76, 79, 82 and P2764 - Transmission Pressure Regulator Faults

1. Clear the fault code.
2. Run a road test to include use of all gears.
3. Stop the test and check for logged DTCs.
4. If any of the above DTCs are logged again, replace the mechatronic unit. Repeat the road test to ensure that the problem is resolved.

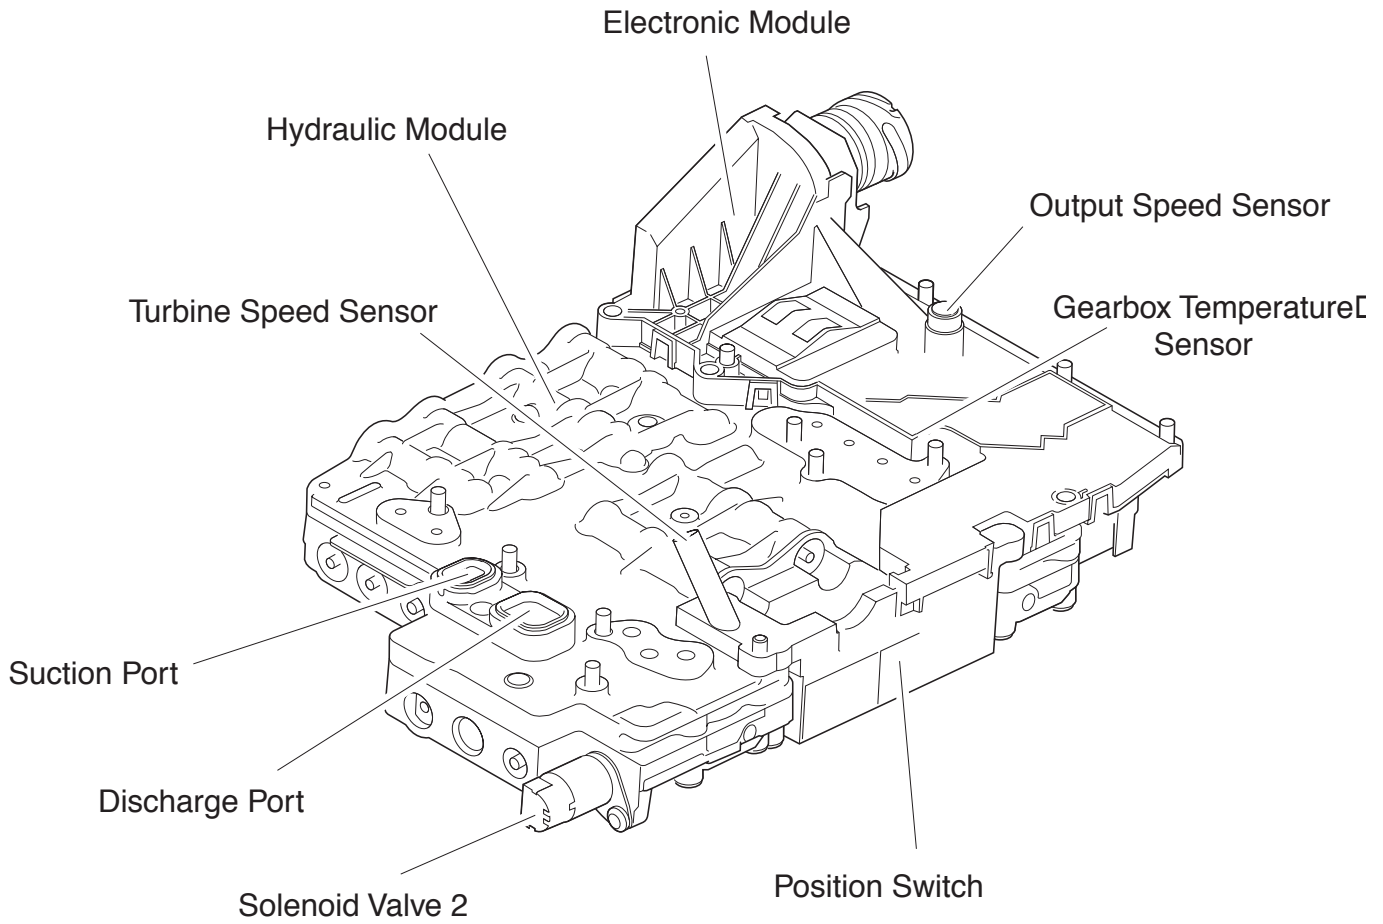
Figure 1. Mecchatronic Unit

P0741 - Torque Converter Clutch Faults

5. Check the condition of the transmission connector socket pin C0932-14.
