DB9

OBD II Diagnostic Manual
Preliminary Issue

ASTON MARTIN LAGONDA LIMITED

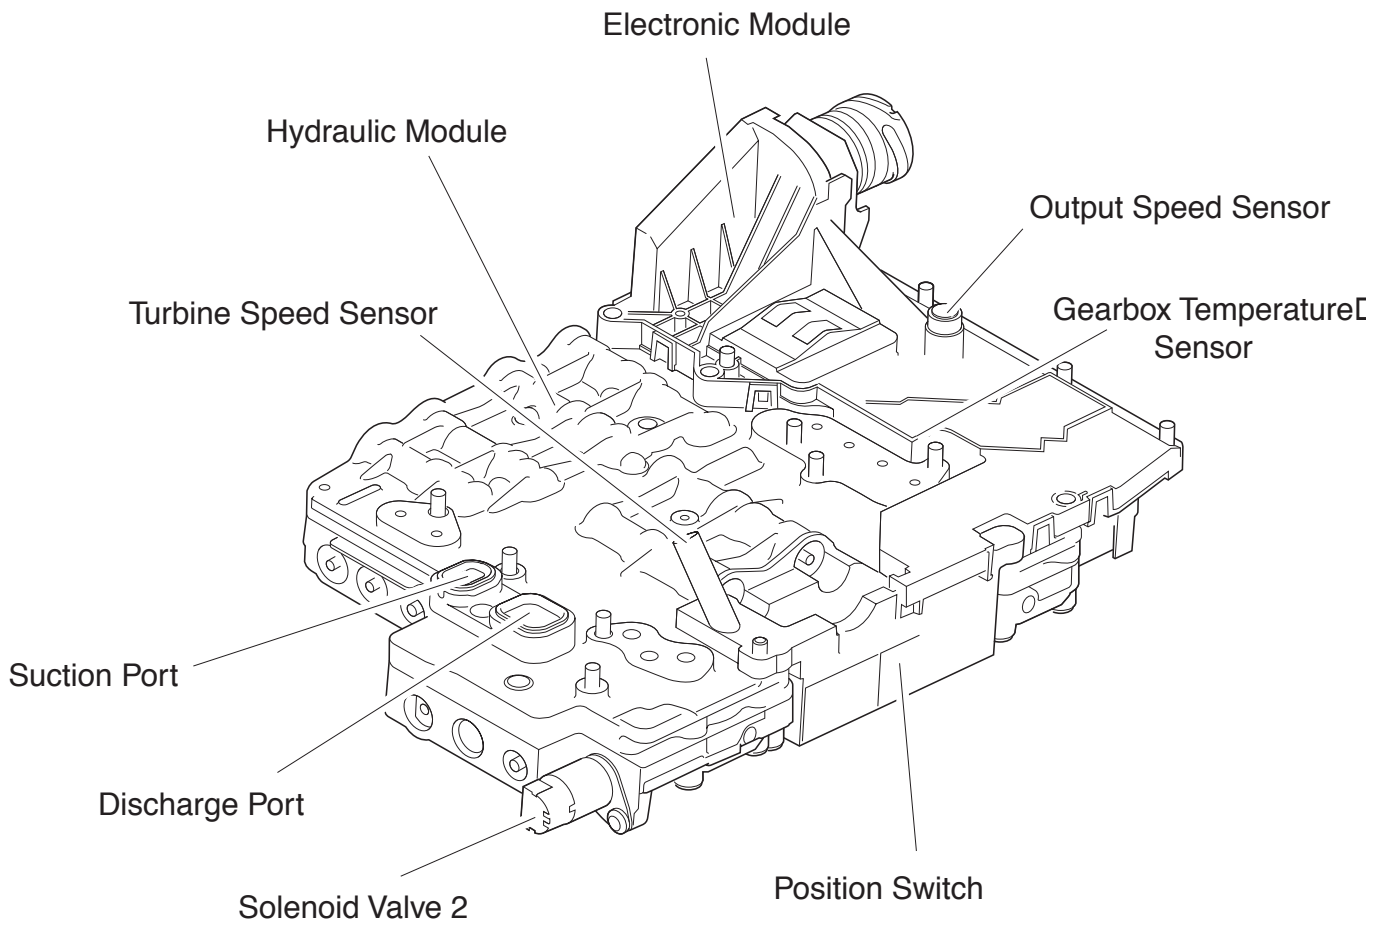
Figure 1. Mechatronic Unit

P0771 - Torque Converter Clutch Faults

1. Connect the WDS and confirm that P0771 is logged.
2. Clear the logged code.
3. With the engine running, select each gear mode by pressing the P, R, N and D buttons in turn.
4. Check that the telltale lamp in each switch illuminates to indicate that the mode has been successfully engaged.
5. Recheck for logged DTCs. if P0771 is logged again, replace the mechatronic unit.
6. Run a brief road test to include use of all gearshift modes to confirm that the problem is resolved.

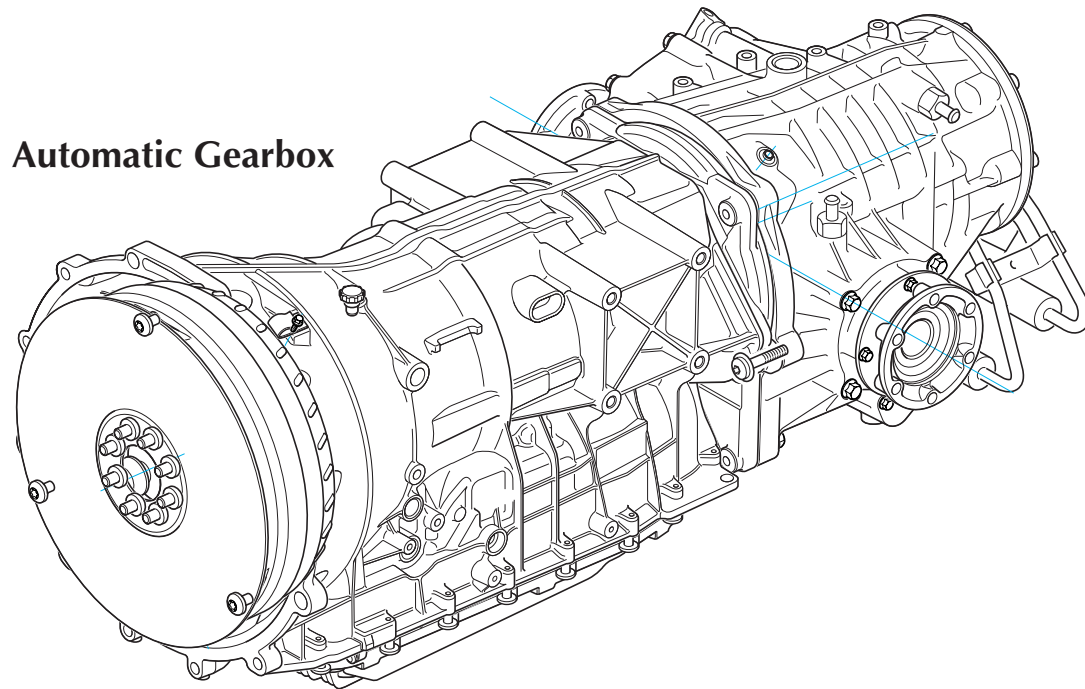
Figure 1. Automatic Gearbox Unit

P0780 to P0784 and P0829 - Transmission Gear Load Errors

1. Check the transmission cooling system for leaks. If any leak is identified, service the system as necessary.
2. Check and if necessary top up the transmission fluid. Low fluid level will affect gear loading. Clear any logged fault codes. Run a brief road test including use of all gears. Check for any logged DTCs
3. If the fault code is logged again, contact Aston Martin Technical Service.

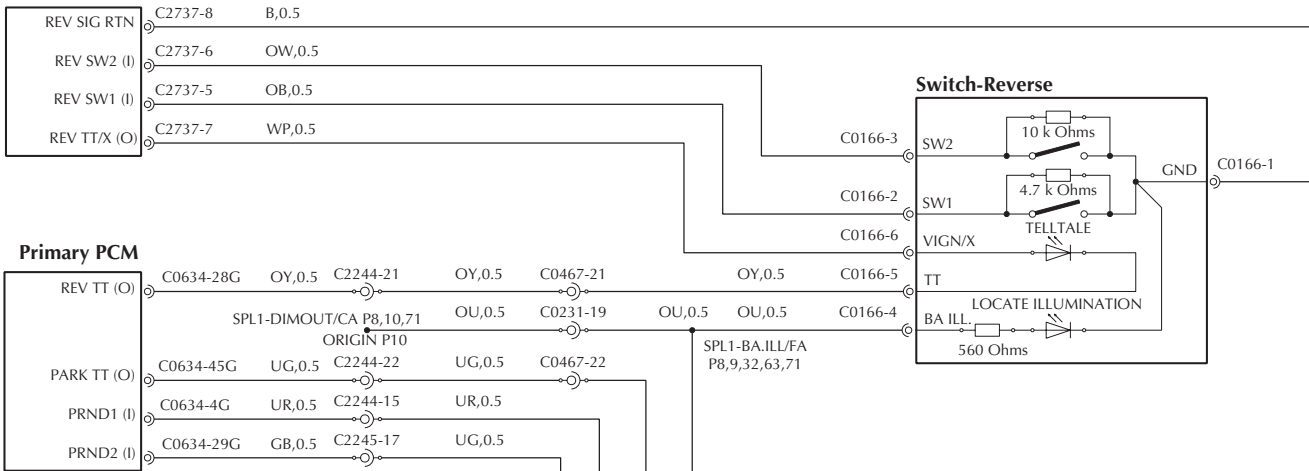
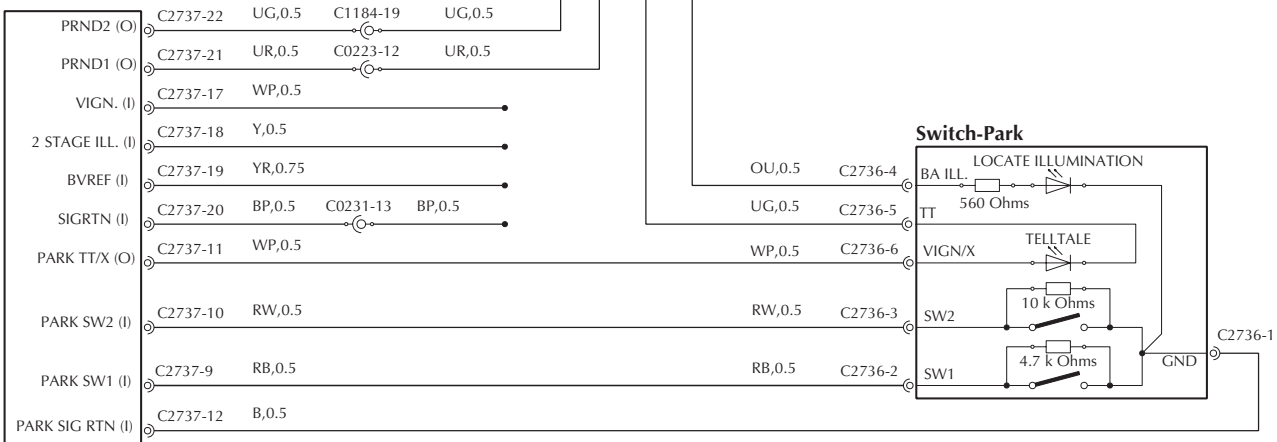
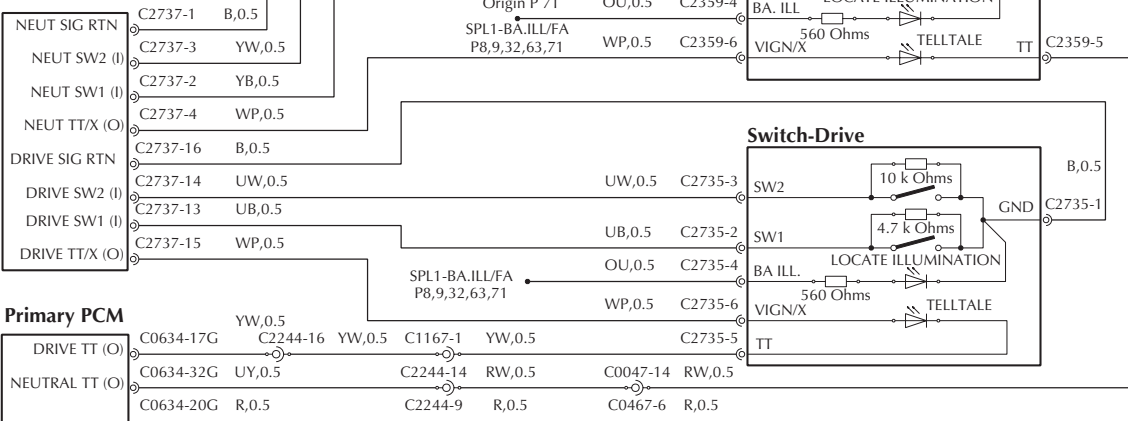
Figure 1. Park, Reverse, Neutral, Drive Switch Circuits

P0812, P081C, P081D, P0853 - Reverse, Neutral, Drive Switch Input Circuit

Interface-Auto Switches

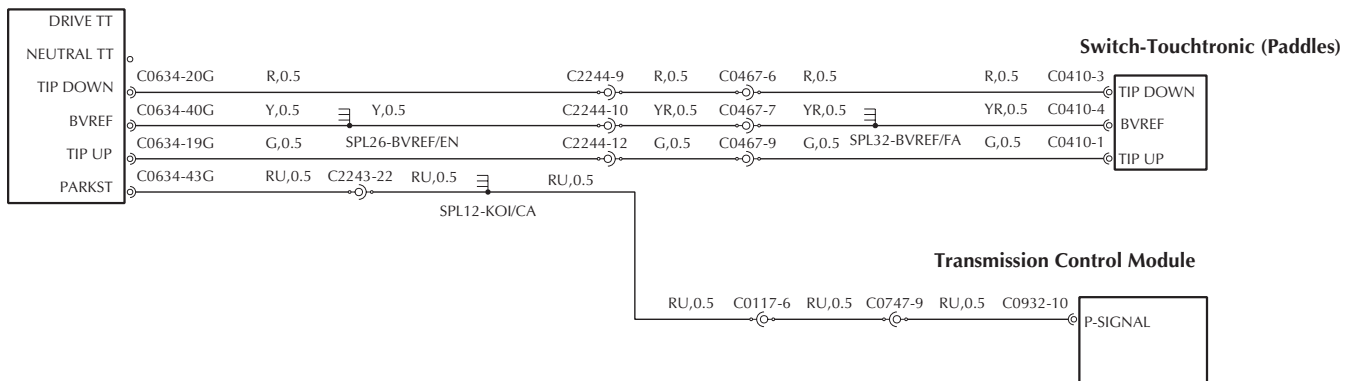
Figure 1. Up / Down Circuit

P0815, P0816 - Paddle Circuit Fault

Primary PCM

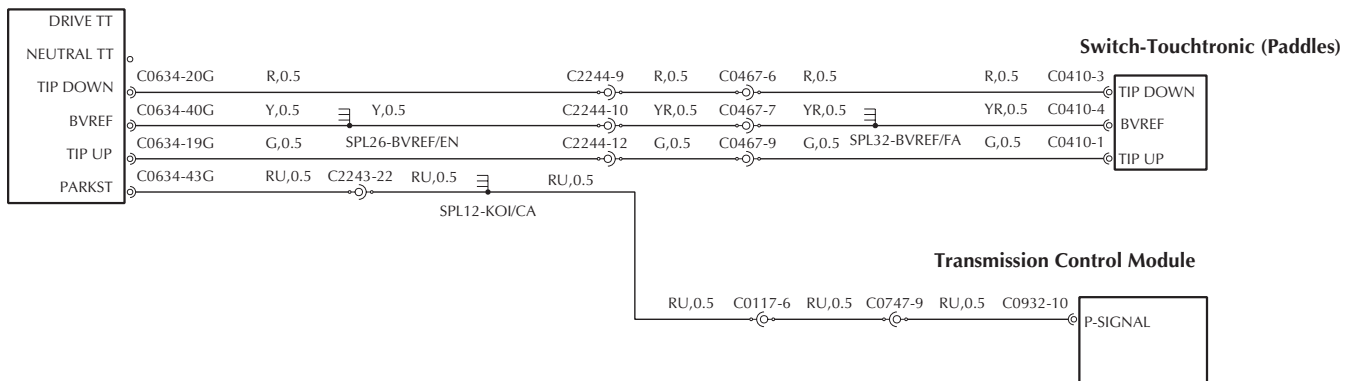
Figure 1. Up / Down Circuit

P0826 - Up and Down Switch Input Circuit

Primary PCM

If either signal does not respond, troubleshoot the paddle switch to PCM circuit and service as necessary. On completion of the servicing, repeat the signal check to ensure that the problem is resolved.

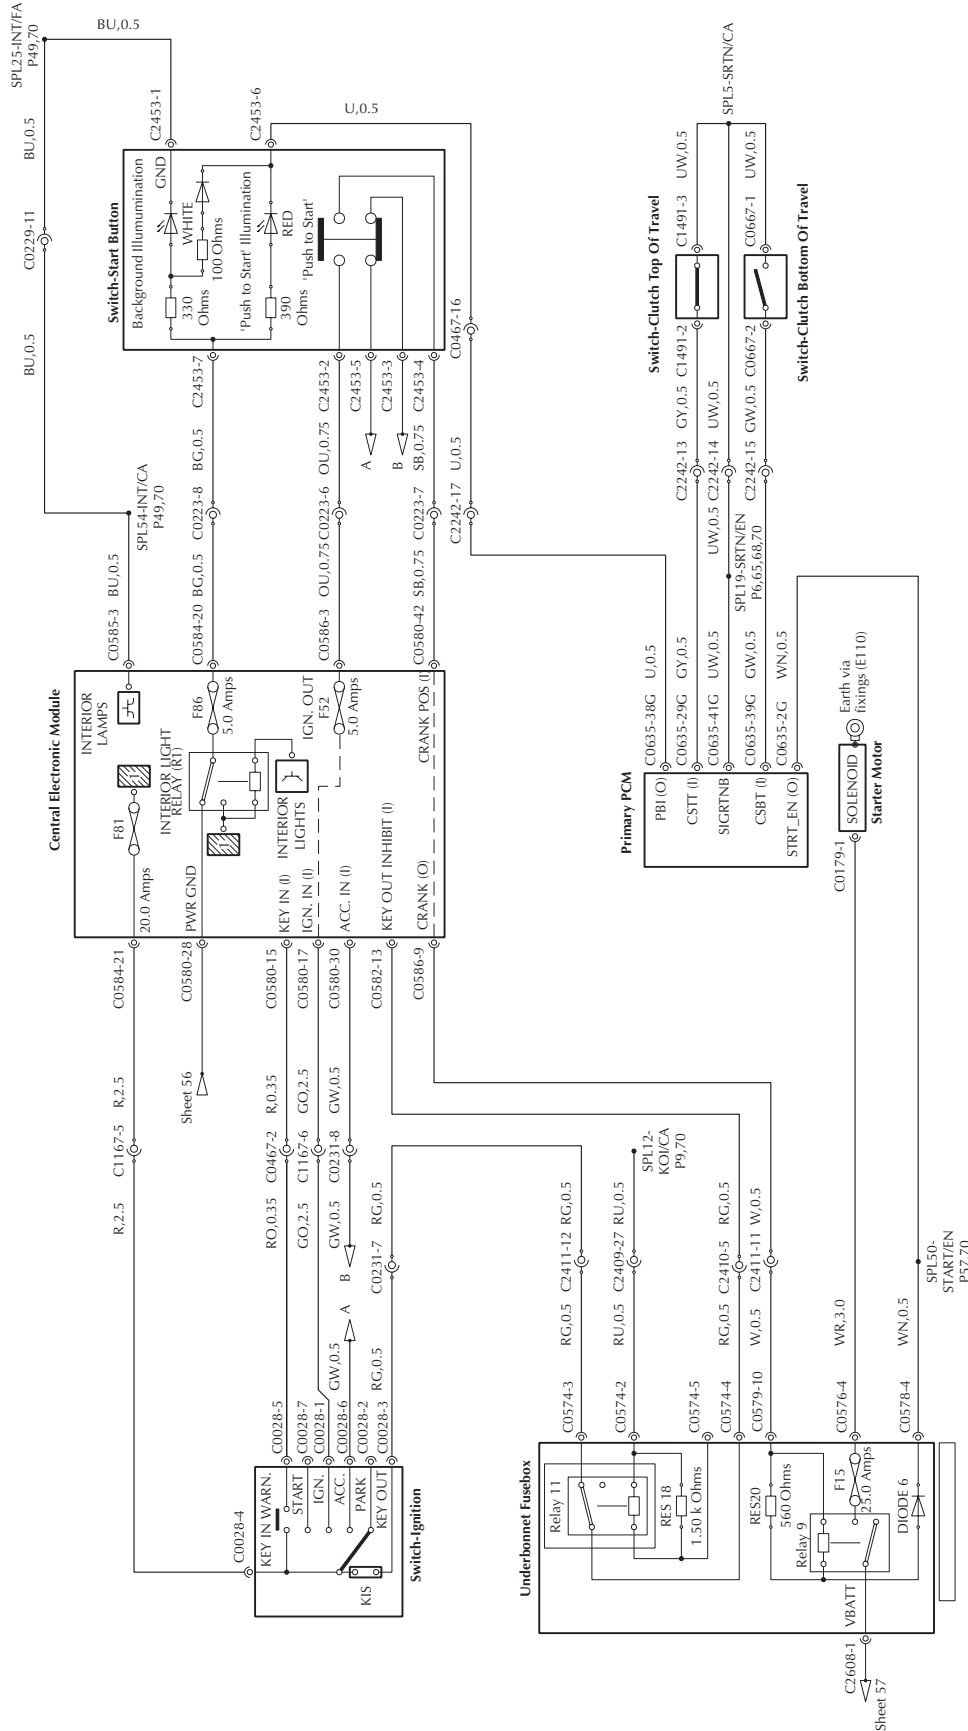
Figure 1. Start Enable Circuit (Manual Transmission)

P0830, P0833 - Clutch Switch Malfunction

If the engine starts without pressing the clutch, check for other relevant fault codes and analyse the problem to ensure that underbonnet relay 9 is only energised with the ignition on, the clutch pressed and the start button pressed.

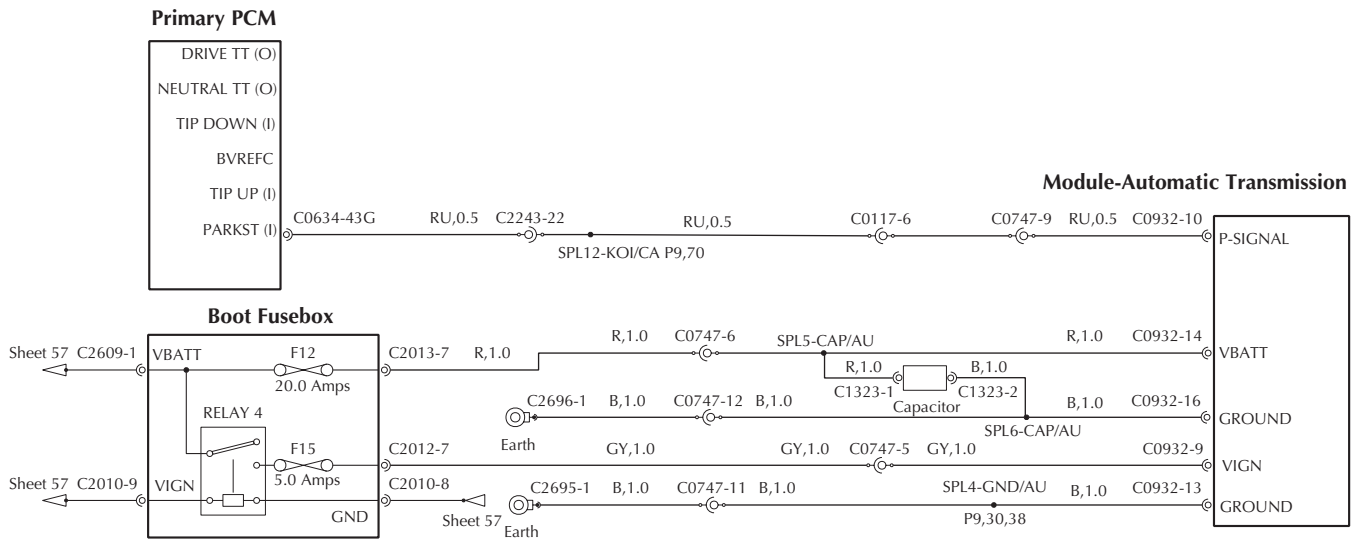
Figure 1. Parklock Status Circuit

P0850 - Parklock Sensor Fault

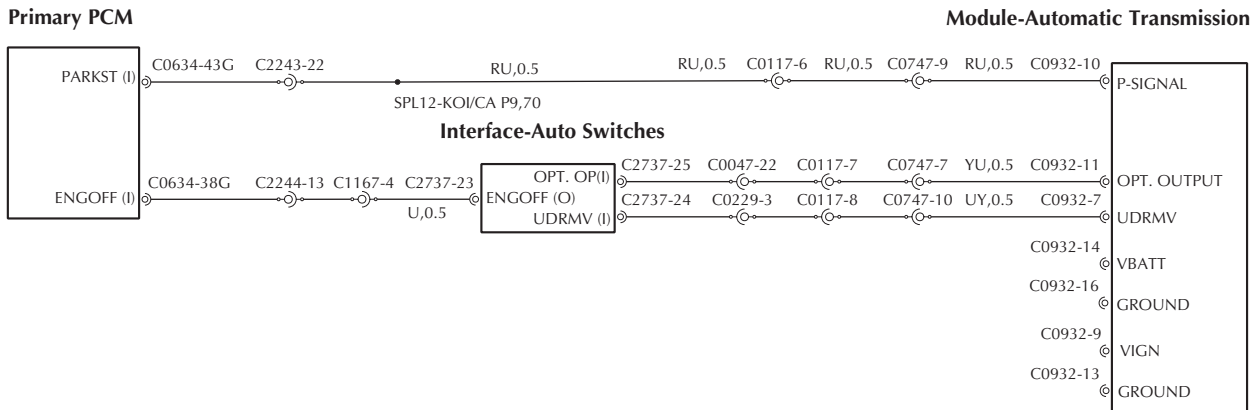
Figure 1. Heartbeat Signal Circuit

P0860, P0861, P0862 - Transmission Module to PCM Heartbeat Signal Fault

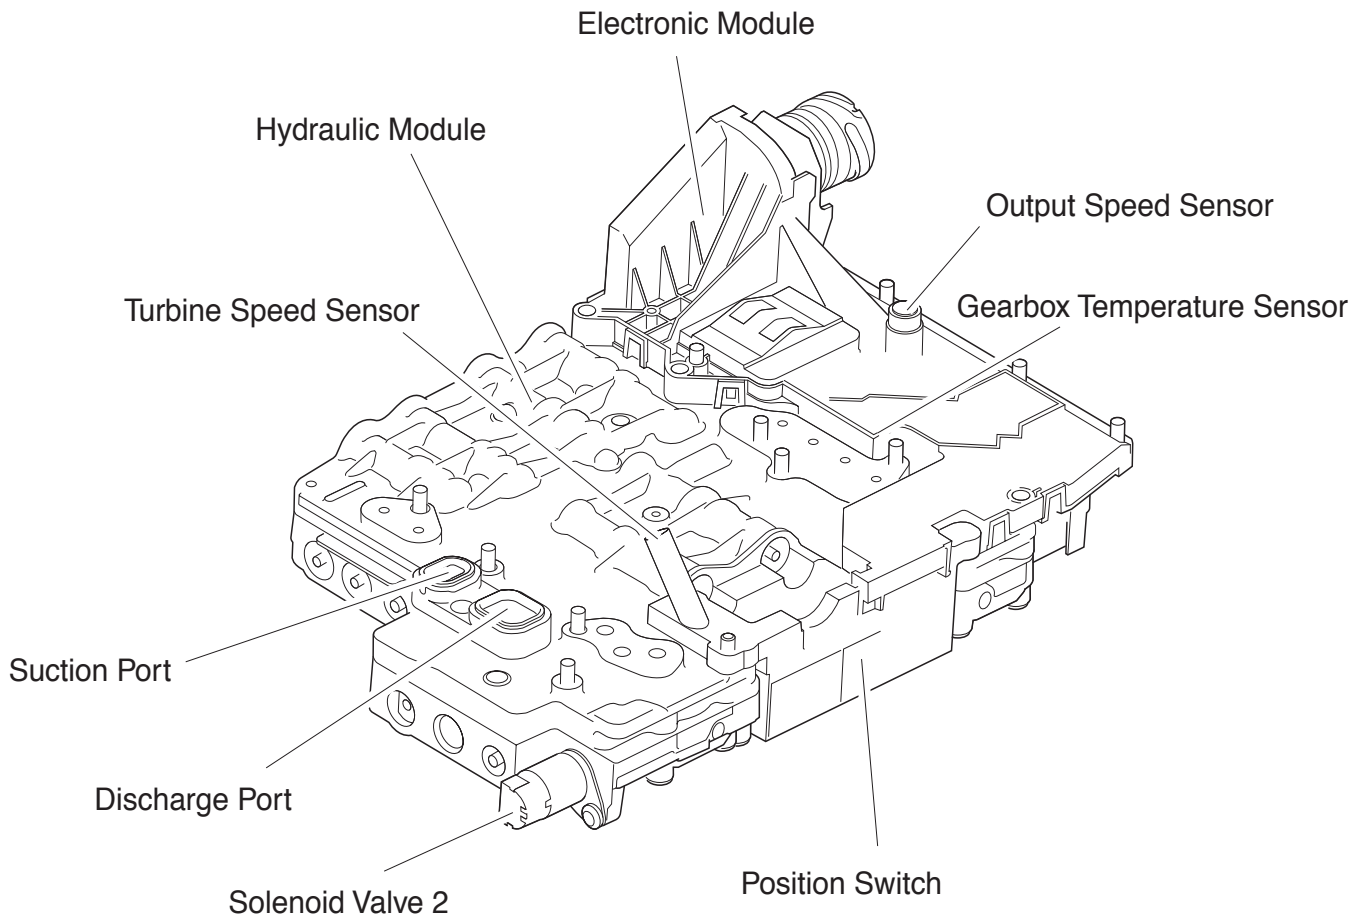
Figure 1. Mechatronic Unit

P0961, P0972, P0975, P0978, P0981, P2762 - Transmission Pressure Regulator Fault

1. Connect the WDS and confirm that one of the above codes is logged.
2. Clear the logged DTCs.
3. Run a short road test and then check the logged DTCs again.
4. If any of the above DTCs are logged again, replace the mechatronic unit. and run a brief road test to ensure that the problem is resolved.

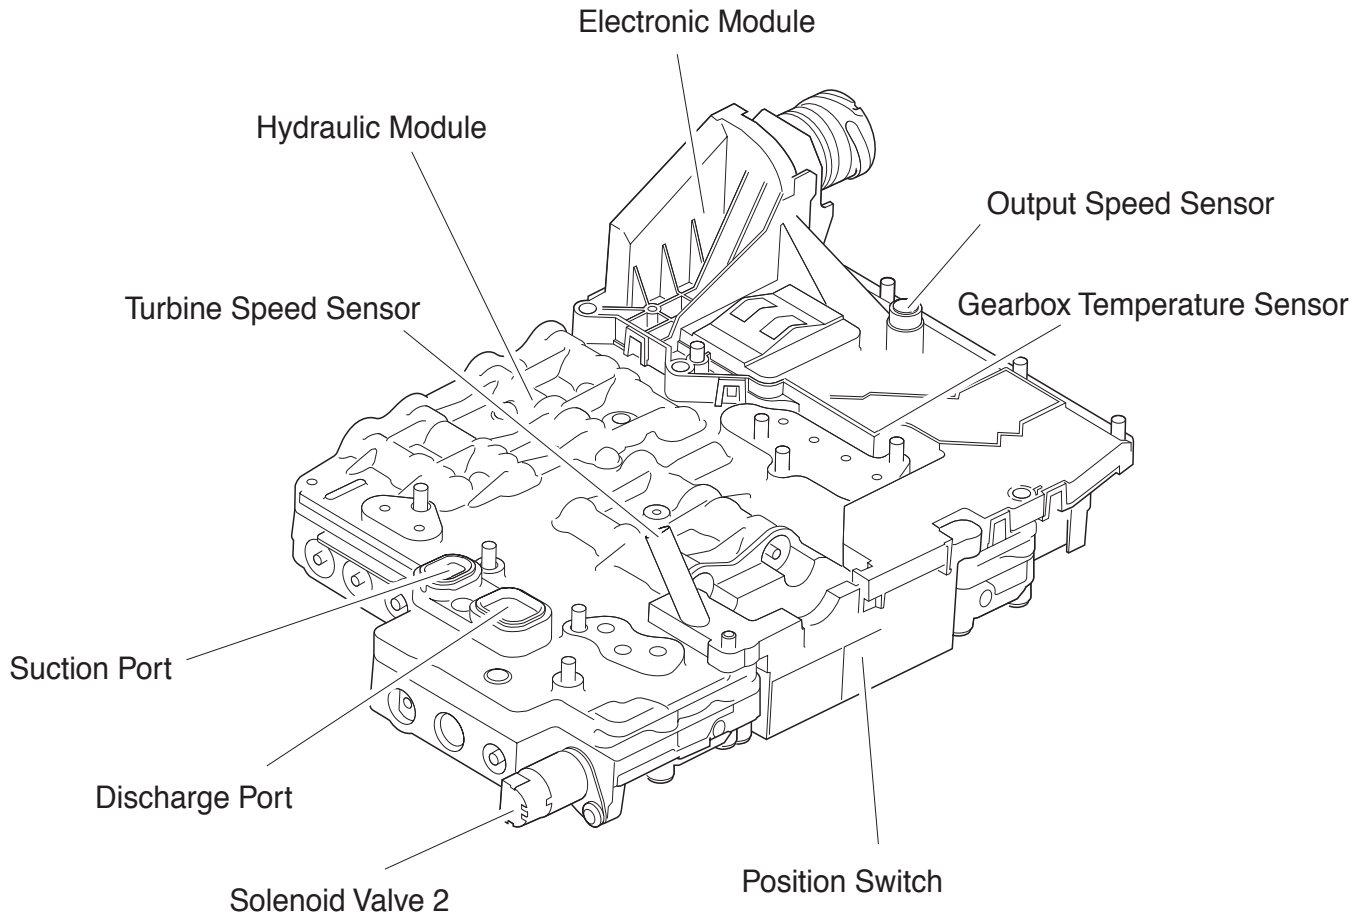
Figure 1. Transmission Pressure Regulators

P0963, P0974, P0977, P0980, P0983, P2763 - Transmission Pressure Regulator Fault

1. Connect the WDS and confirm that one of the above codes is logged.
2. Clear the logged DTCs.
3. Run a short road test and then check the logged DTCs again.
4. If any of the above DTCs are logged again, replace the mechatronic unit. and run a brief road test to ensure that the problem is resolved.

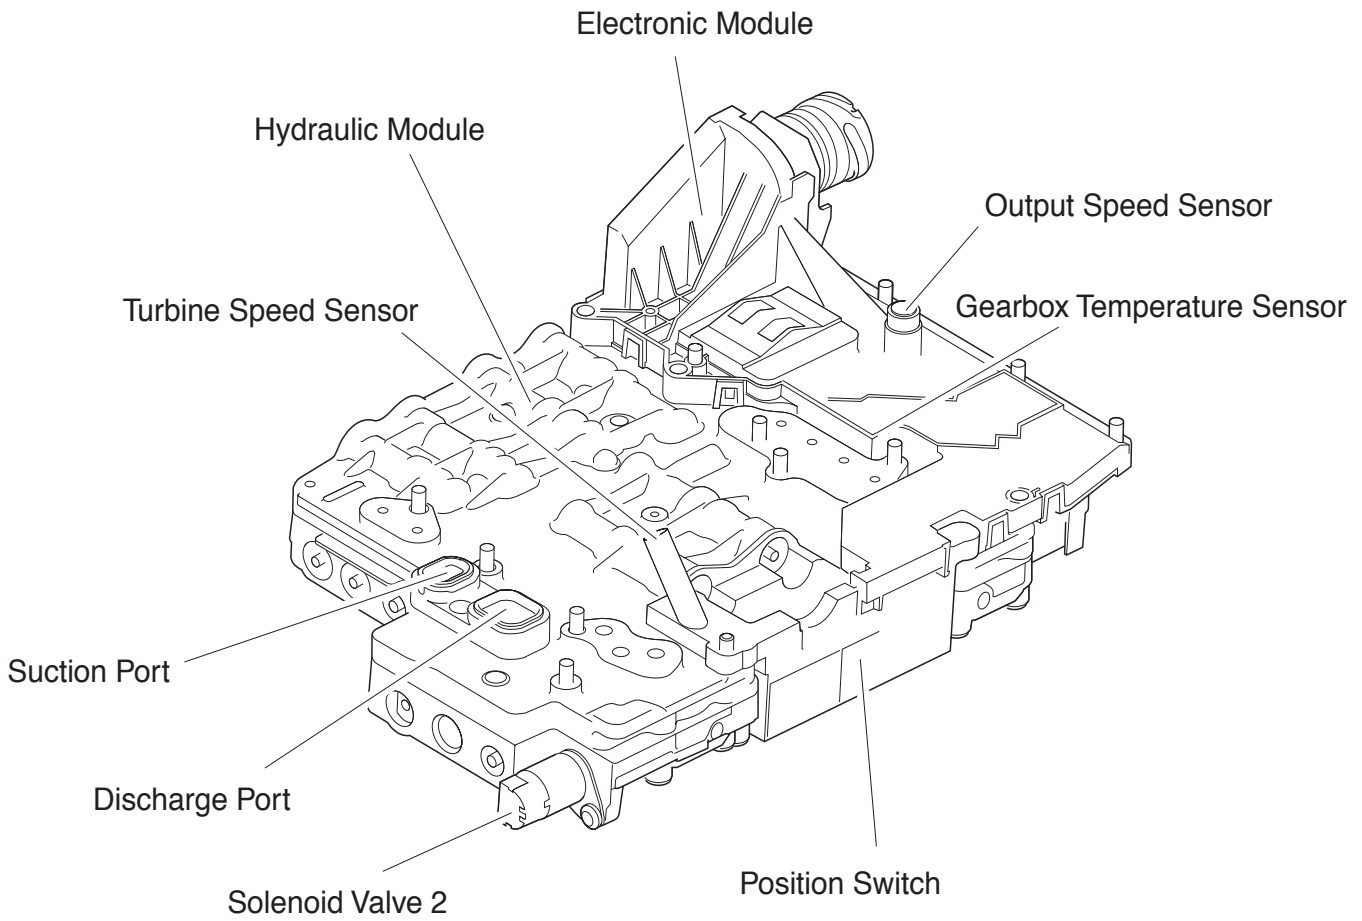
Figure 1. Mechatronic Unit

P0985, P0998. - Transmission Solenoid Fault

4. Check the condition of the transmission connector socket pin C0932-14.

If the socket is serviceable, the cause of the shift solenoid problem lies in the mechatronic unit.

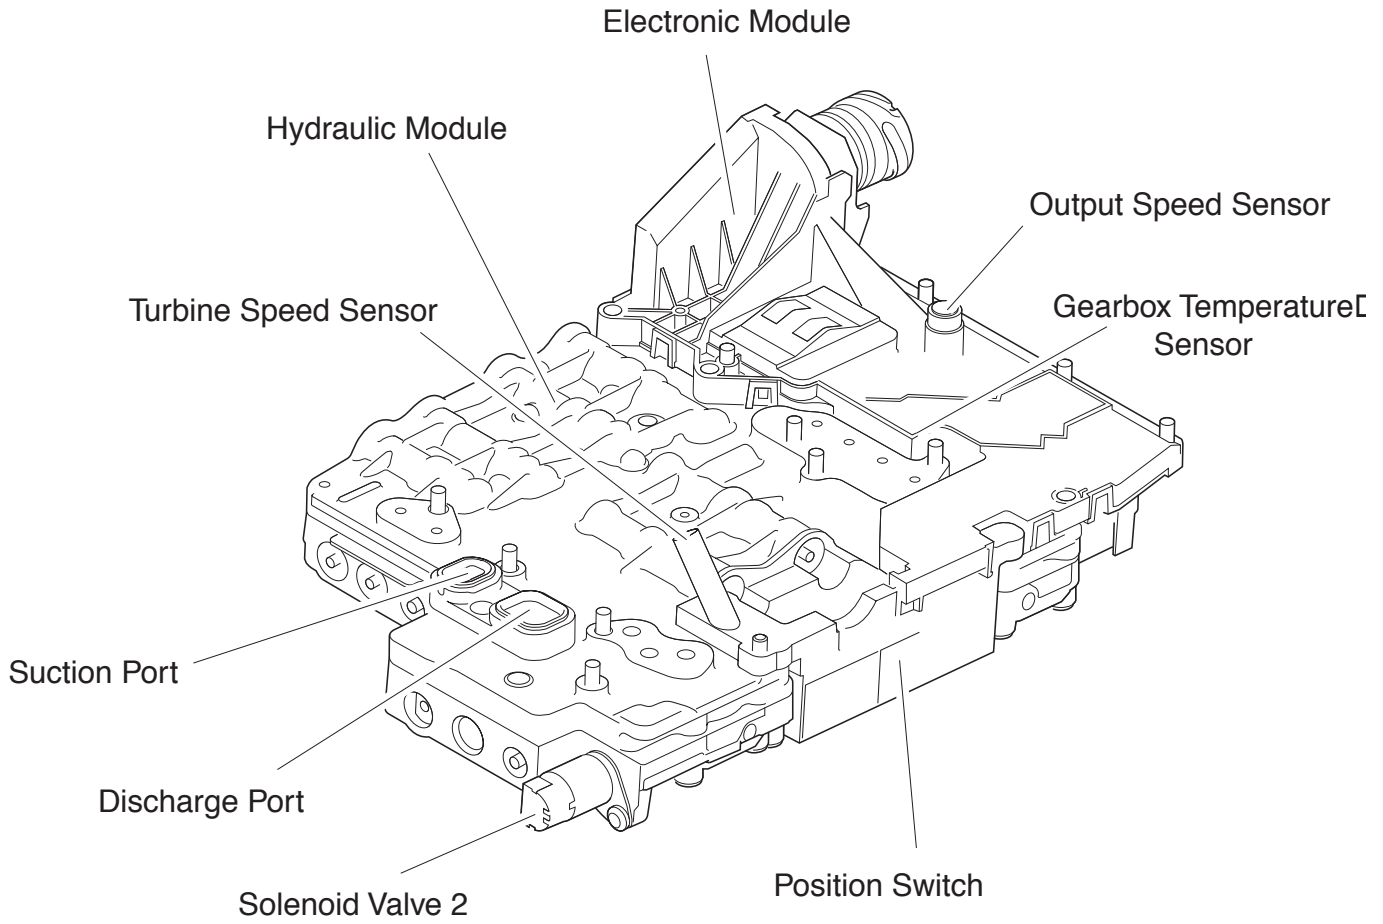
Figure 1. Transmission Pressure Regulators

P0986, P0999 - Transmission Solenoid Fault

1. Connect the WDS and confirm that one of the above codes is logged.
2. Clear the logged DTCs.
3. Run a short road test and then check the logged DTCs again.
4. If any of the above DTCs are logged again, replace the mechatronic unit, and run a brief road test to ensure that the problem is resolved.

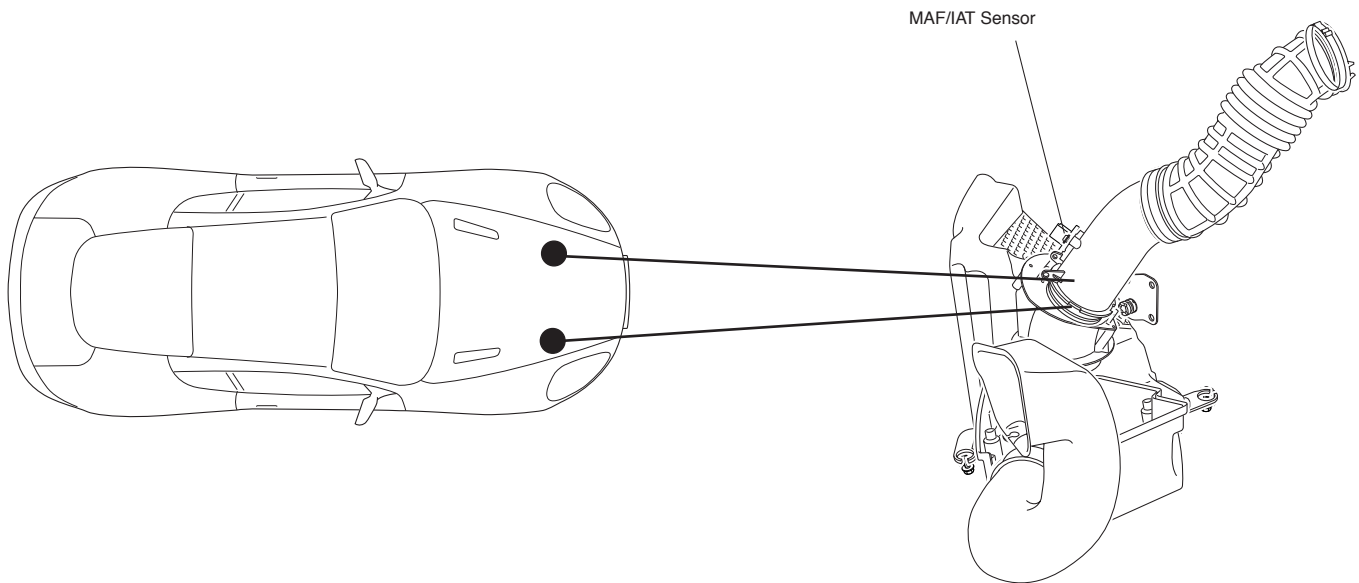
Figure 1. MAFS Location

P1101 - Mass Airflow Sensor

1. Connect the WDS or Scan Tool. Check that fault code P1101 is present
2. Check the air filter for correct fitting. Check all ducting for blockage or leaks (including the crankcase ventilation system). Service or repair as necessary.
3. Check the MAF sensor and PCM connectors for damaged pins, poor connection, etc.

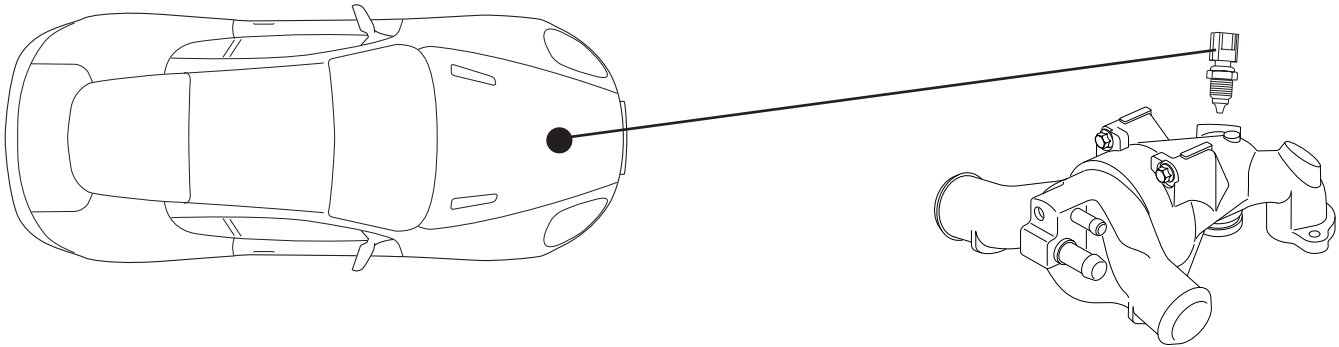
Figure 1. Engine Coolant Temperature Sensor Location

P1116 - Engine Coolant Temperature

If only P1116 is present, Check that the engine is fully warmed up (above 82°C). If below 82°C, warm up the engine and rerun the KOER test. If P1116 is not logged again, the fault was caused by low coolant temperature and is now cleared.

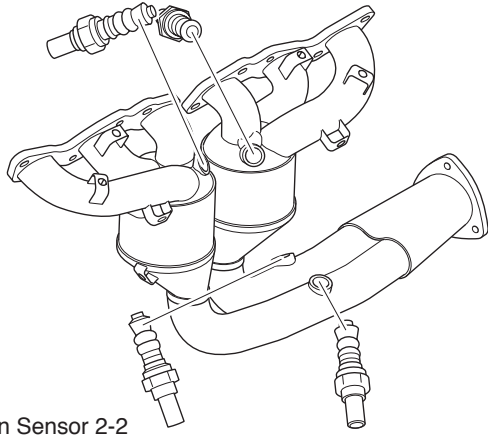
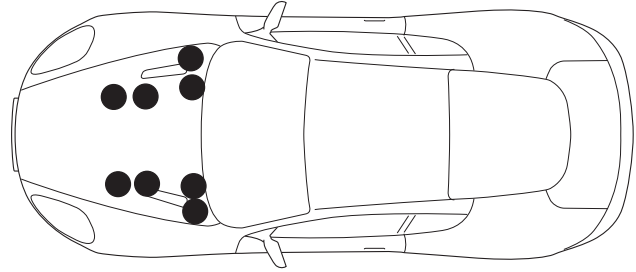
Heated Oxygen Sensor 1-1 Heated Oxygen Sensor 2-1

Figure 1. HO2S Location

If the HO2S heaters are commanded on and erroneous oxygen readings occur, analyse the problem using the P code procedure for the suspect sensor.

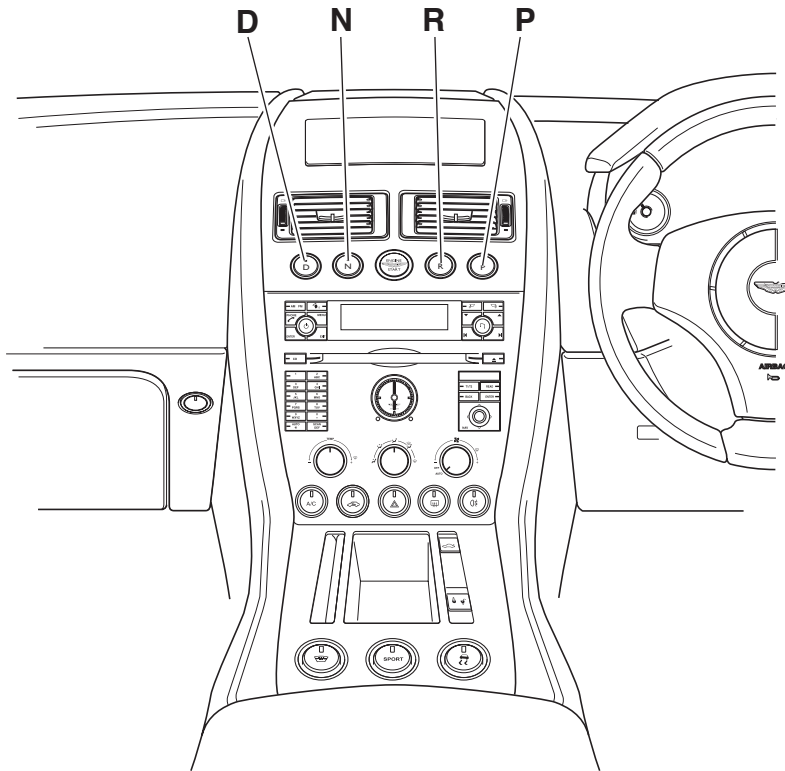
Figure 1. The Driver Interface

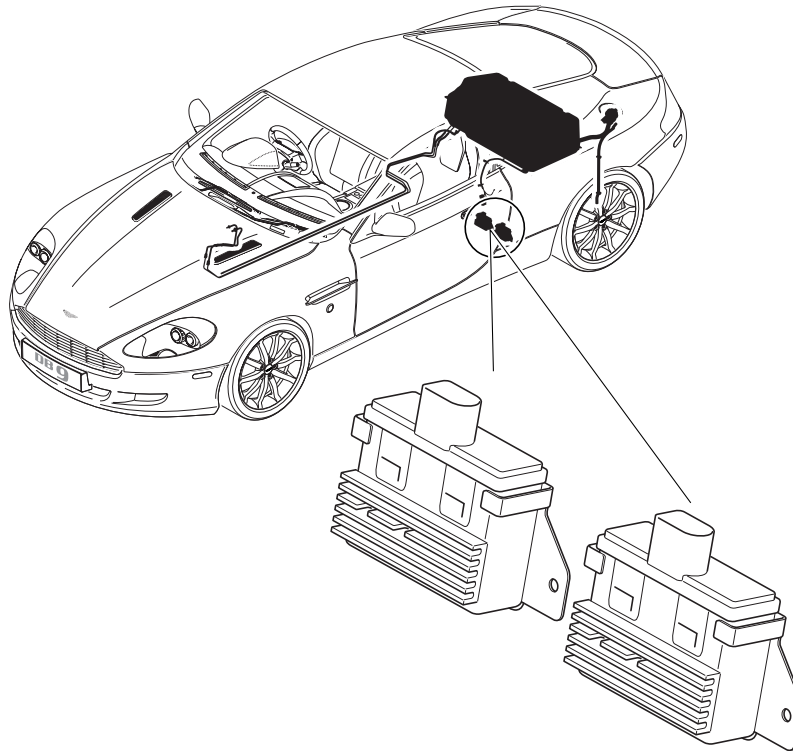
Figure 1. Fuel Pump Drive Module Location

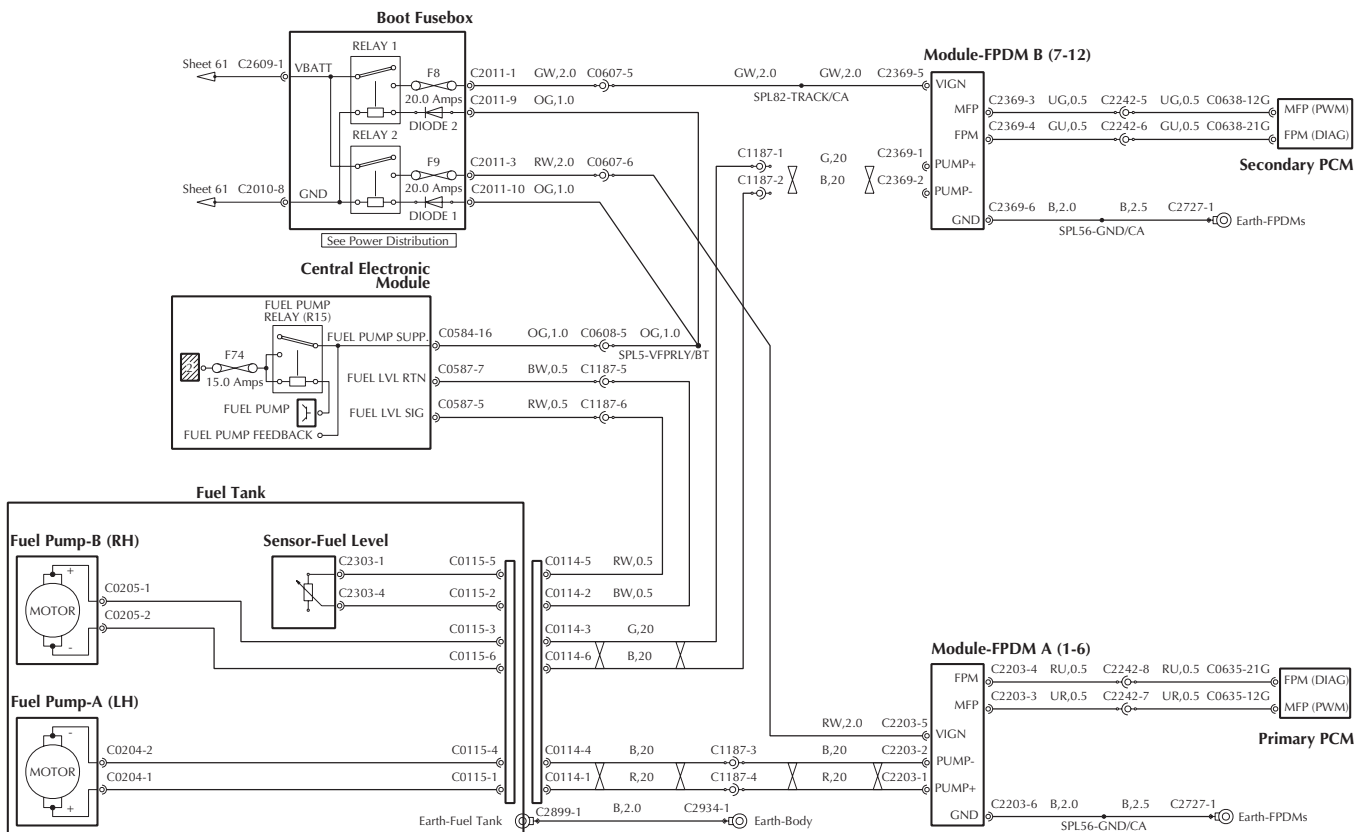
Figure 2. Fuel Pump Drive Module Circuit

2. Swap the FPDM connectors side to side. Run a KOER test. Check for DTC codes. If the P1233/35 or 1237 fault has swapped to the alternative PCM, replace the fuel pump drive module.

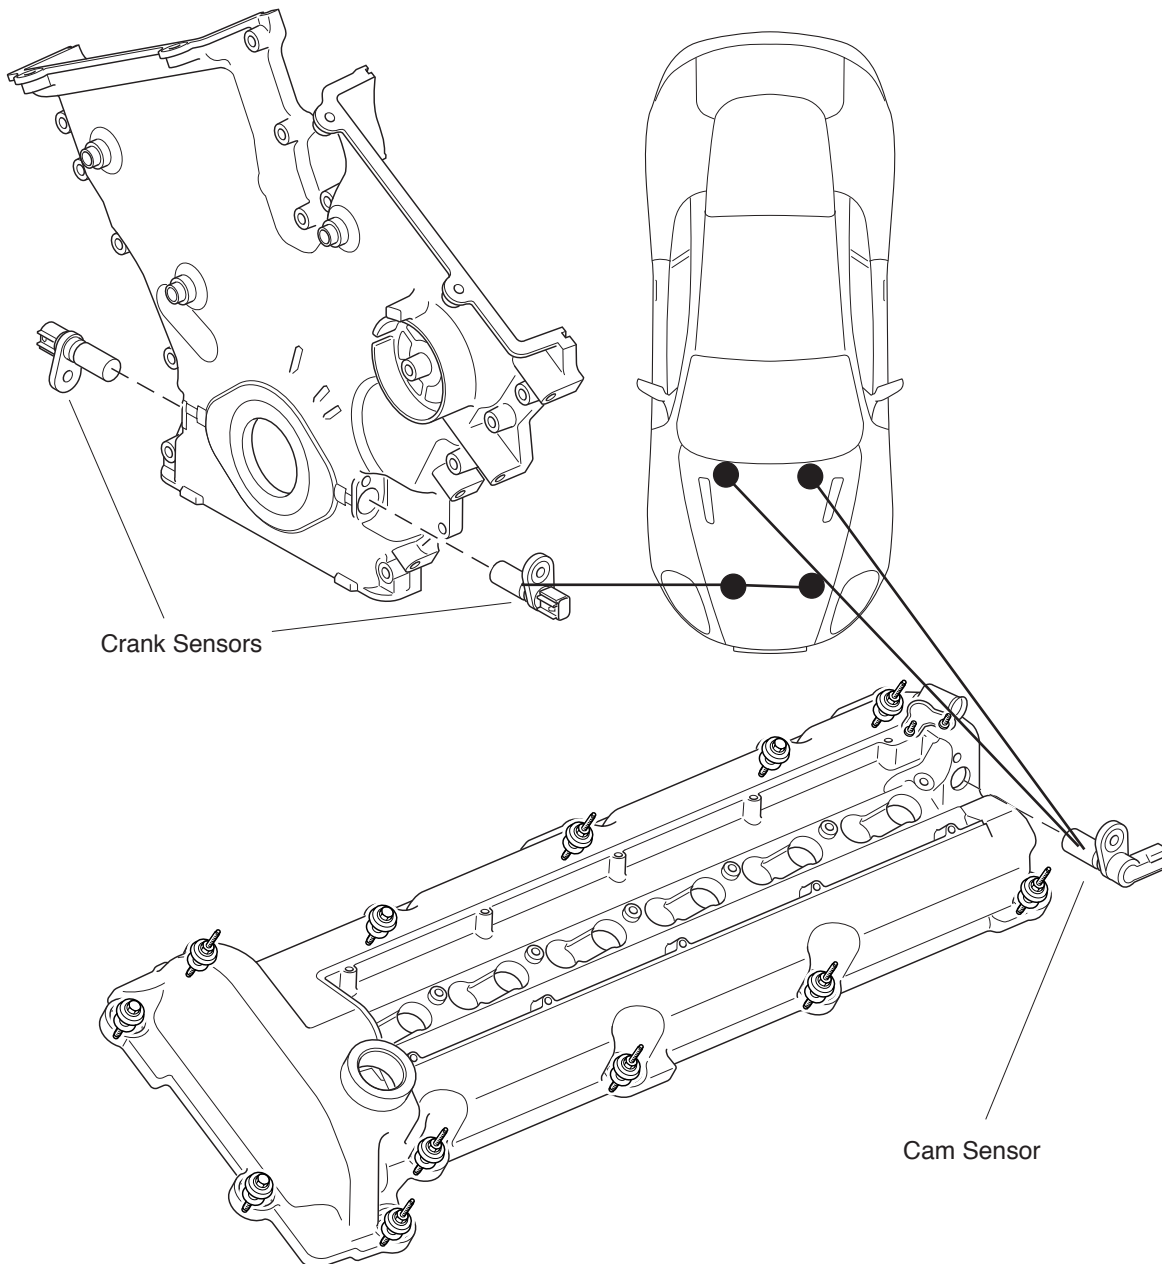
Figure 1. Crankshaft and Camshaft Sensor Locations

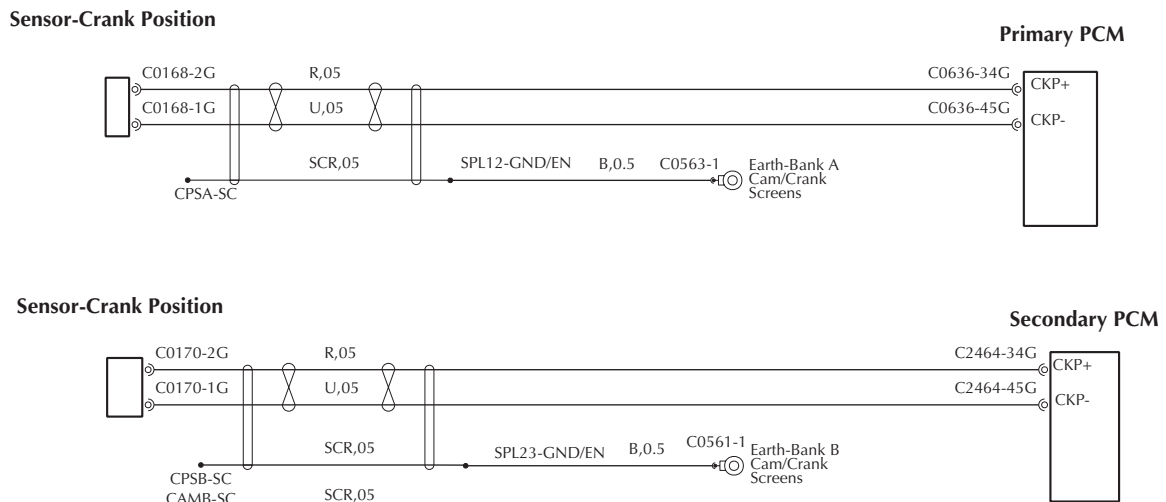
Figure 2. Crankshaft and Camshaft Sensor Circuits

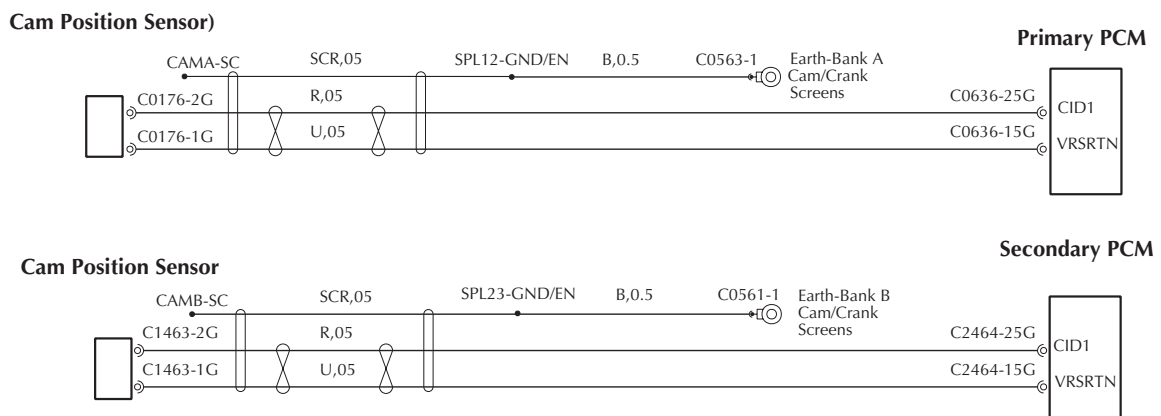
Figure 2. Camshaft Sensor (CID) Circuit

4. If any CID pulse is missing or malformed, swap the camshaft sensors bank to bank and repeat the datalogger check.

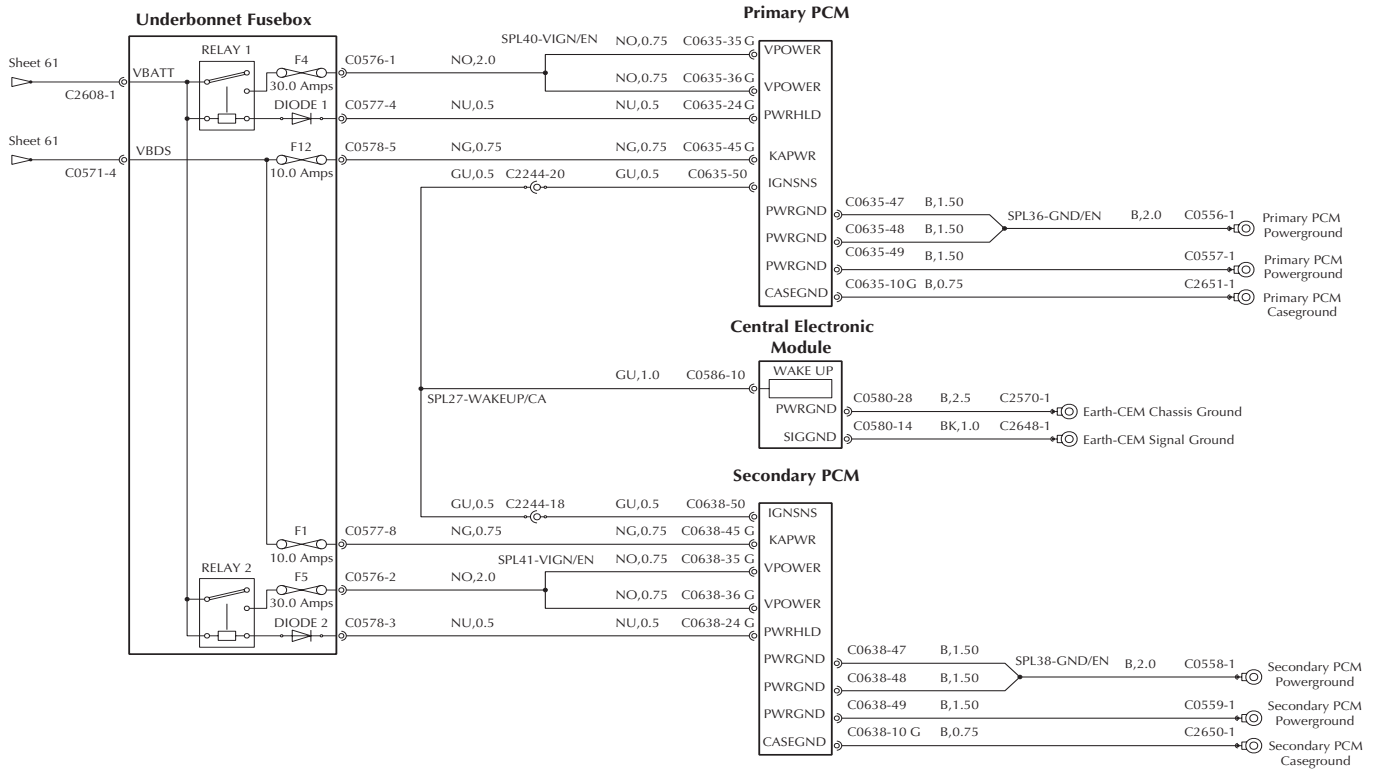
Figure 1. PCM System Power Circuits

If VPower is above 12.5 volts at both fuses, go to step 4
4. Check the VPower voltage at the battery whilst cranking the engine. If the voltage drops below 9.6 volts, the battery is defective, replace the battery.

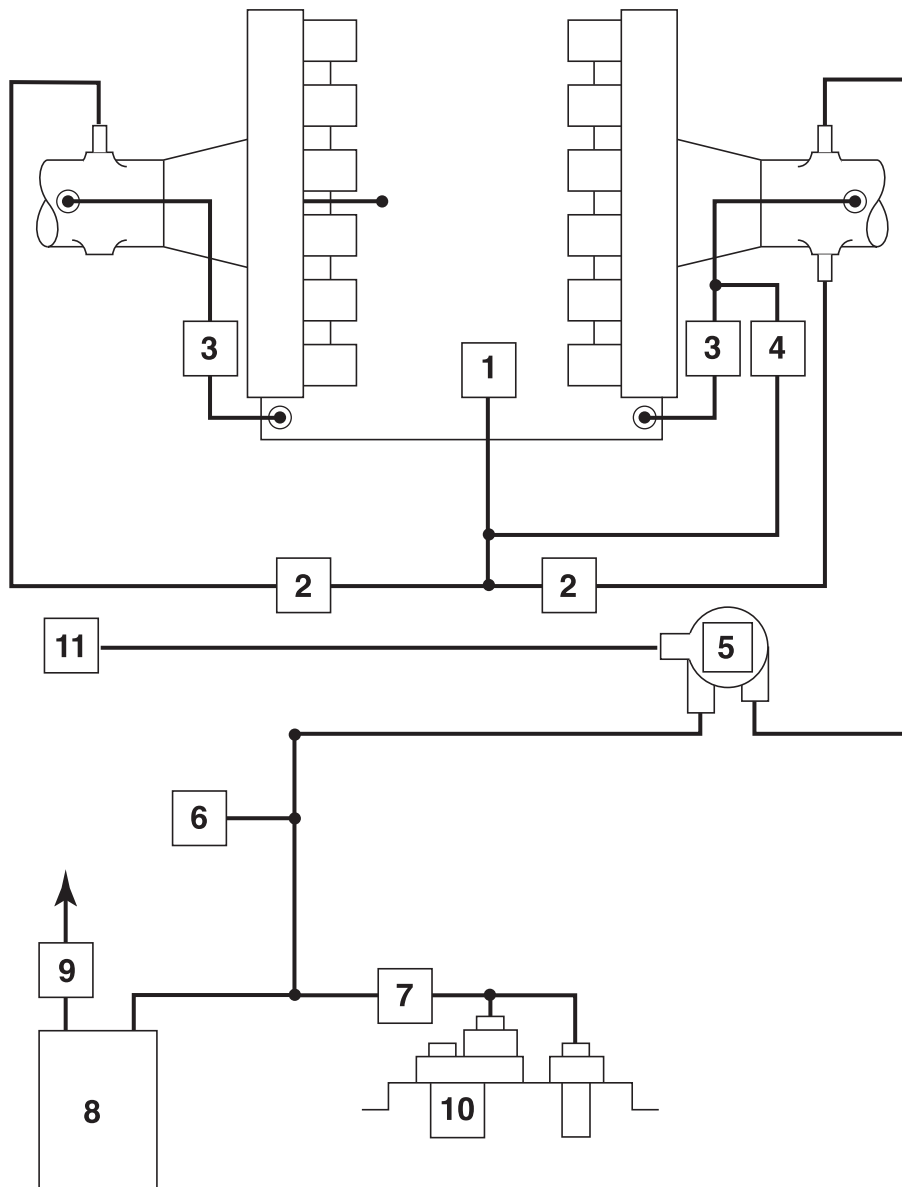
| 1. Oil Separator | 6. Service Port |
