DB9

OBD II Diagnostic Manual
Preliminary Issue

ASTON MARTIN LAGONDA LIMITED

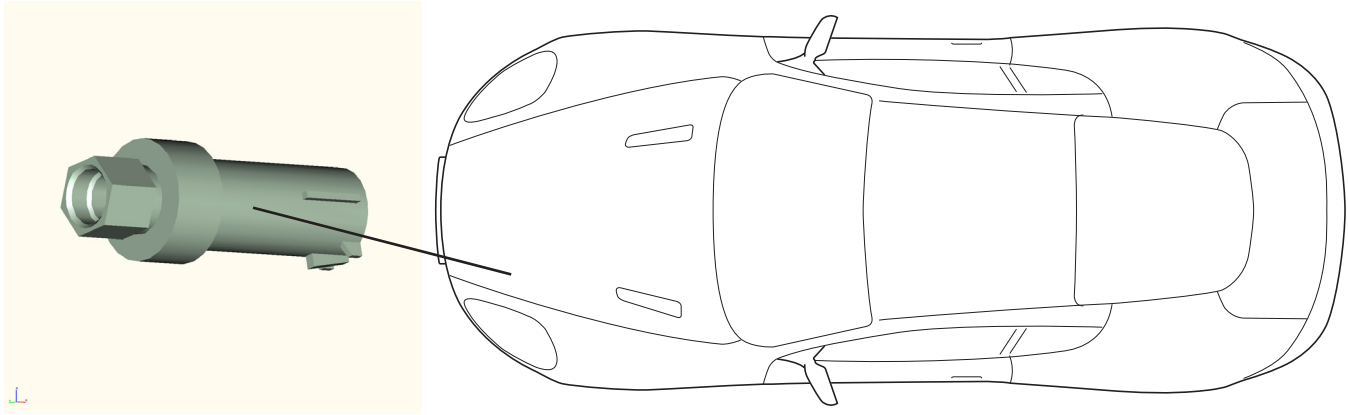
Figure 1. A/C Pressure Sensor Location

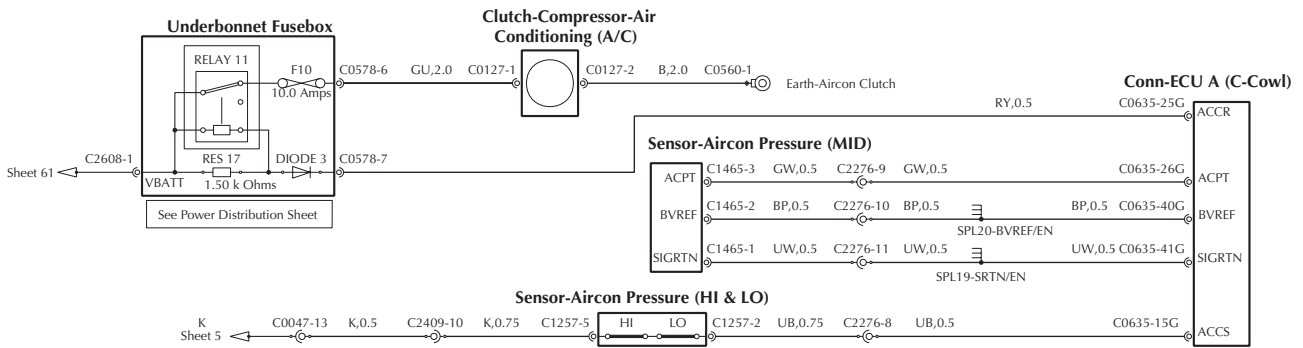
Figure 2. A/C Pressure Sensor Circuit

If less than +12 volts is measured, replace the A/C control module.

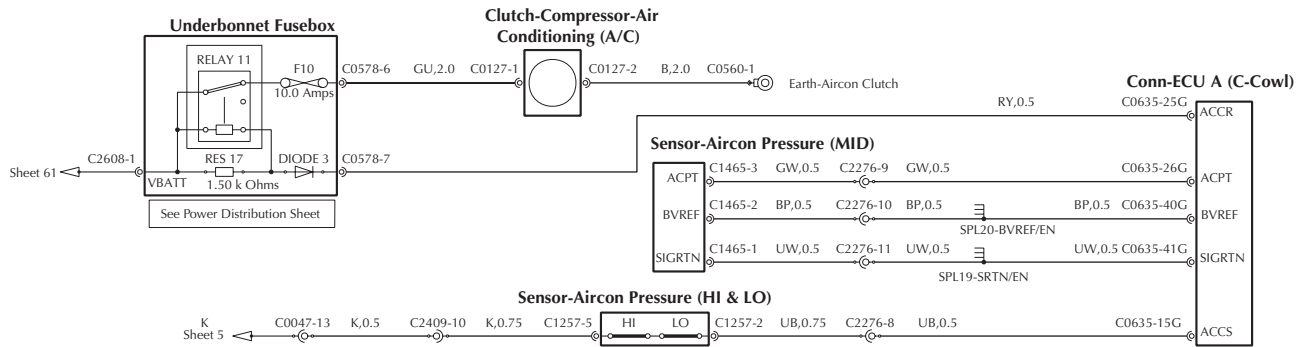
Figure 1. A/C Pressure Sensor Circuit

If no continuity fault is identified, replace the A/C pressure sensor. Clear the P1464 code and run a KOER / A/C on test to ensure that the problem is resolved.

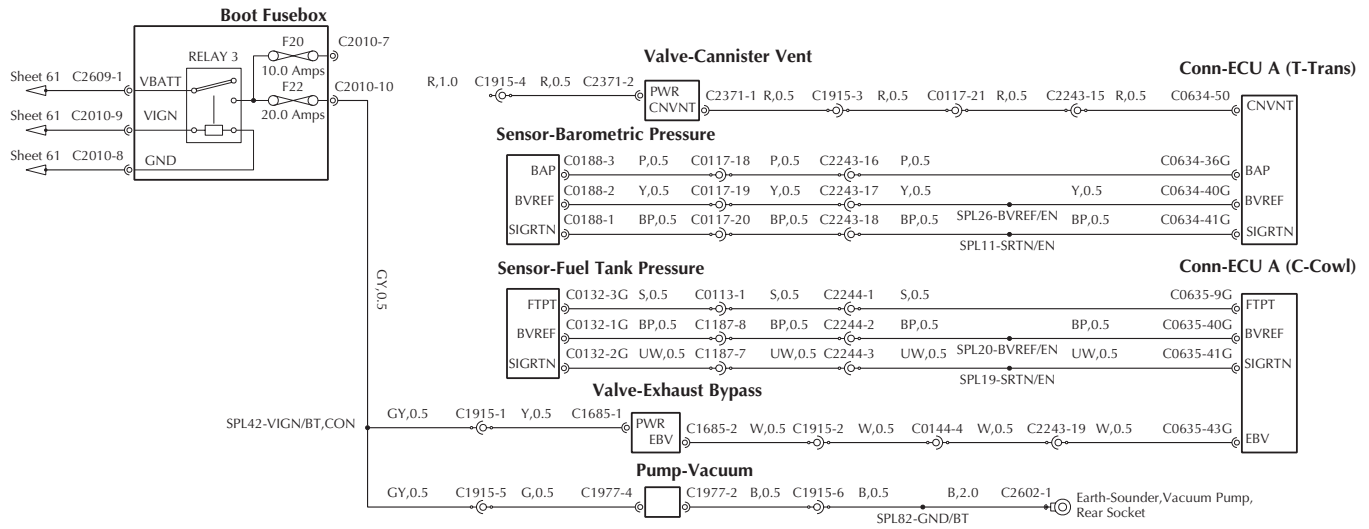
Figure 1. Bypass Control Circuit

If continuity is good, replace the bypass valve. Clear the P1488 code and run a KOER test to ensure that the problem is resolved.

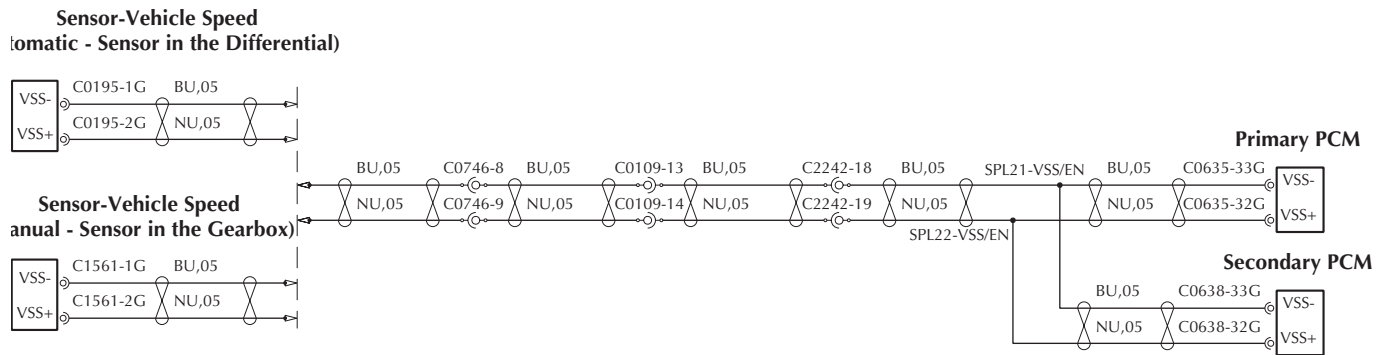
Figure 2. Vehicle Speed Sensor Circuit

Disconnect the VSS sensor and measure the sensor resistance from pin 1 to pin 2. The sensor resistance should be approximately 780Ω. If in range, continue with this procedure. If out of range, replace the sensor, clear all DTCs and run a road test to ensure that the problem is resolved.

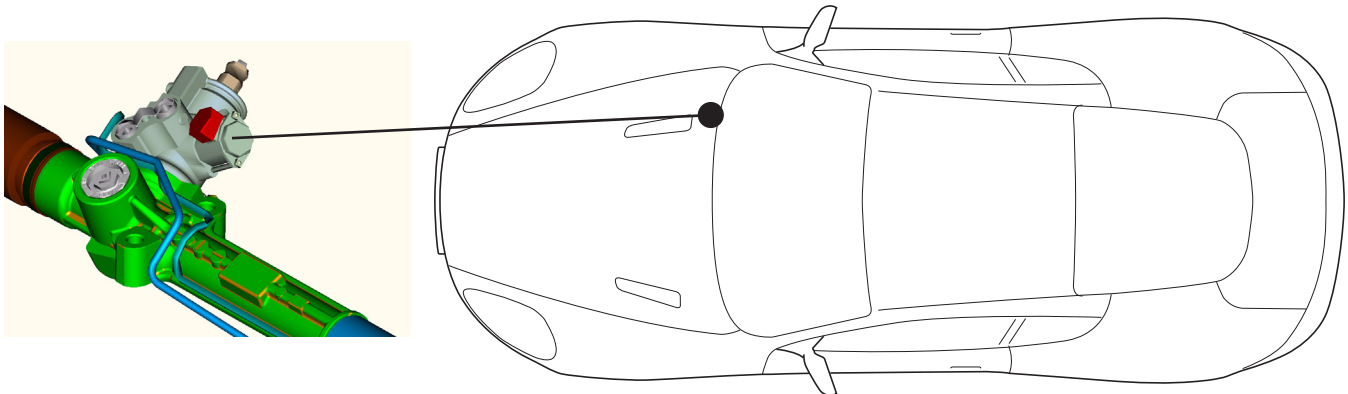
Figure 1. Power Steering Pressure Switch Location

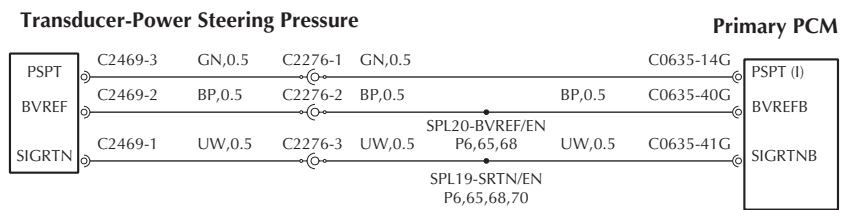
Figure 2. Power Steering Pressure Switch Circuit

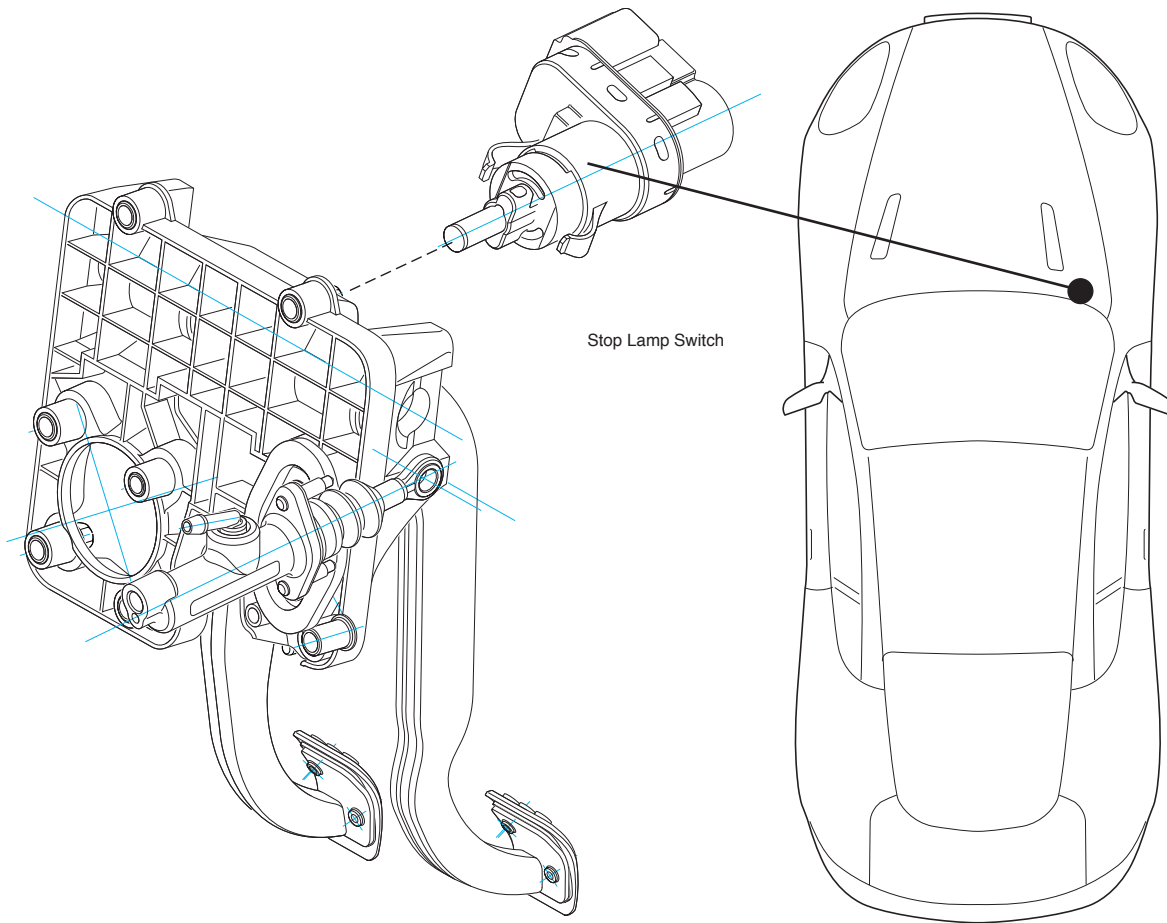
Figure 1. Brake Pedal Switch Circuit

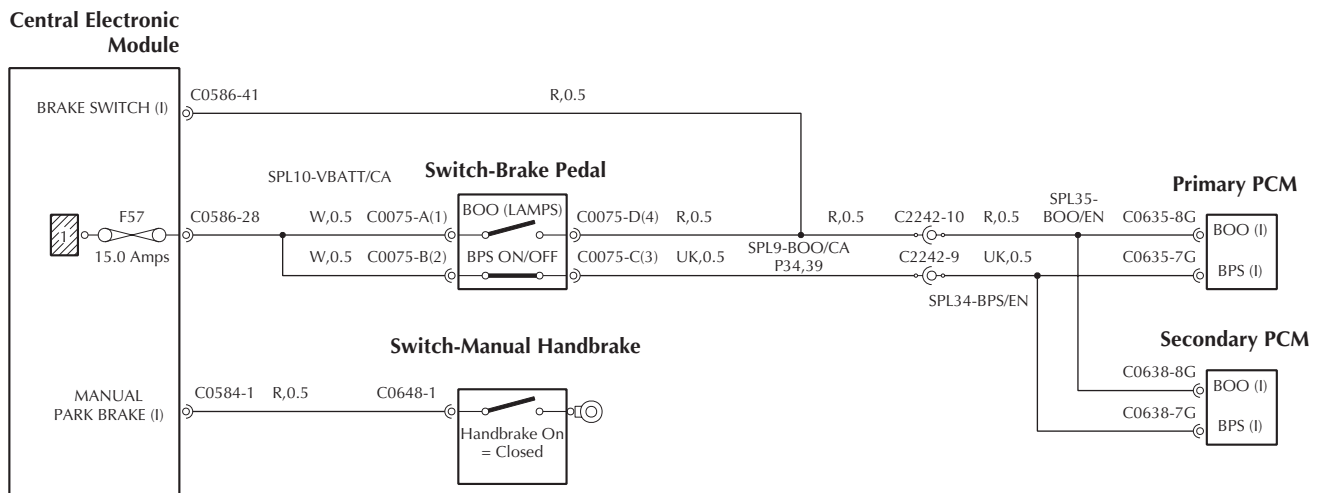
Figure 2. Brake Switch Circuit

4. Ignition off. Complete a continuity check from PCM pin C0635-7 (or C0638-7), through the brake switch to Central Electronic Module pin C0586-28. Press and release the brake pedal. Continuity should be broken when the brake pedal is pressed.

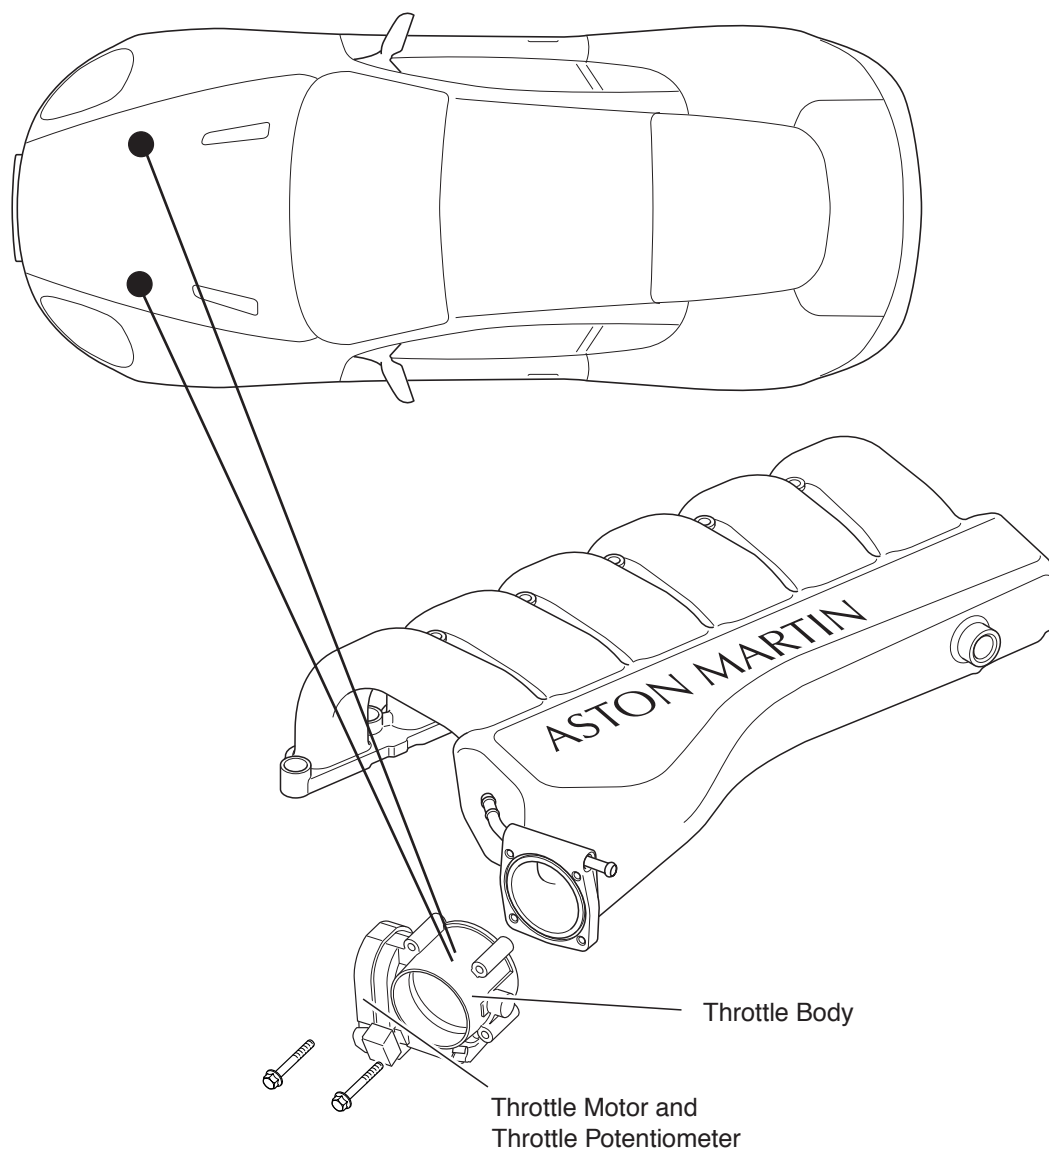
Figure 1. Throttle Potentiometer Location

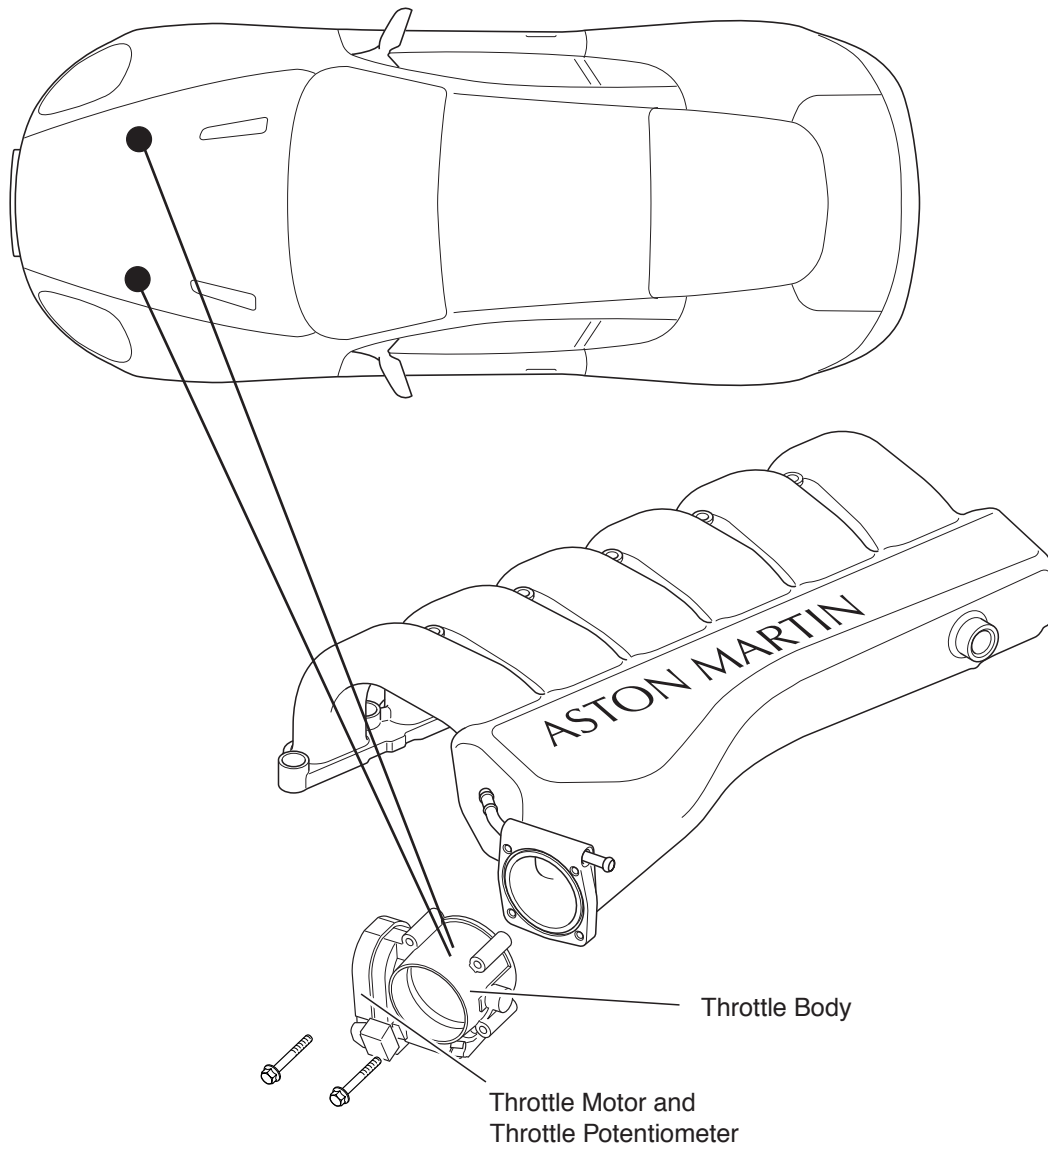
Figure 1. Throttle Potentiometer Location

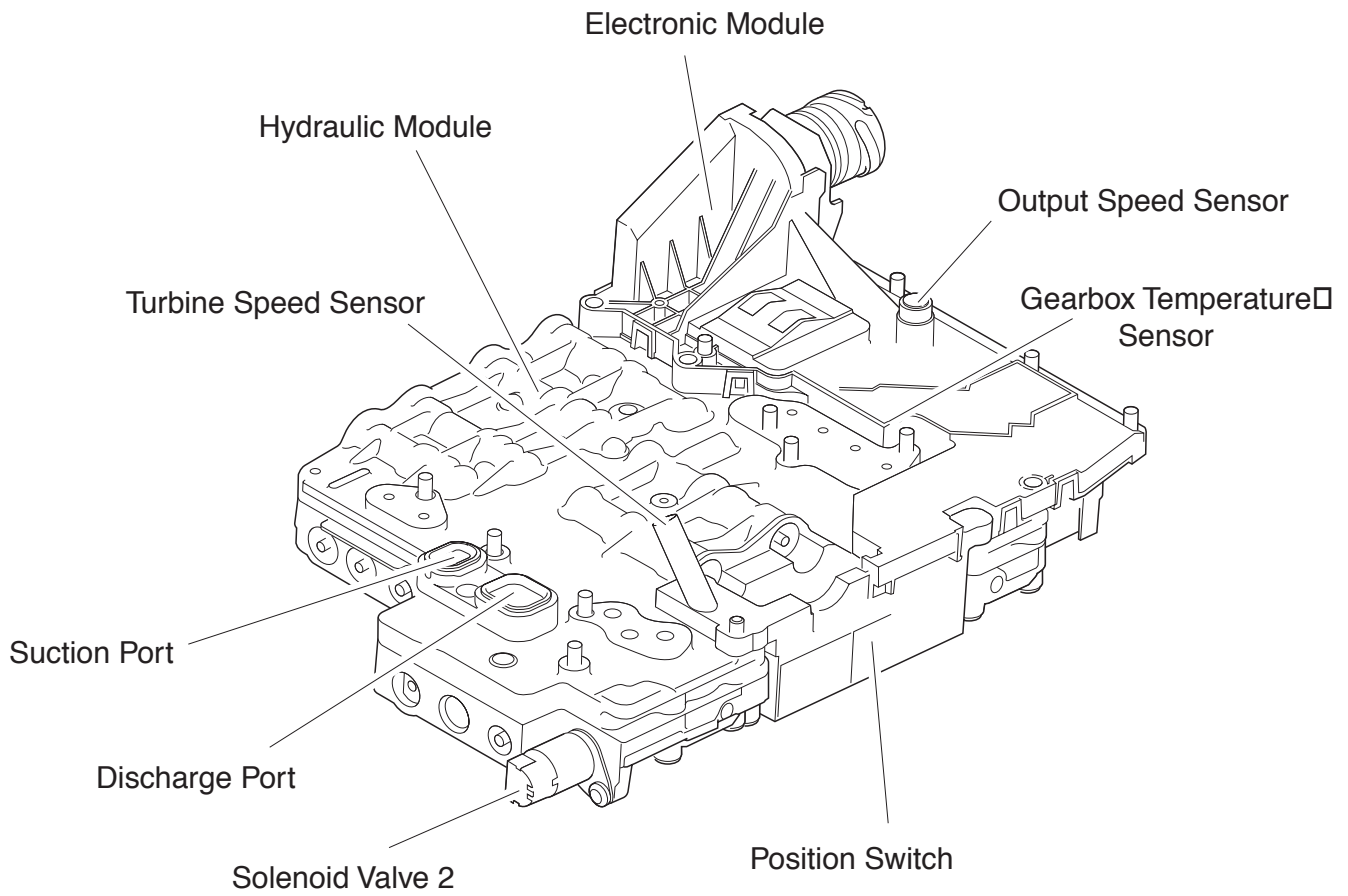
Figure 1. Mechatronic Unit

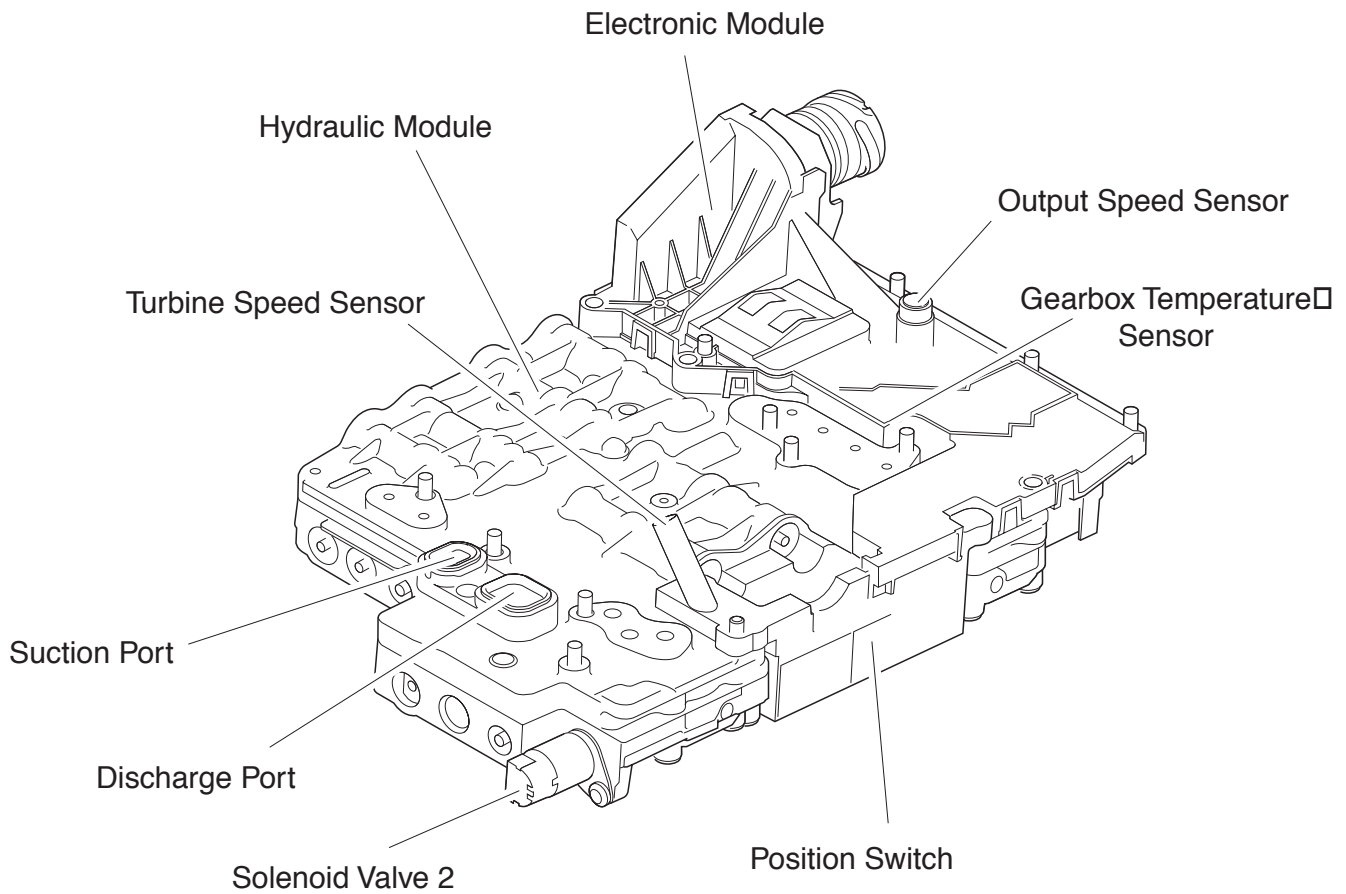
Figure 1. Mechatronic Unit

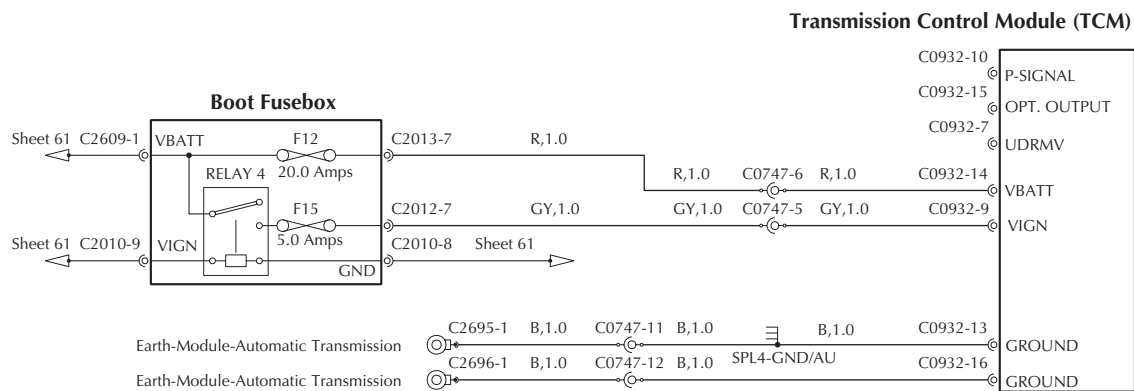
Figure 2. TCM Input Power Circuit.

If 12 volts is measured, check for a damaged pin on C0932 gearbox connector and service if necessary. If the pin is good, go to step 4.

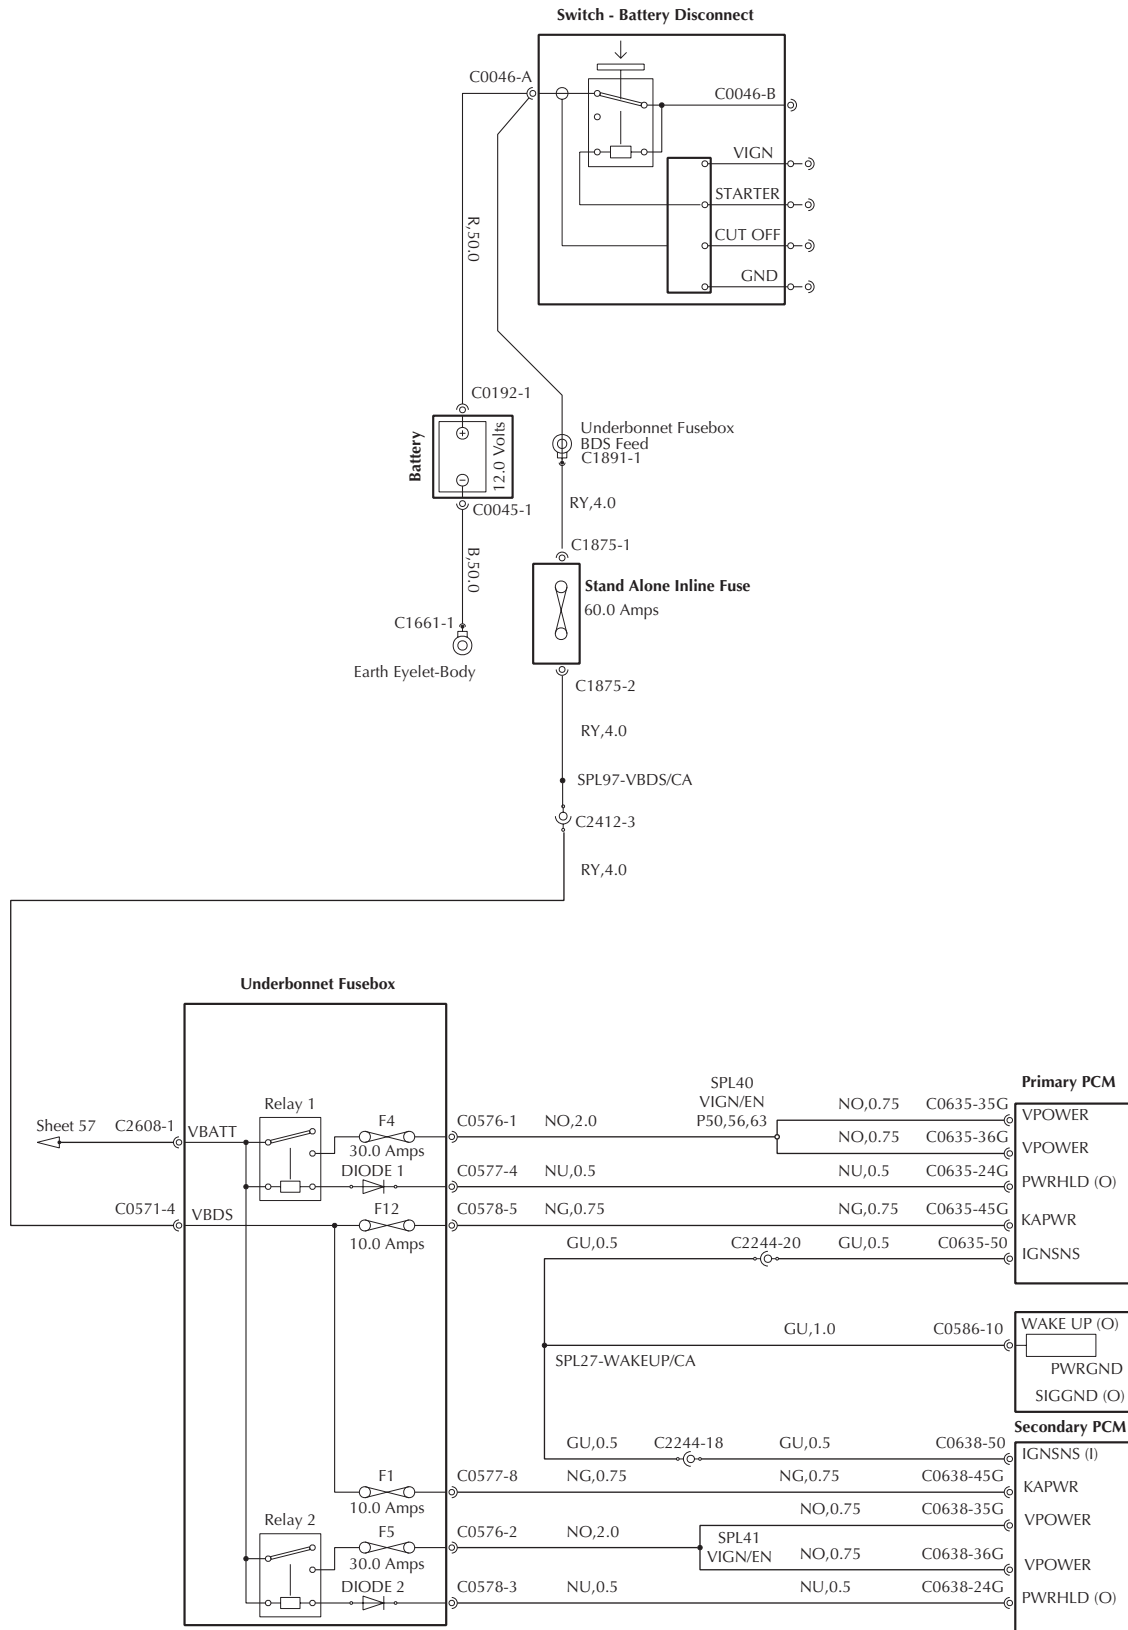
Figure 1. KAPWR Circuit

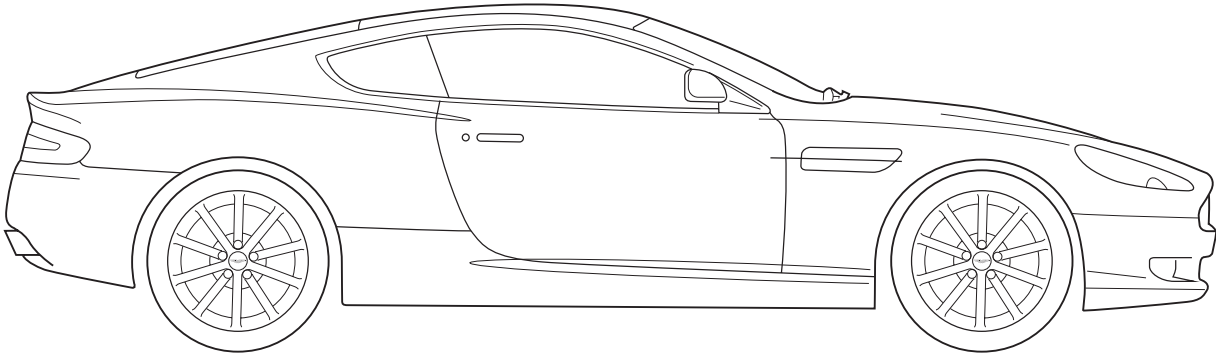
Figure 1. DB9 with correct wheels and tyres

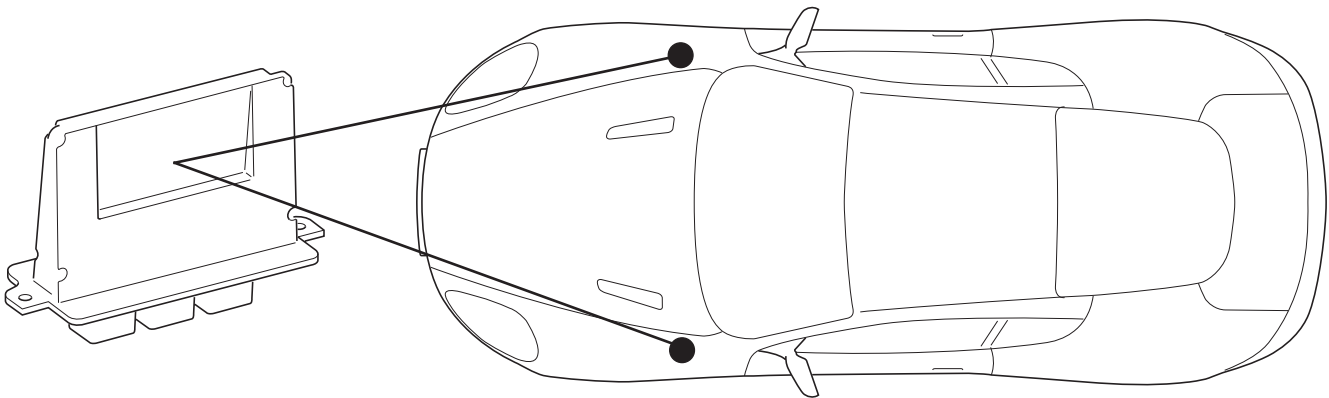
Figure 1. Powertrain Control Module (PCM) Location

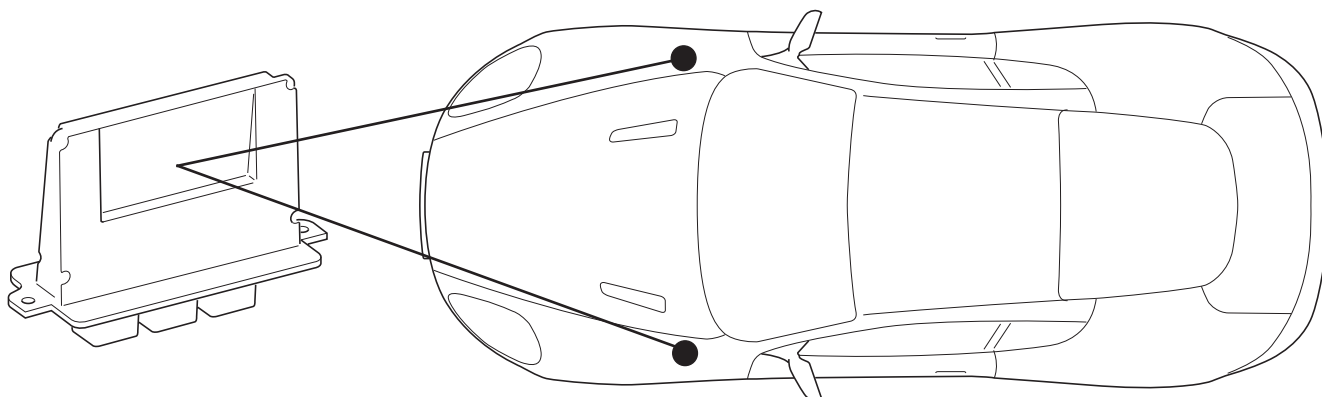
Figure 1. Powertrain Control Module (PCM) Location

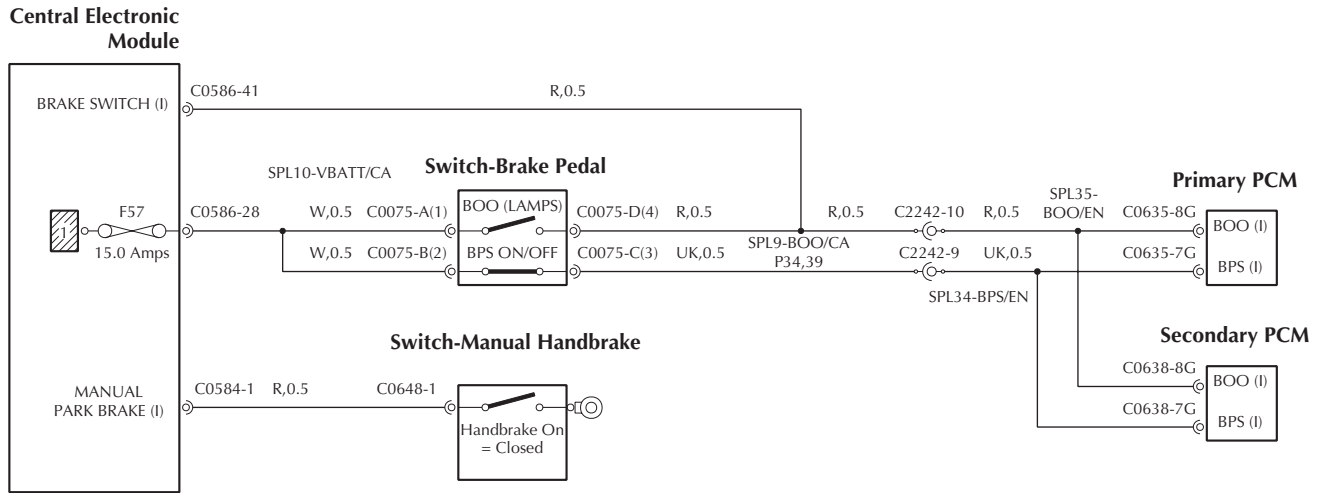
Figure 1. Brake Switch Circuit

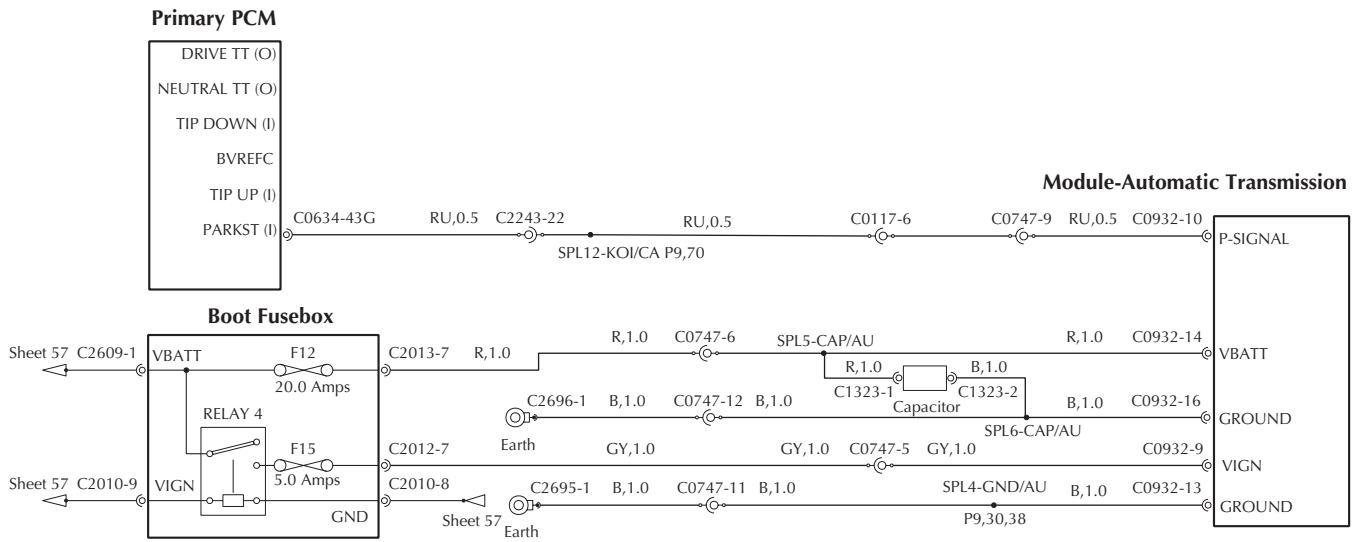
Figure 1. Park Status Circuit

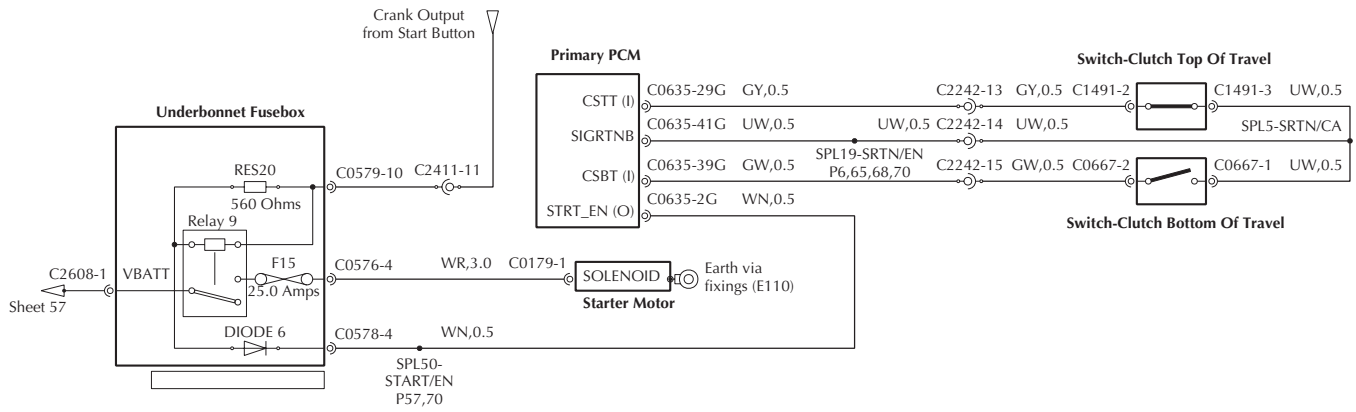
Figure 1. Clutch Switch Circuit

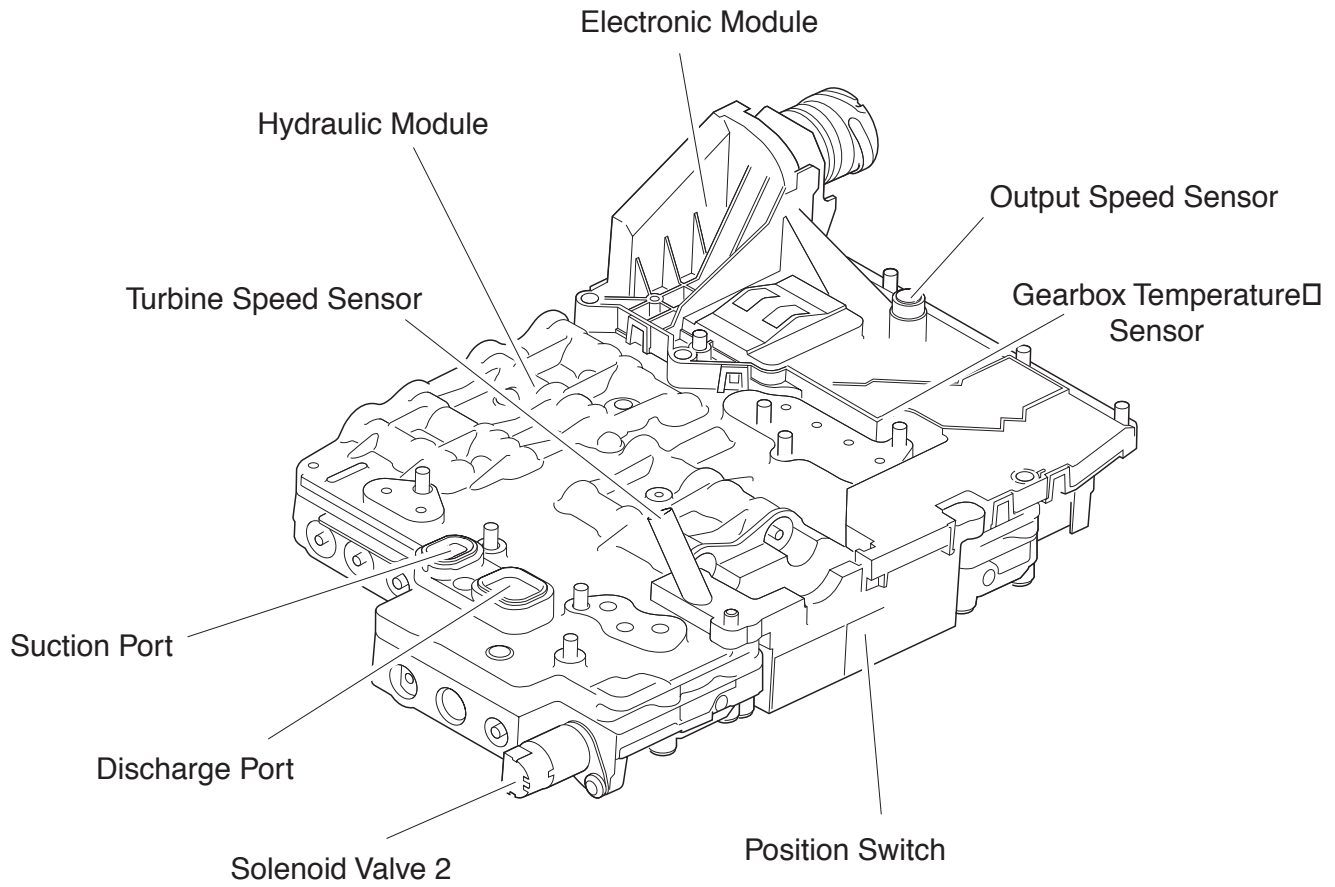
Figure 1. Mechatronic Unit

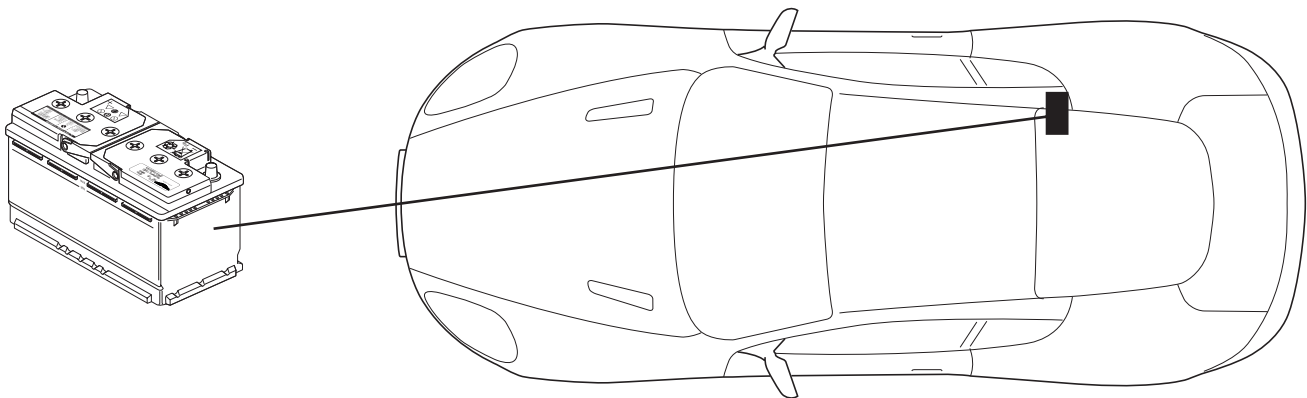
Figure 1. Battery Location

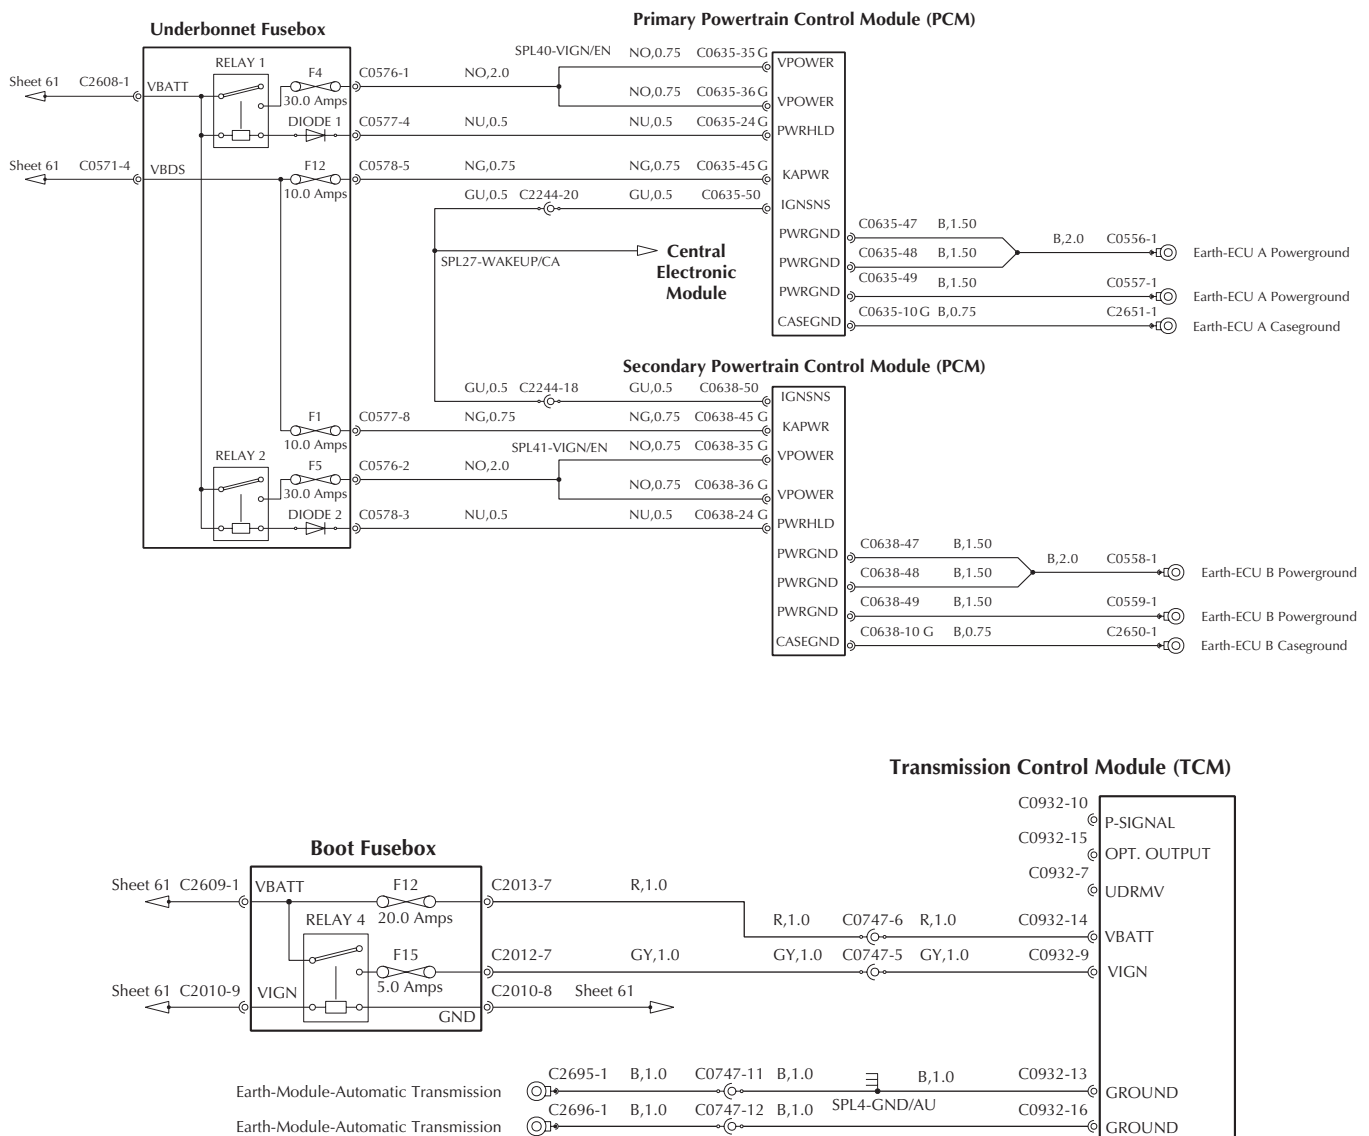
Figure 2. PCM and TCM Input Power Circuit.

3. Check the condition of the transmission connector socket pin C0932-14.

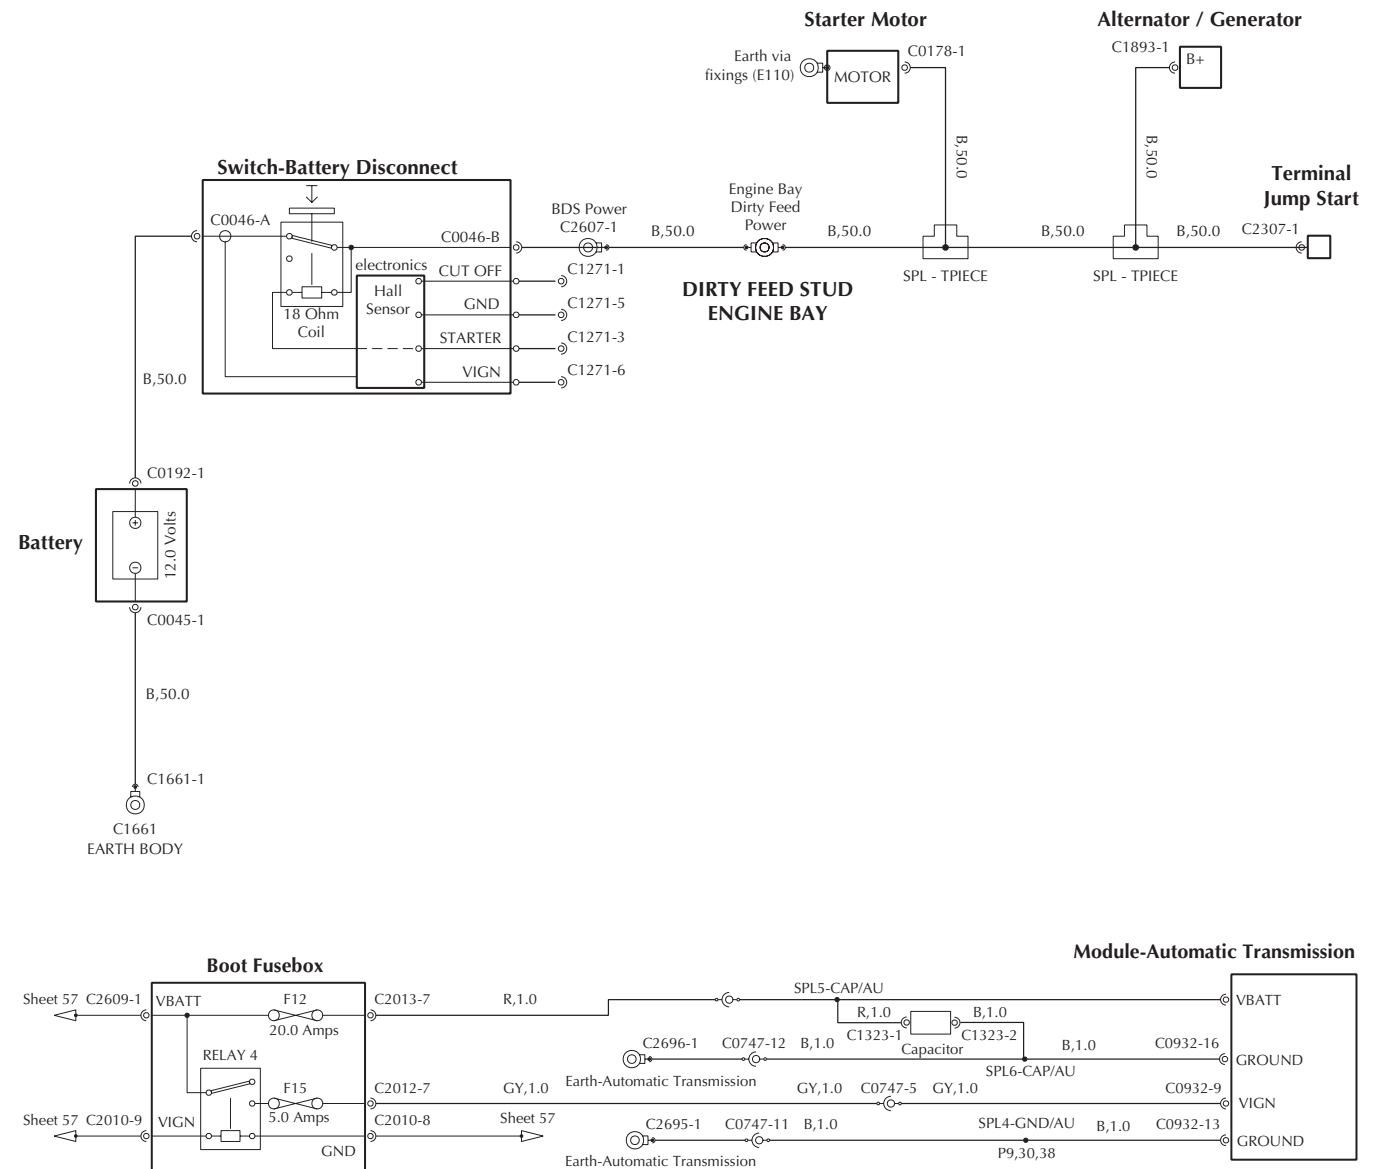
Figure 1. Battery Charging Circuit and Transmission Power Supply

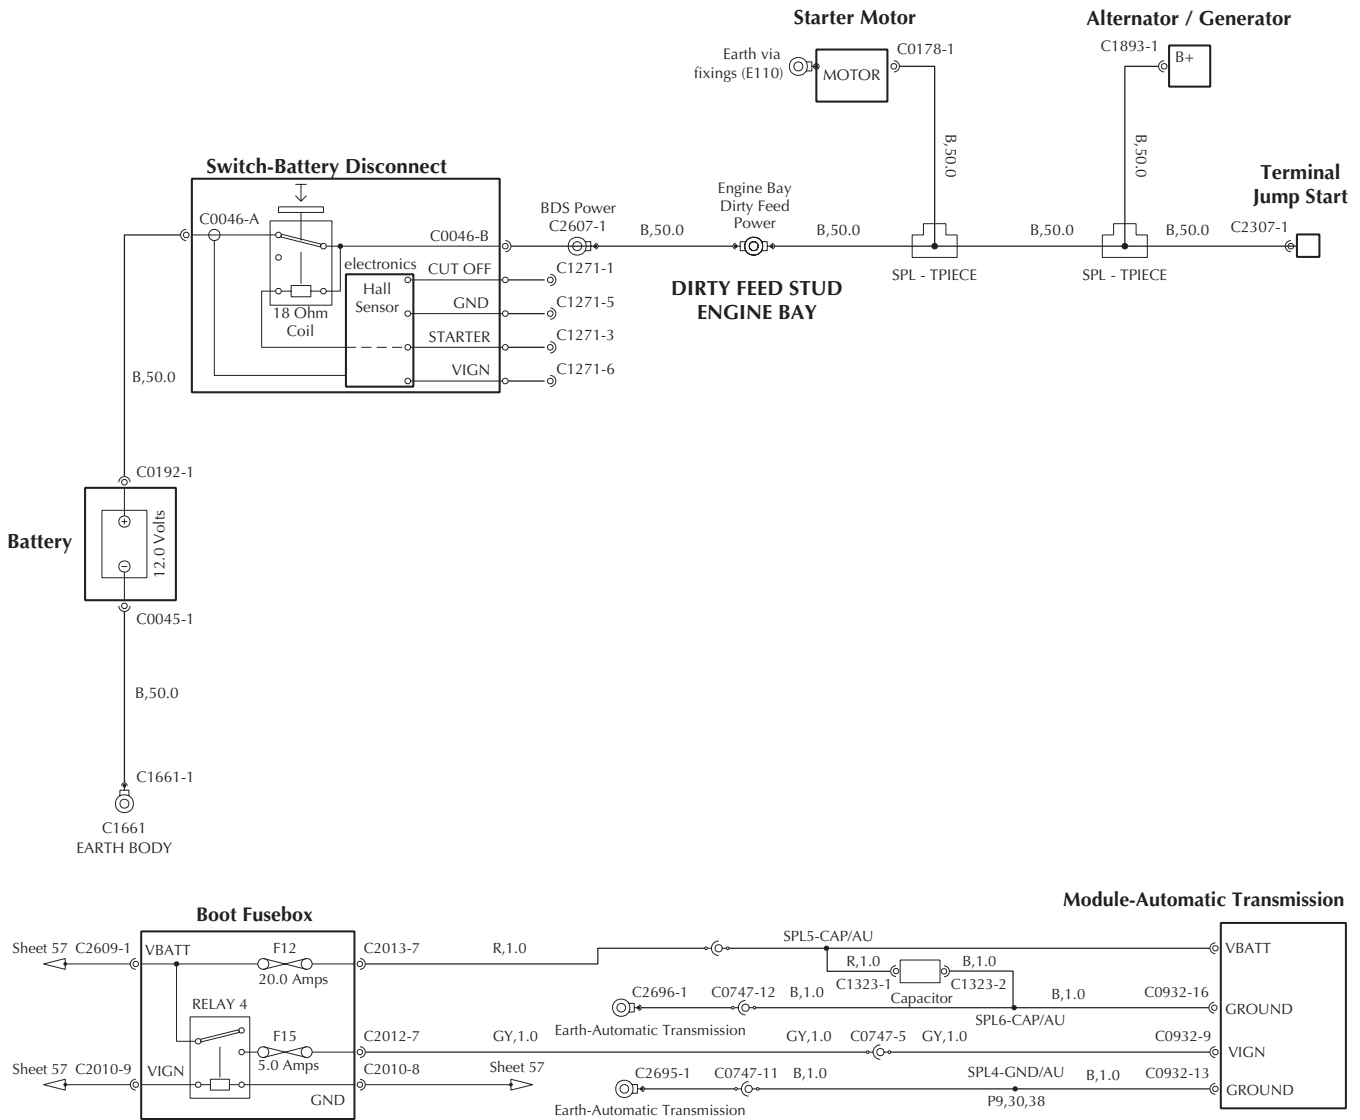
Figure 1. Battery Charging Circuit and Transmission Power Supply

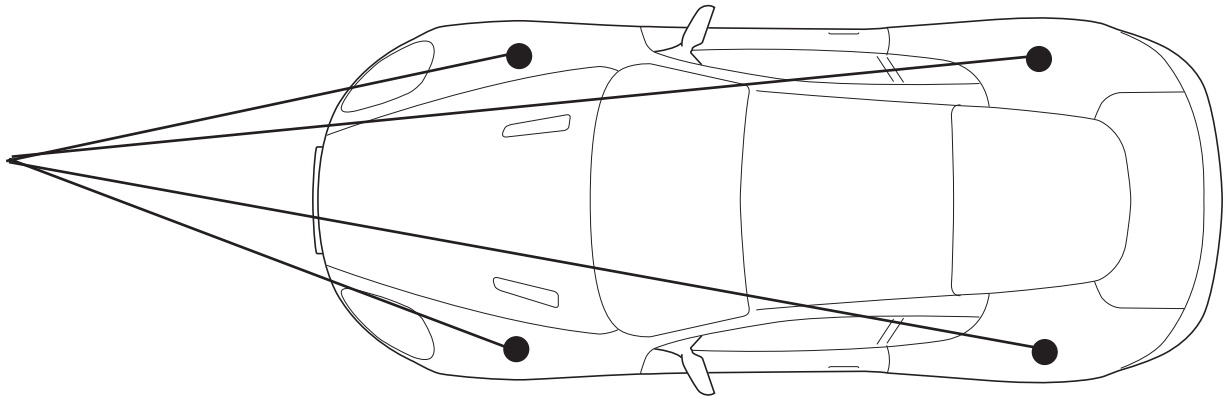
Figure 1. Wheel Speed Sensor Location
