DB9

OBD II Diagnostic Manual
Preliminary Issue

ASTON MARTIN LAGONDA LIMITED

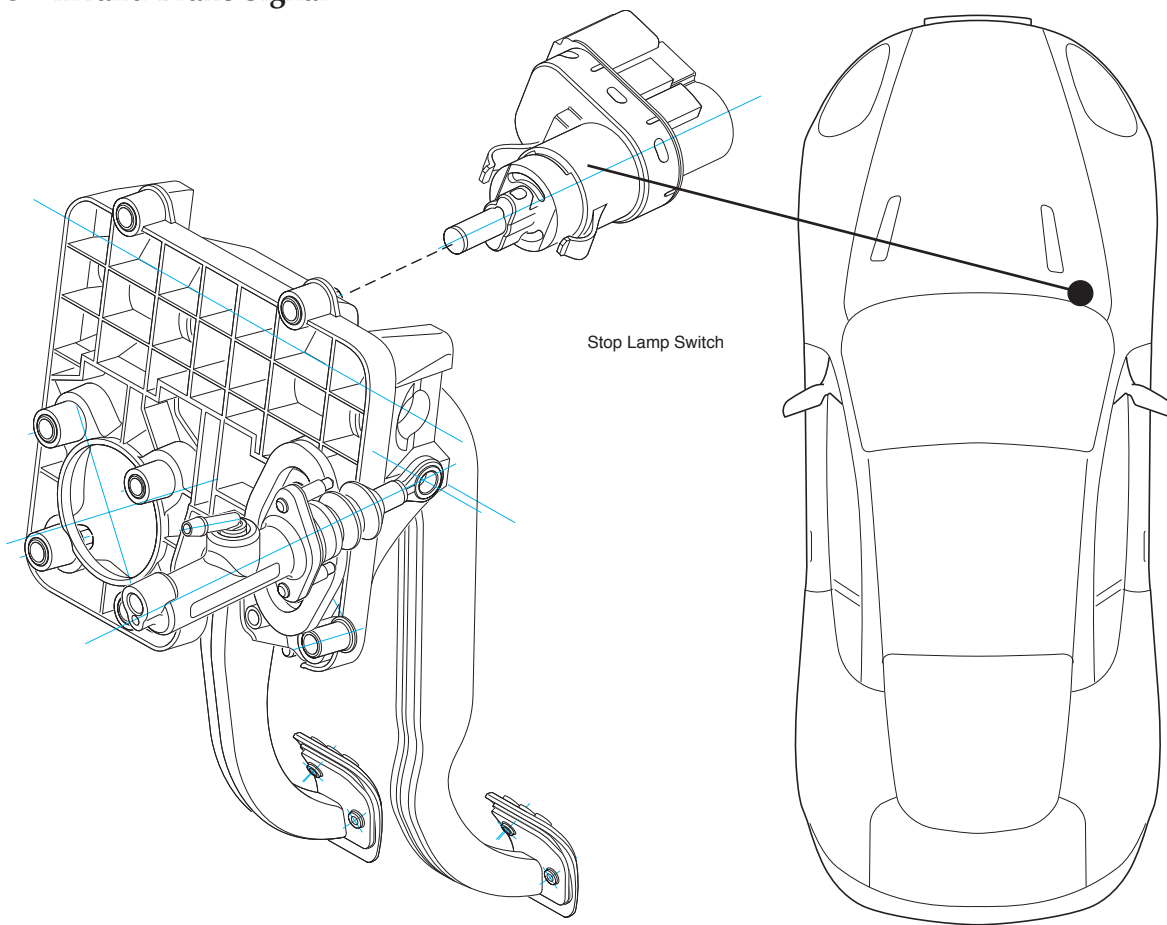
Figure 1. Brake Pedal Switch Location

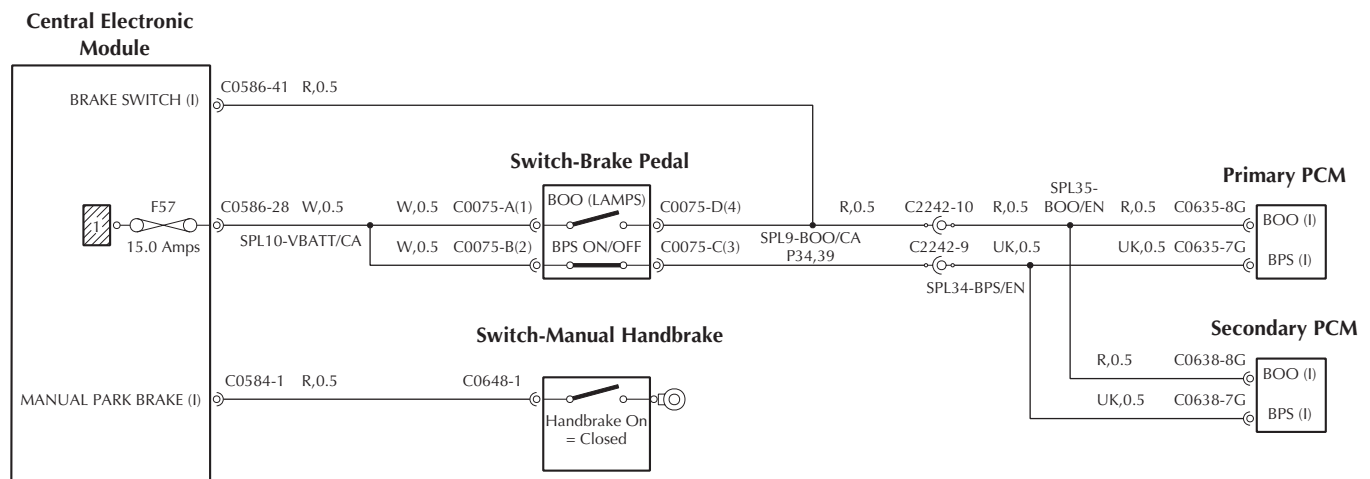
Figure 2. Brake Pedal Circuit

4. Ignition off. Complete a continuity check from PCM pin C0635-7 (or C0638-7), through the brake switch to Central Electronic Module pin C0586-28. Press and release the brake pedal. Continuity should be broken when the brake pedal is pressed.

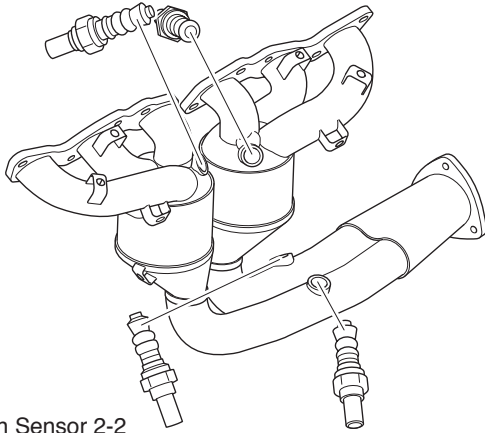
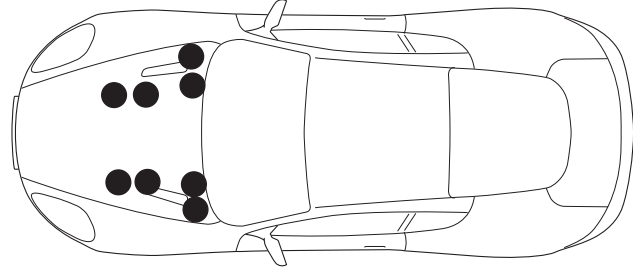
Figure 1. Oxygen Sensor Location

Heated Oxygen Sensor 1-1 Heated Oxygen Sensor 2-1

Heated Oxygen Sensor 2-2

Heated Oxygen Sensor 1-2

Remove each oxygen sensor and check for contamination or damage. Service any defects identified.
